FLOOD HAZARD ASSESSMENT FOR SARPANG DZONGKHAG

**FLOOD ENGINEERING AND MANAGEMENT DIVISION,
DEPARTMENT OF ENGINEERING SERVICES
MINISTRY OF WORKS AND HUMAN SETTLEMENT**

YEAR 2019

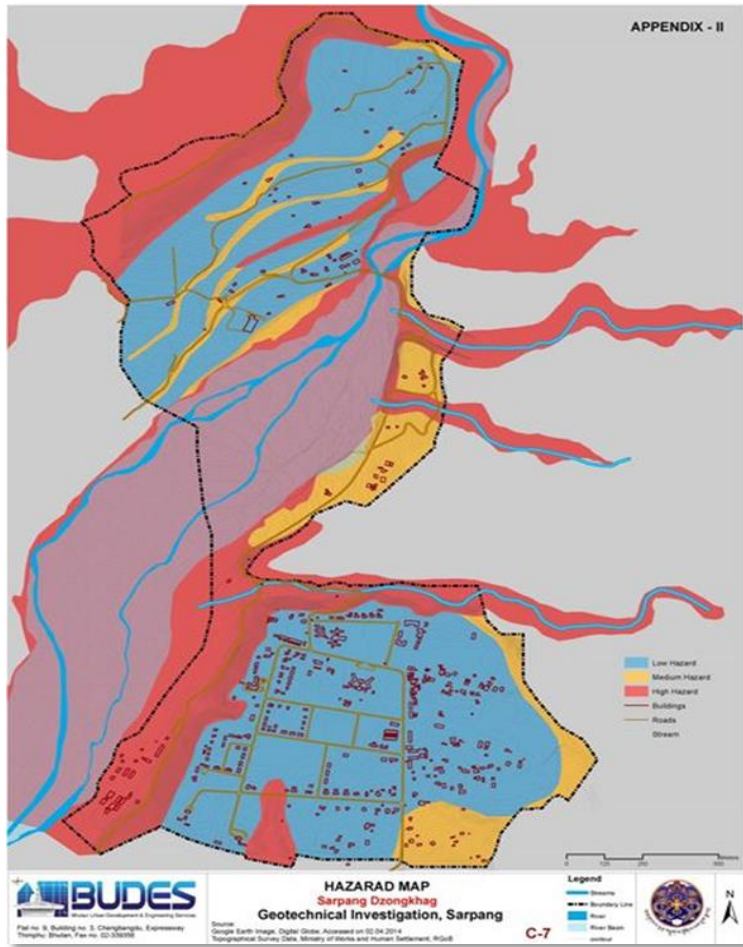
Figure 4 : Hazard Map for Sarpang Township.

Based on the study conducted, the hazard map as shown in *Figure 4* is divided into three zones: high hazard zone (red), medium hazard zones (yellow) and low hazard zones (blue).

High Hazard Zone: The high hazard zone covers the area with slopes greater than 230 (42 %), and areas which are vulnerable to flood, landslides and other unstable conditions. About 50 % of the area mapped falls under this zone, which is expected given the nature of the steep topography, fragile geology and risk of flooding from the Sarpang river as well as seasonal flooding (debris flow) during monsoon seasons. It is recommended that no settlement is approved within this zone because of the high risk of property damage and loss of lives.

Medium Hazard Zone: The medium hazard zone covers the area with slopes between 150 and 230 (27 % and 42 %), and areas which could prove to be hazardous in the absence of proper engineering efforts and mitigation measures. About 10 % of the area mapped falls under this zone. Although construction could be allowed in this zone on a case by case basis, it is paramount that destabilizing factors are studied in detail to provide relevant mitigation measures.

Low Hazard Zone: The low hazard zone covers the area with slopes less than 150 (27 %) and areas with no perceivable dangers to human settlement under normal conditions. About 40 % of the area mapped falls under this zone. Due to the minimum threat to human lives and property, this zone is deemed most fit for future settlements and other engineering works. However, it should be noted that misguided construction and unforeseen natural calamities could destabilize this zone in the future. Therefore, it is recommended that thorough study of impacts of manmade structures is done before approval of any projects in this zone as well.

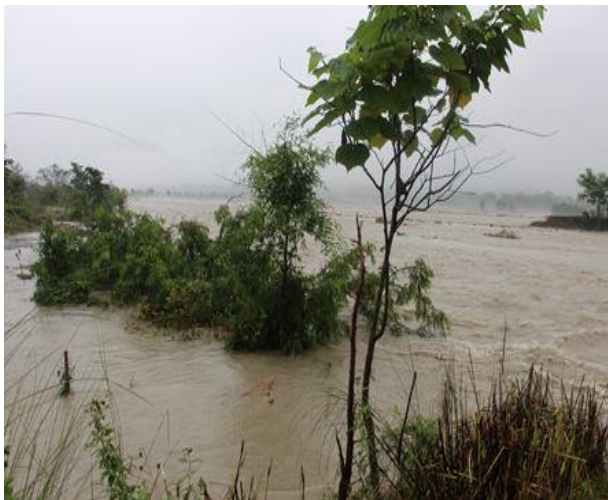
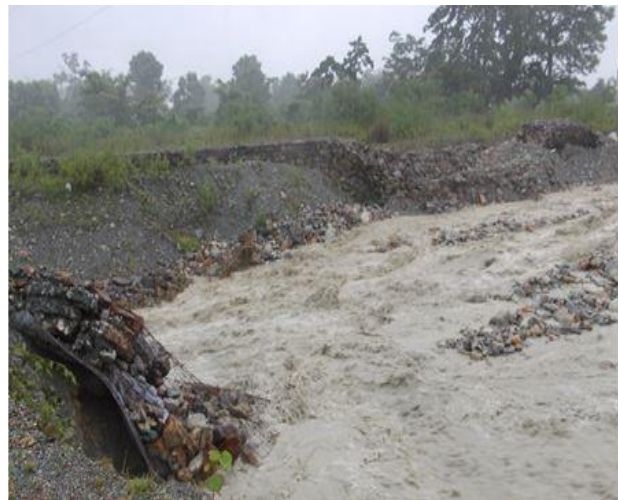
Figure 5: Flood event in Sarpang Dzongkhag

Further, infrastructure like roads, bridges, flood protection structures etc. are also being washed away by the flood every year as seen in *Figure 5* and hence, the Dzongkhag continue to invest huge amount of money for reconstruction works every financial year. Huge investment has also been made in the past for flood protection works. Further, due to climate change, the rainfall pattern and rainfall intensity has changed increasing the vulnerability of the community to flooding in the Dzongkhag. Therefore, to reduce the vulnerability of the community to flood, preliminary flood hazard assessment is carried out to identify the critical river in the Dzongkhag. Further, for the identified critical river, preliminary flood hazard map will be developed accordingly.

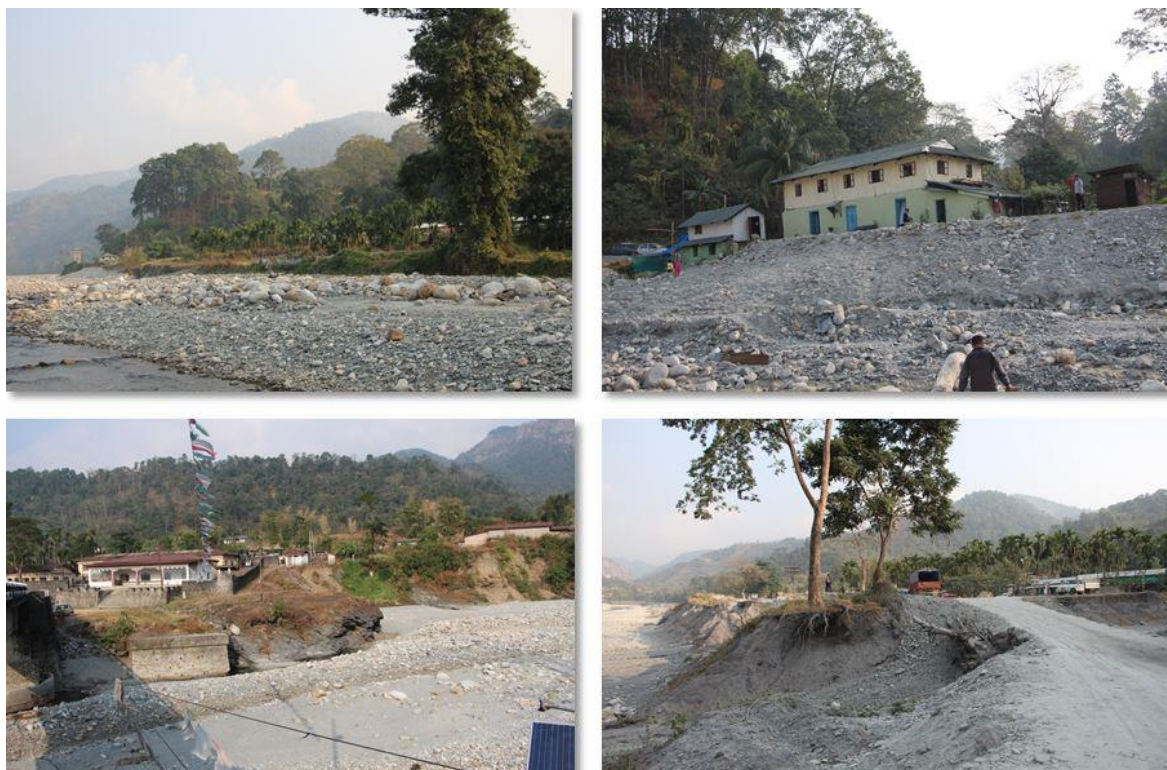
Figure 7: Critical areas along Sarpang Chhu.

The Sarpang Chhu has been creating havoc to the inhabitants and increasing the vulnerability of communities to the flooding every rainy season as seen from *Figure 7*. It has been changing its courses every season thus, rendering some of the fertile agricultural land useless, making people homeless and causing severe damages to roads and other infrastructures. As per the site investigations through visual inspection, the catchment of the Sarpang Chhu upstream of Hilley Bridge looks fragile and fresh landslides were seen. This can be confirmed from the siltation problem observed in Sarpang Chhu during the rainy season resulting in increased height of river bed. In the past, Sarpang Chhu has been trained by constructing flood protection structures. However, the structures had were repeatedly damaged or washed away because of the recurrent flash floods.

As per the record, lots of investment has been made in the past for flood protection works along the banks of Sarpang Chhu and still more protection works are required. A mixture of flood protection works such as embankment with AB mattresses, gabion walls, RRM walls etc. with different heights and designs have been constructed along the banks of Sarpang Chhu. Some of the walls are still functioning partially at present.

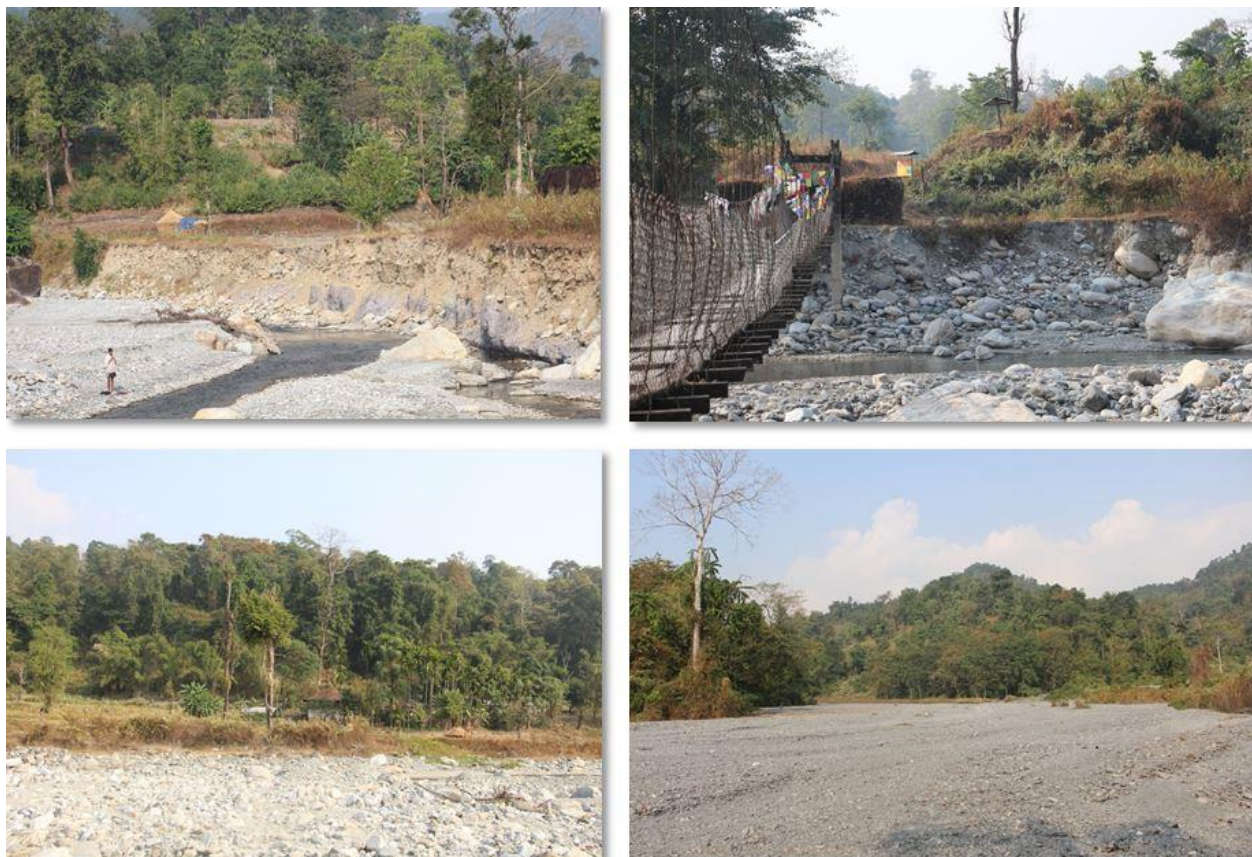
Figure 8: Flood prone areas in Gakiling Gewog.

Therefore, if proper interventions are not done at this stage, then there is higher probability of river breaching their banks and entering the Sisty village. Hence, it is highly recommended to construct flood protection structures along the left bank of Sisty Khola and also to restore the foundation of suspension bridge abutment.

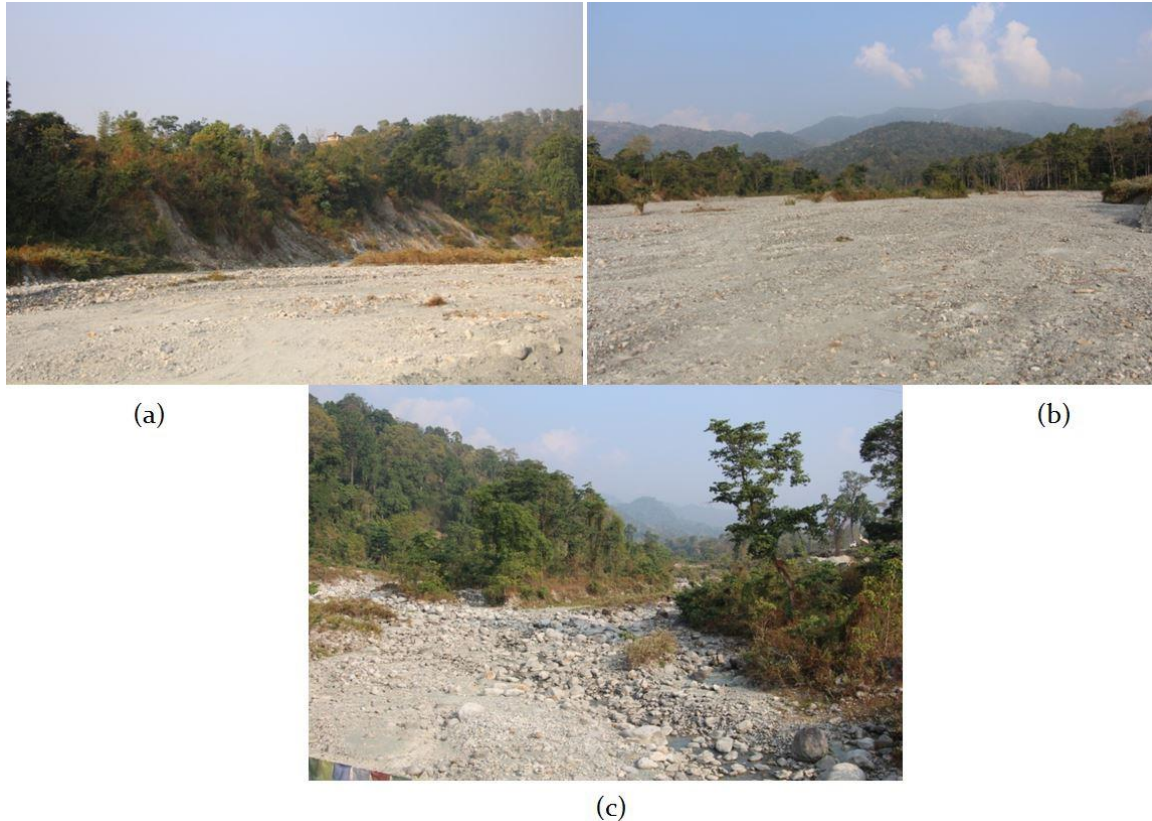
Figure 9: (a) Tinpati Khola (b) Leukhola and (c) Dholkhola

As seen in the *Figure 9*, the settlements are not located near the rivers, therefore, there are not so much destructions by the rivers during the rainy seasons. All the three rivers are seasonal. During the assessment, it has been observed that there is minor scouring along the river banks of the three rivers. Tinpati Khola and Leukhola are of meandering nature and lots of forest land has been converted to the flood plains along the rivers.

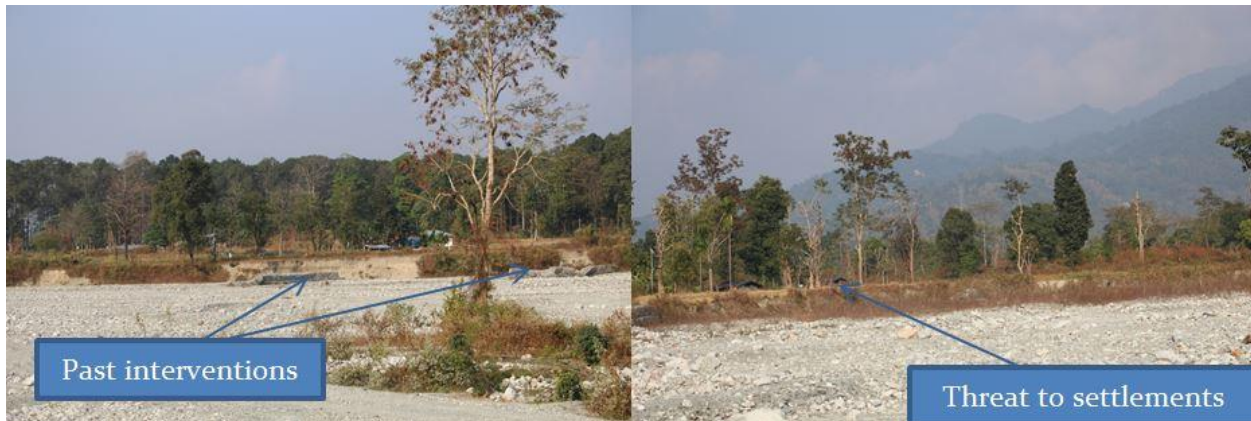
Figure 11: Threat from the Paithra Khola.

During the site investigation, it has been observed that Paithrai Khola is one of the notorious rivers posing threat to the settlement and agricultural fields in Samtenling Gewog. This is confirmed by the fact that Dzongkhag Administration has also carried out interventions in the past to reduce the vulnerability of community to flooding in Samtenling village as shown in *Figure 11*. The past interventions carried out have also failed in some places due to erosive nature of the river during the rainy season. The river beds are also covered with sediments implying debris problem in the rivers. From the visual inspection, it can be seen that scouring is happening along the river banks. Therefore, some more interventions are required to protect both the settlements and agricultural lands from flooding from Paithrai Khola in the Gewog.

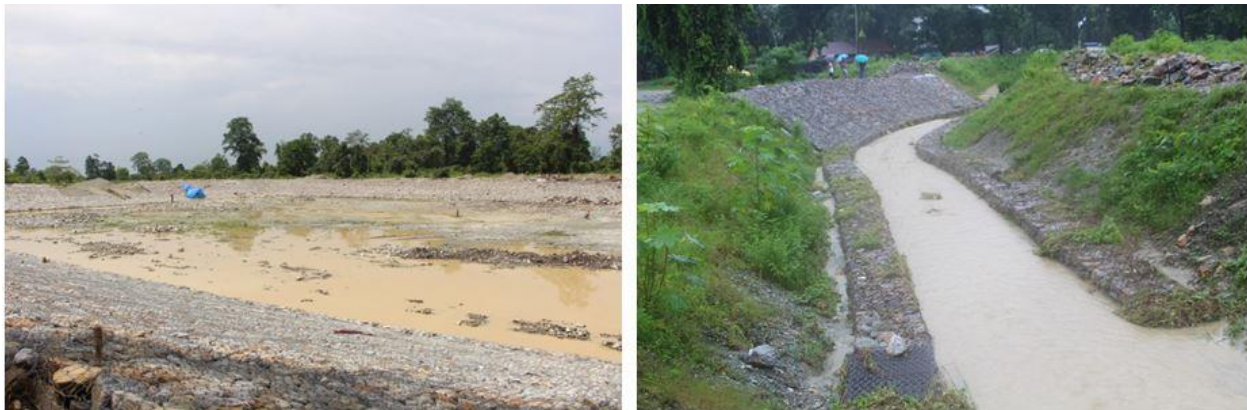
Figure 12: Detention pond and floodway in Gelephu.

Therefore, to reduce the impacts of flooding near the international check post, FEMD constructed a detention pond with a capacity to store the runoff of 38,100 cum for a certain period of time as presented in *Figure 12*. The concept of detention pond was introduced for Aipoly as a pilot project. The water is to be stored and discharged in a controlled way through the outlet within the capacity of the storm water drain near the culvert. The detention pond was designed to be a pool created by excavating the earth below the ground level. The maximum hydrostatic pressure developed with full capacity would be withstood by the natural ground without having to reinforce with additional structures other than revetment. Further, a floodway is also constructed at the downstream of the detention pond to properly discharge the water retained in the pond to the drain near the international check post.

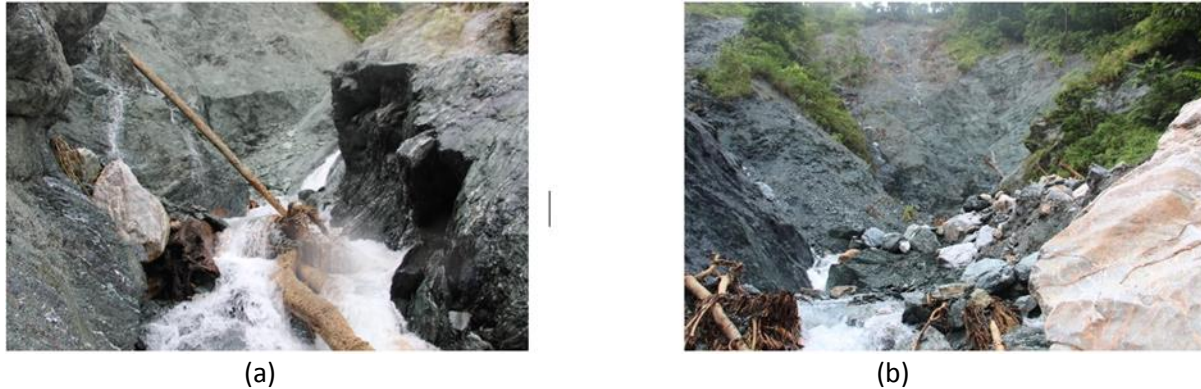
Figure 14: (a) Source of Shetikheri (b) Landslide at source.

contributed to the increase in runoff and sediment load. The source of the Shetikheri is as shown in *Figure 14*.

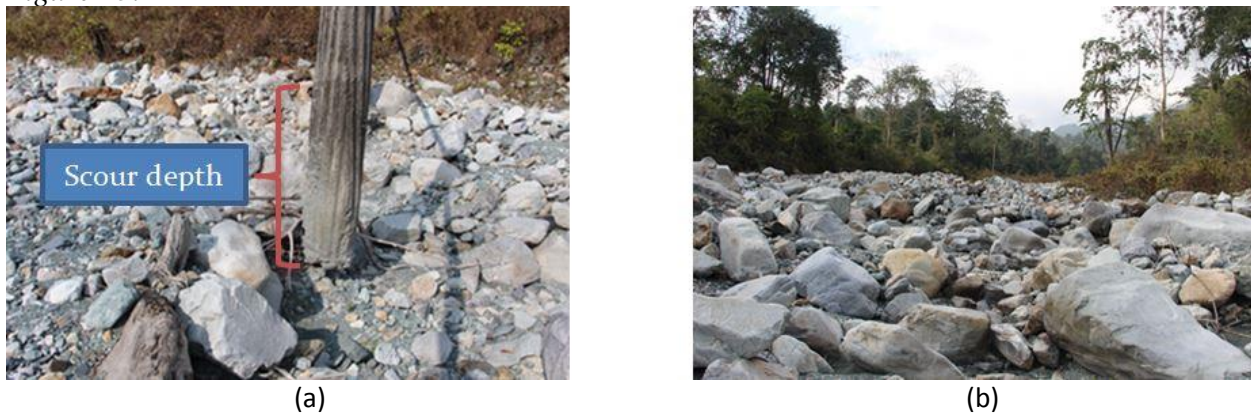
Figure 15: (a) Scour depth on the pillars (b) Debris collected at the downstream of Shetikheri.

During heavy rain over an extended period of time, it carries huge volume of debris as given in *Figure 15*.

It normally starts to meander along its way causing flooding at various locations downstream. As per the assessment, there is an erosion of the bank on the upstream portion and thus, the sediments are transported to the lower plains in the downstream portion of the river during rainy season. As the sediments are transported to the floodplains, the elevations of the floodplains are raised and thus, the flow path of the river is reduced. Therefore, the river flows through a new path during peak season with lower elevation resulting in meandering rivers. The Shetikheri stream is adjacent to Pelrithang village (Left Bank) and Zomlingthang village (Right Bank) and encroachment towards these settlements during the monsoon is common due to its meandering nature. Meandering or change in course is caused mainly due to the deposition of massive quantity of debris during the flooding.

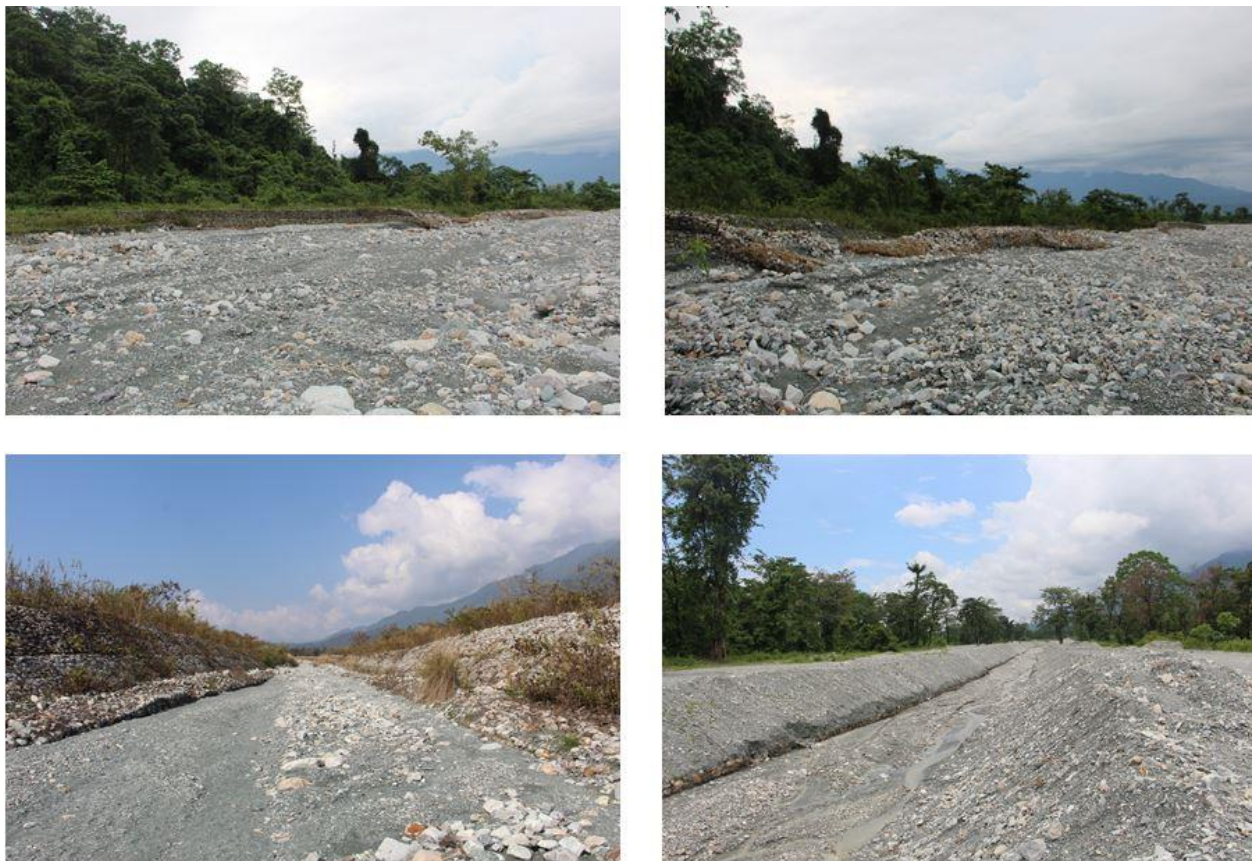
Figure 16: Past interventions along Shetikheri (Gabion walls and floodways).

Past interventions for flood protection has also been done by construction gabion walls of height ranging from 2 to 3 metres at critical points. Further, in order to prevent flooding of the adjacent villages, channelization/floodway was constructed as given in *Figure 16*. A floodway of 12m width was constructed upstream of the culvert on the main highway in the year 2012 with technical backstopping from FEMD. In the financial year, 2015-2016, floodway of width 20 metres and length 700 metres was awarded to contractor, which was still ongoing at the time of flooding in July, 2016. Further, during the financial year 2016-2017, gabion walls with apron have been designed at the identified critical areas by FEMD to reduce the vulnerability of communities to flooding in Gelephu Gewog.

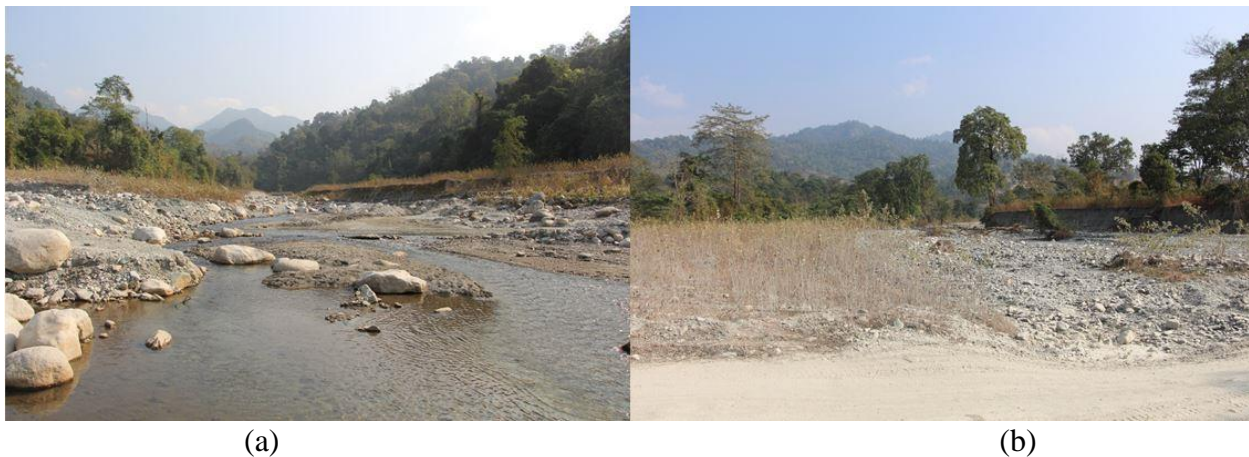
Figure 19: (a) Thewar Khola and (B) Masana Khola in Shershong Gewog.

Figure 19. When the Thewar Khola gets swollen, the connectivity between Shershong village to Norbuling village in the Shershong Gewog and also connectivity between Shershong Gewog and Chuzaygang are affected. Similarly, when Masana Khola gets swollen, there are no connectivity between Shershong Gewog and Chuzaygang Gewog.

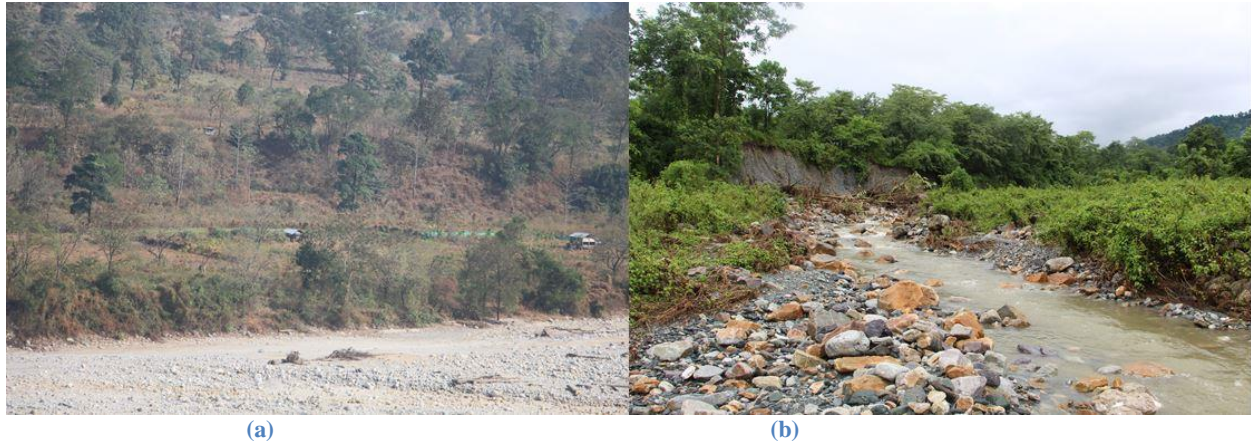
Figure 20 : (a) Mao River and (b) Jangkukung Chhu.

During the assessment, the team observed the Shershong village located on the left bank of Mao River is threatened by the Mao River. There are chances of Mao River breaching its bank and damaging the agricultural fields in Shershong village in future as seen in figure below.

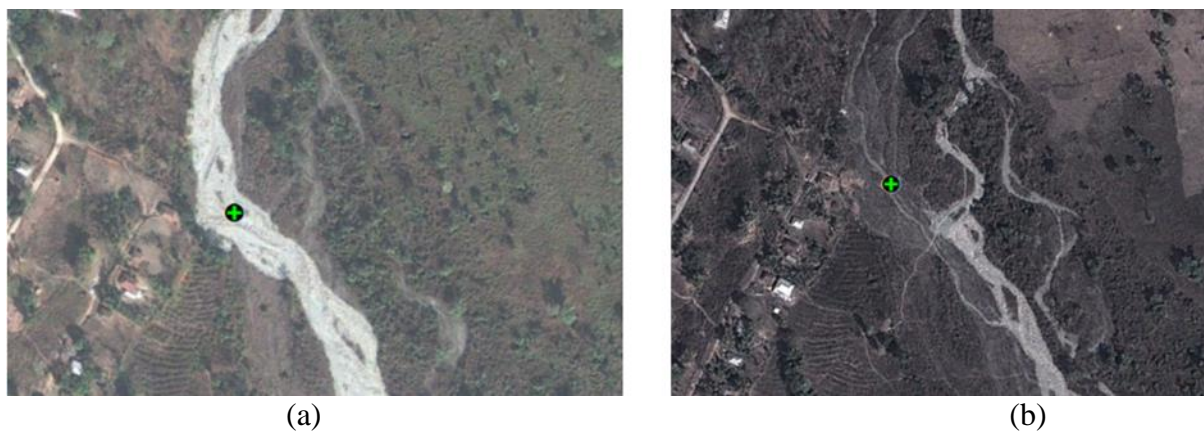
Figure 21: (a) Flowpath in 2010 (b) Flowpath in 2013.

The team observed that Jangkukung Chhu does not pose much threat to the settlements at present. However, it has been noticed that a lone house on the right bank of the river is threatened by the landslides caused by the erosion of the river bank. Therefore, a google image time series analysis has been carried to see the meandering nature of the stream. It is observed that the river course changes from time to time as presented in *Figure 21*.

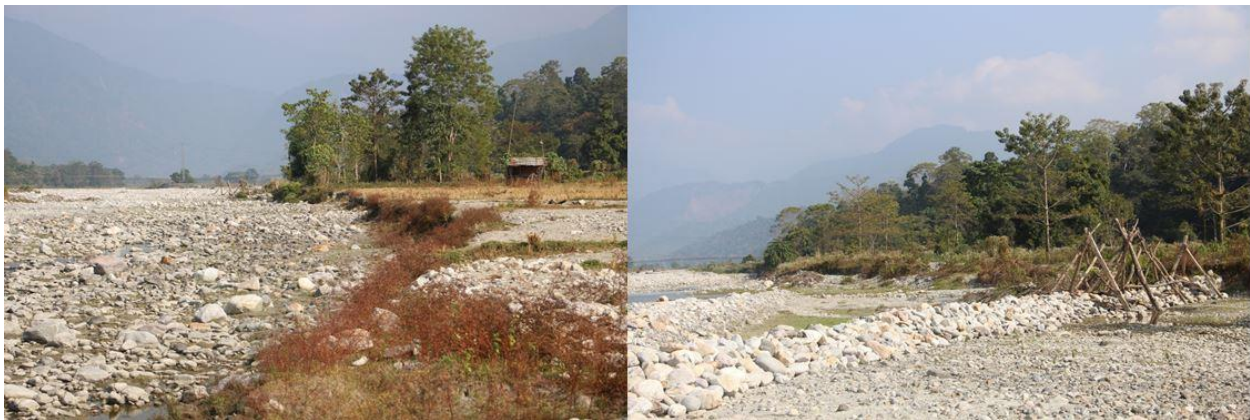
Figure 22: Agricultural field on the left bank of Taklai Chhu.

Taklai Rivers flows through Zamlingthang village under Umling Gewog. Almost 75% of the paddy field was washed away by flash flood in mid-2016. These areas affected by the flood were mainly used for agriculture purposes and there were no household. During the site investigations also, the flooding threat was mainly to the agricultural land used for rice cultivations in the Gewog. The recent flood in 2016 also resulted in the river bed level reaching almost the same level as existing ground level as given in *Figure 22* and therefore, an appropriate flood protection structures are required on the left bank of the Taklai River to protect the agricultural field.

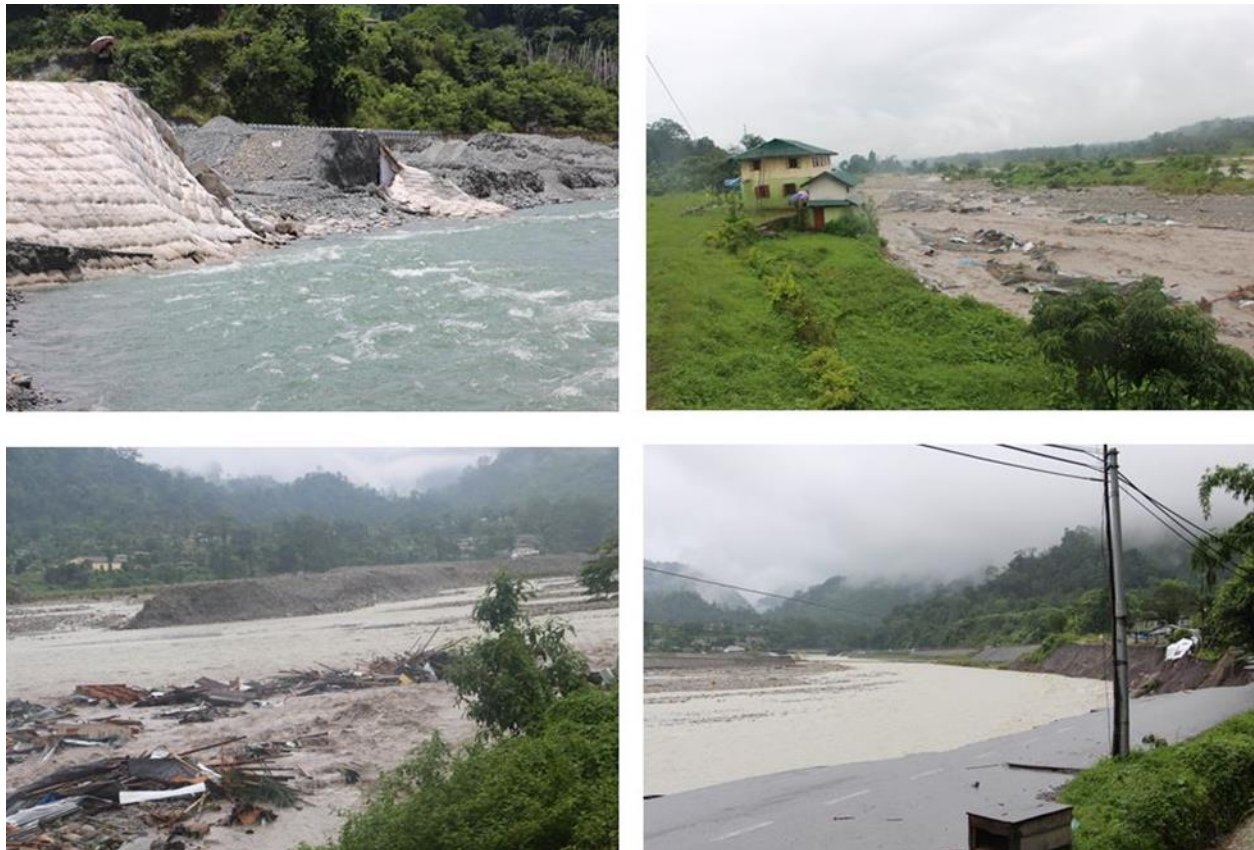
Figure 23: Destruction caused by the flood in July, 2016.

Sarpang Dzongkhag experiences heavy rains during summer season every year. The people living in the Sarpang Bazaar, mostly made up of bamboo houses located on the left bank of Sarpang Chhu live in fear. As per the local residents, Sarpang town experienced major devastating flood in the year 1996, which washed away the whole Sarpang Bazaar. Recently, the flood in July 2016, also caused major damages to the roads, ongoing flood protection structures, agricultural fields and rendered all the people residing in Sarpang Bazaar homeless as shown in *Figure 23*.

The recent flood was caused due to continuous rain that lasted for more than a week. Non-stop rain that started since 14th July led to the swollen Sarpang Chhu which began to change its course towards the left (*Figure 25*) from its usual flow along the right bank (*Figure 24*). The meandering of the river was caused due to the sedimentation at the low point triggered by the change in direction upon hitting the huge boulder and RRM wall at the right side of the bridge abutment. From 21st July morning, the river encroached towards the Sarpang makeshift town and slowly scoured and carried away the land and the houses. By 25th July, the river had washed away 480 m of Gelephu-Sarpang-Damphu primary national highway. The river however, didn't enter the small island in the midst of Sarpang Chhu which has a Hindu Temple.

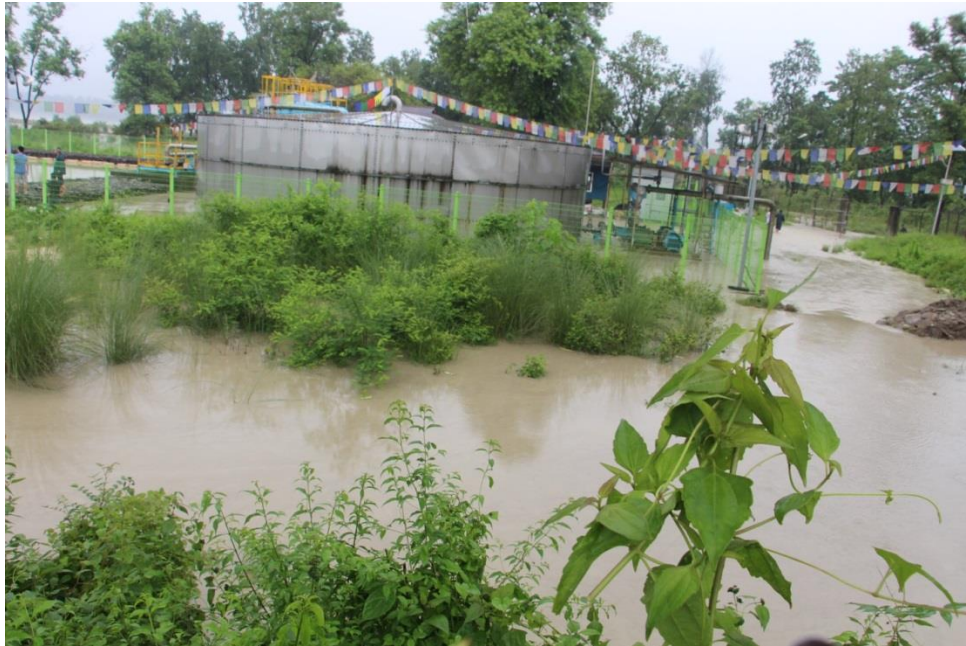
Figure 26: Mao River flowing towards the Infiltration Gallery.

During the flood on 22nd July, 2016 the flood water has entered the infiltration gallery filling it with huge debris and sediments as seen in

Figure 26. The flood damaged the 500m long spur wall which collapsed resulting in filling up of the infiltration gallery with debris. It also caused damages to RRM wall. The fencing (MS angle and MS wire mesh) around the infiltration gallery were also damaged incurring a loss of about Nu. 0.7 Million.

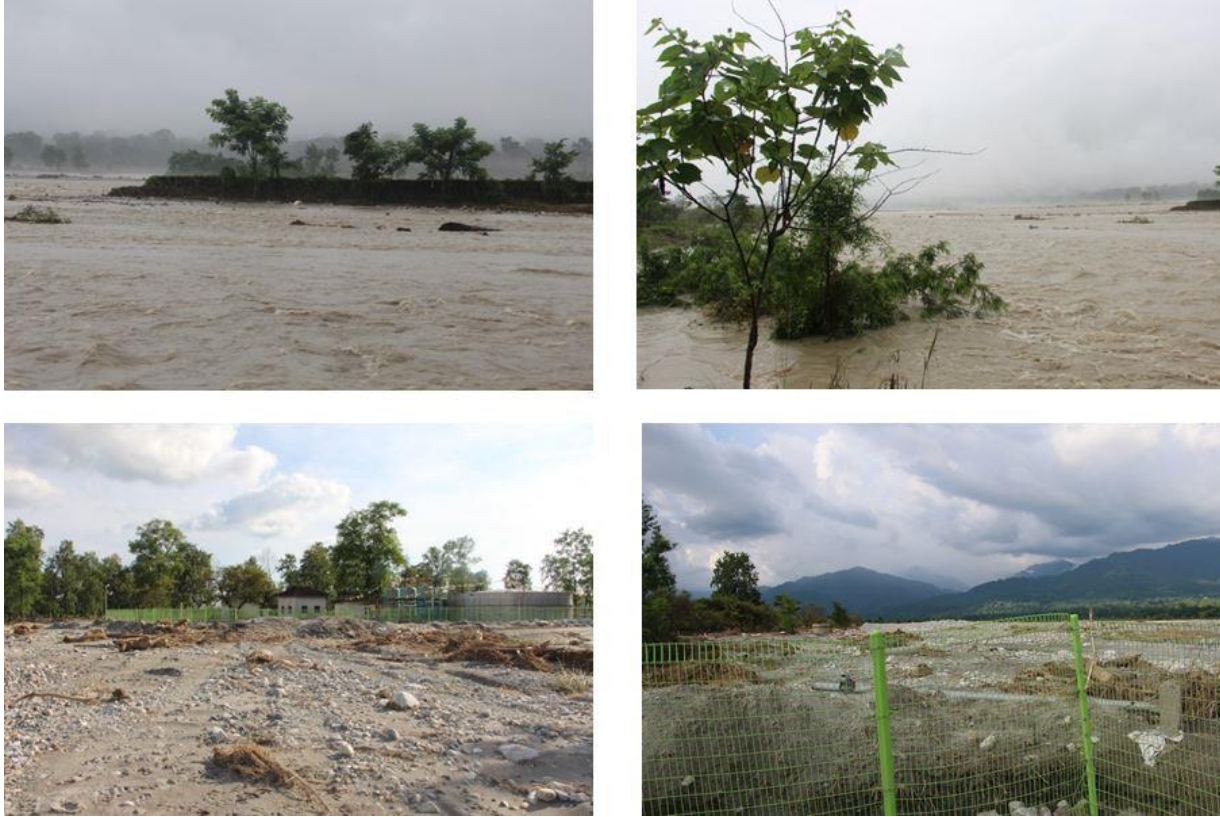
Figure 27: Destructions caused by Mao River near the Infiltration gallery.

The Inner surface of the Infiltration gallery is constructed using gabion walls. The depth of the infiltration gallery is 13m below the ground. During the flood, although efforts were made to prevent heavy debris from entering into the infiltration gallery by the Thromde officials with the help of volunteers, huge amount of silting has been deposited inside the infiltration gallery. This has resulted in reducing the pump efficiency as well as the quantity of water supply. The restoration works for the infiltration gallery incurred about Nu.0.4 Million which included the use of excavators and removing silts deposits from the gallery. Further, the flood also damaged RRM (Random Rubble Masonry) walls, compound lighting and 2 numbers of submersible pumps incurring a loss of about 0.9 Million, 0.1 Million and 0.6 Million respectively as given in *Figure 27*.

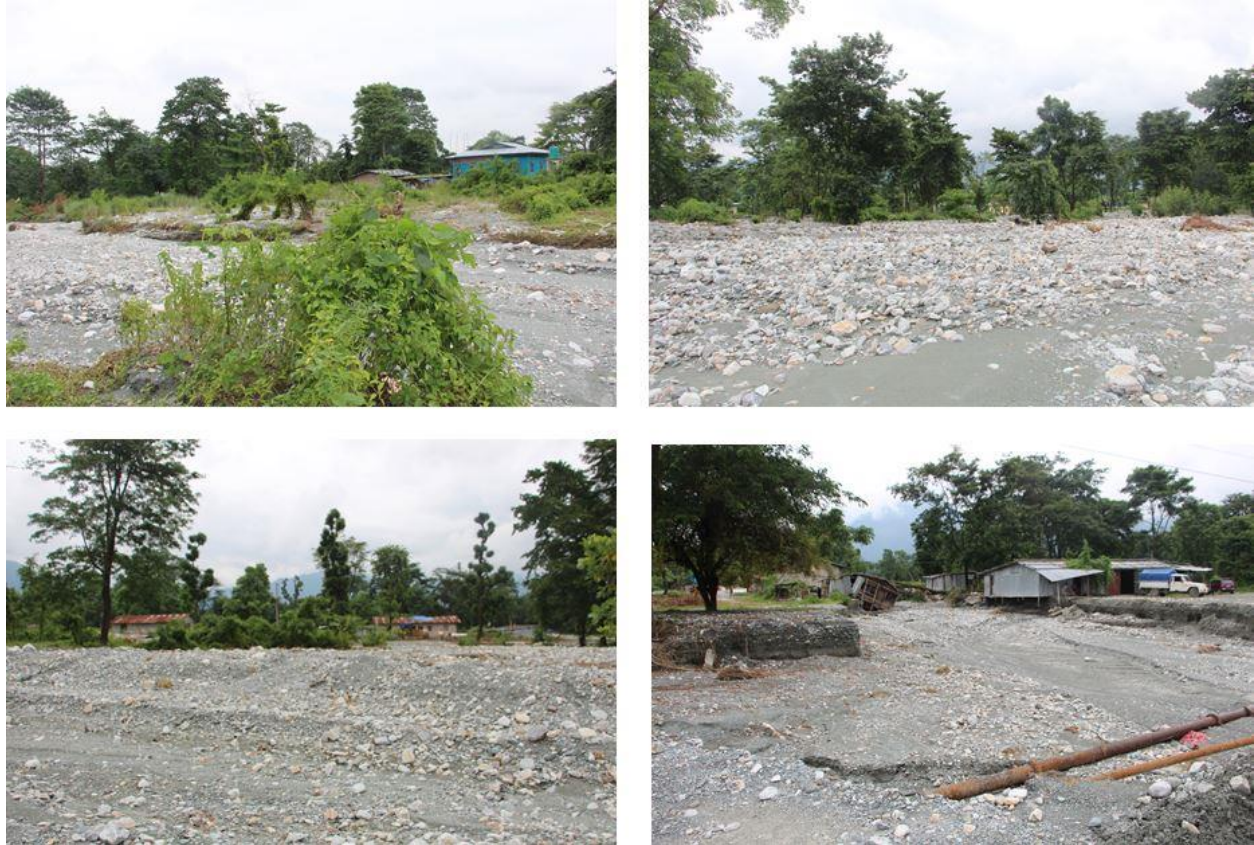
Figure 28: Settlements along Shethikheri affected by the flood.

settlement on right bank, damaging the culvert on the right bank in the process. After continuous deposition on the right bank the river changed its course towards the left affecting the settlement on the left bank. In this way, lots of settlements were affected and people were evacuated with their properties to a safe location.

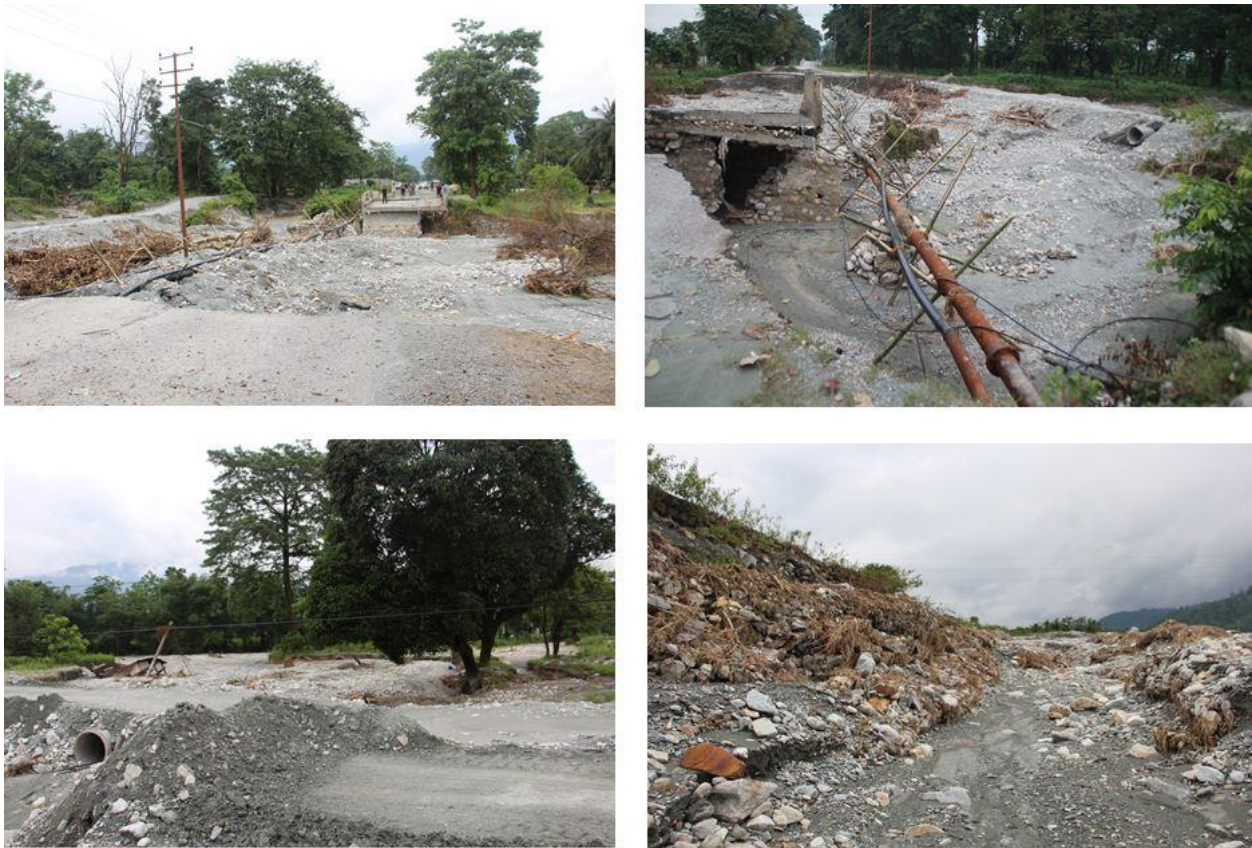
Figure 29: Destructions caused by the Shetikheri stream.

The flooding also damaged roads, transmission lines and water pipe lines on national highway as given in *Figure 29*. The floodway was also damaged and covered with debris. The gabion walls constructed on the critical areas along Shetkheri was also damaged by the flood of July, 2016.

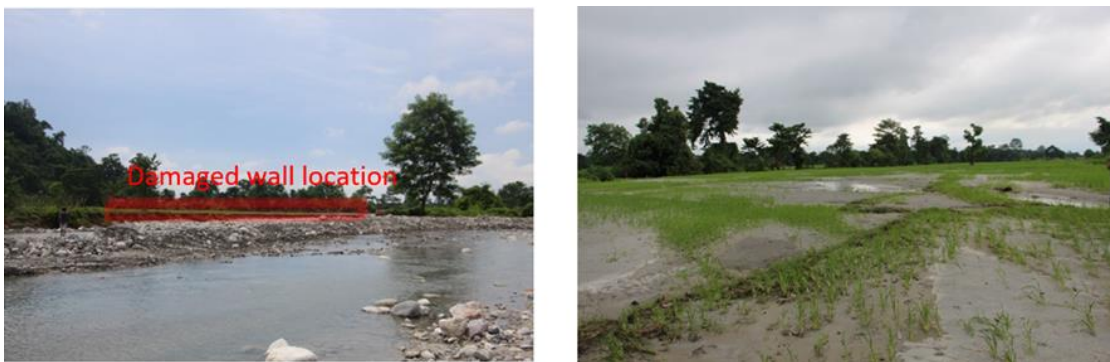
Figure 30: Damaged wall and affected paddy field locations.

The flood in July, 2016 caused major damages to the agricultural land and minor damages to the flood protection structures along Taklaichu as presented in *Figure 30*. It was apparent during the site visit to the affected area that the debris and sediment from the flooding had severely submerged some parts of the agricultural land.

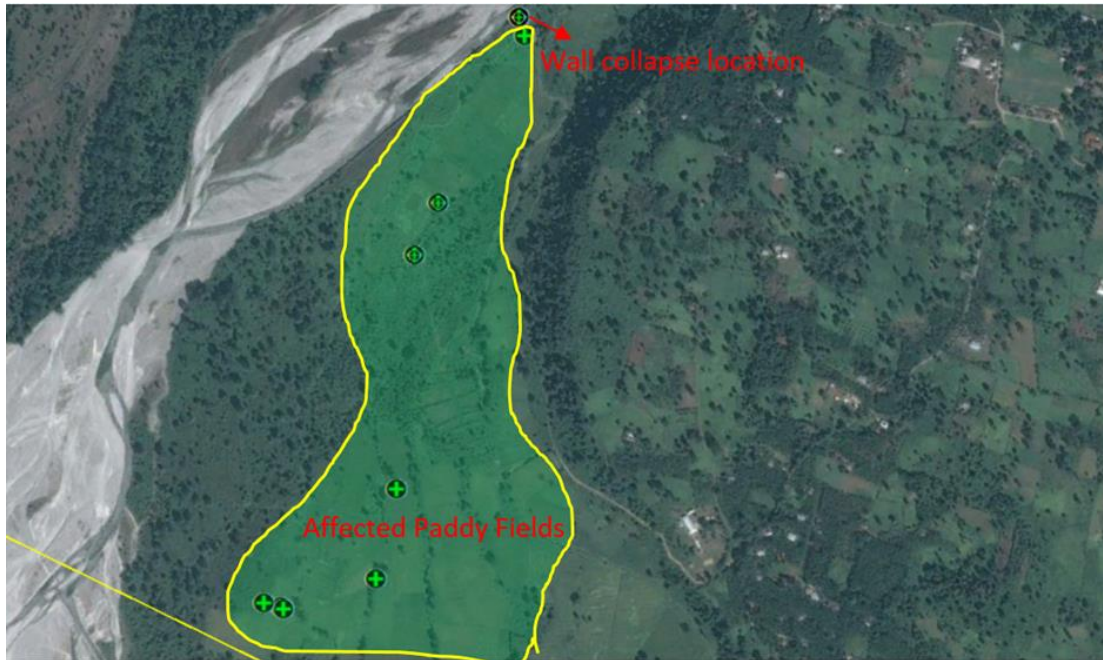
Figure 31: Paddy field damage location at Gadhen and Linger Village.

With regard to impact of flooding on to the 1000m river training walls that existed just before the flood, the team was informed by the local representatives that the wall had suffered some minor damages as a result of floods of 2008 and 2015. Due to shortage of funds, the damaged gabion walls could not be repaired. And therefore, the recent flood broke through the already damaged gabion wall which eventually collapsed resulting in free flow of Taklai River towards the paddy fields, damaging the existing 1000 meter earthen irrigation channel in the process. The earthen channel also aggravated the flooding by favoring the river flow towards the paddy fields. The *Figure 31* shows the location of the affected paddy field by Taklaichu in 2016. In total, 826 meter of gabion of 4 meter height was completely washed away. The remaining 174 meter experienced damages to the apron although the wall was still standing at the time of the visit.

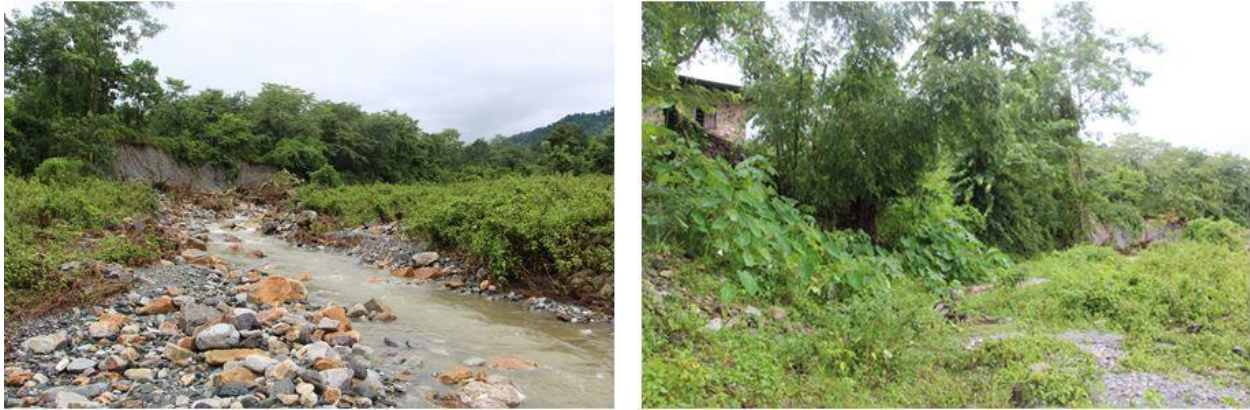
Figure 32: Minor landslide and scouring along Jangkukung chu.

The flood in July, 2016 also causes some minor damages along the river banks of Jangkukung Chhu as a result of scouring and erosion. The local people informed that there are about 25 households along the right bank of Jangkukung chhu. As per the assessment, there were signs of fresh scouring and slides along the right bank and one house was found directly exposed to the risk of flooding as seen in *Figure 32*. As per the house owner, the recent flood scours the river bank and created slides, which started to encroach into his land.

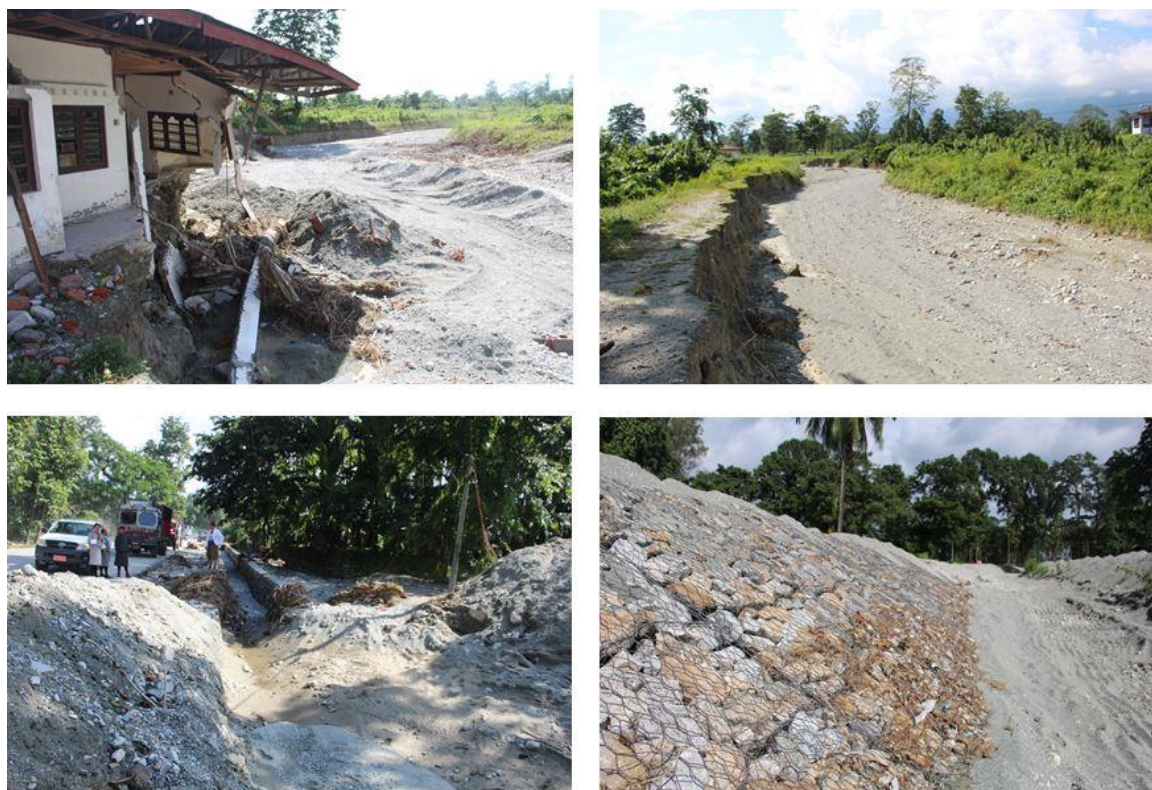
Figure 41: Flood damages along small Aipoly.

The ongoing floodway construction protected the houses and settlements during the recent flood as it provided sufficient flow path for the discharge generated after the pond collapsed. The flood way however got filled up with sediments during the event and scouring of the flood way banks occurred throughout the entire stretch as given in *Figure 41*. The physical progress of the work was 30% and the financial progress was 20% as of 6th July 2016.
