# FLOOD HAZARD ASSESSMENT FOR CHUKHA DZONGKHAG

FLOOD ENGINEERING AND MANAGEMENT DIVISION,  
DEPARTMENT OF ENGINEERING SERVICES  
MINISTRY OF WORKS AND HUMAN SETTLEMENT

YEAR 2019

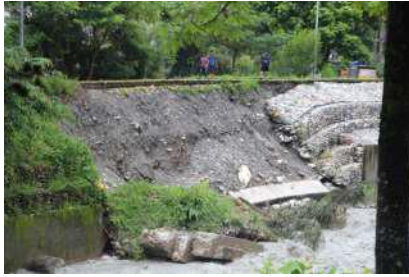
Figure 2: Damages caused by Dhoti Khola.

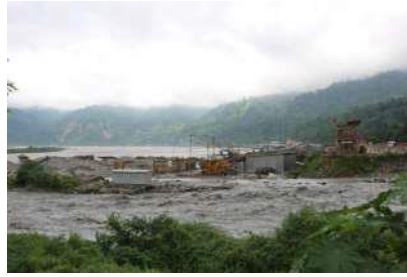
Figure 3: Damaged caused to the properties at the confluence of Dhoti Khola.

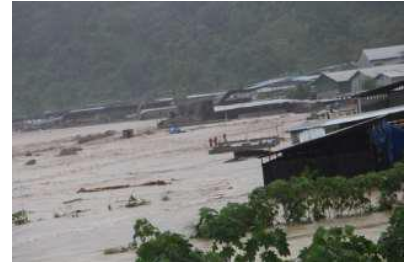
Figure 4: Damages caused by Amochu.

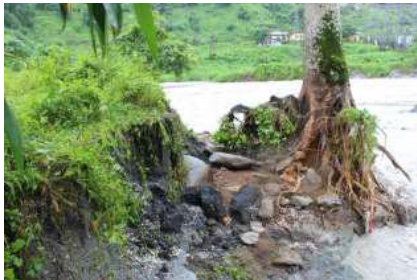
Similarly, Barsa River also caused erosion along the river banks due to increase in the river discharge during the southern flooding in July, 2016 as depicted in Figure 5 and Figure 6. However, the flood protection structures along the river banks protected the settlements from the flood as seen from Figure 6 during the 2016 flood. The electric power station located on the right bank of Barsa River is on the risk of flooding as it is situated very near to the river.

Figure 5: River bank erosion during the flooding.

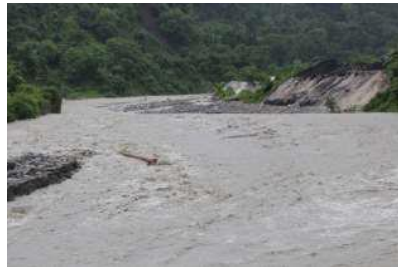
Figure 6: Barsa chhu during the high discharge.

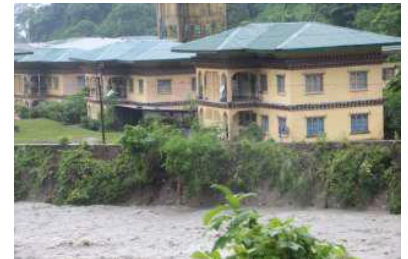
Figure 7: The flood protection structure protecting the housing colony.

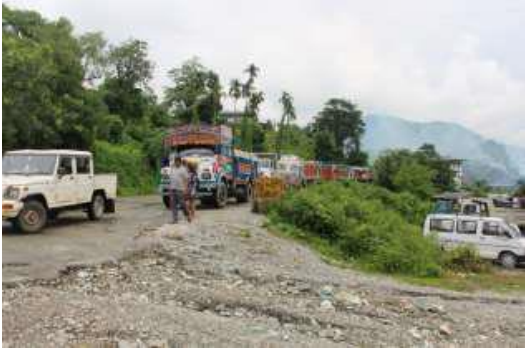
The Bhalujhora River also caused damaged to the temporary road/ bypass connecting Phuentsholing to Pasakha. The Figure 8 shows the vehicles and people stranded due to increase in river discharge during the July, 2016 flood. The Bhalujhora Bridge as seen in Figure 9 at present can only be used by people and light vehicles during low flow and dry season as it was damaged by the flood in 2012. The heavy vehicles use bypass located on the upstream of the bridge to go to Pasakha industrial area. The river meanders and changes its course very season.

Figure 8: The vehicles stranded during the July, 2016 flood.

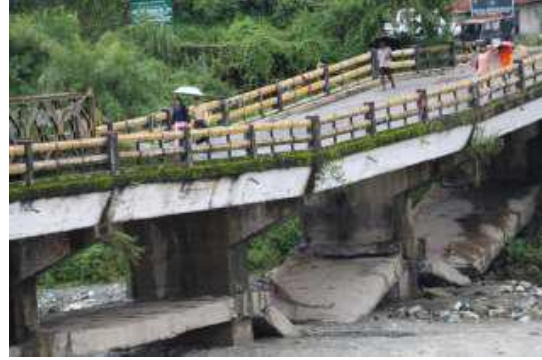
Figure 9: The Bhalujhora Bridge.

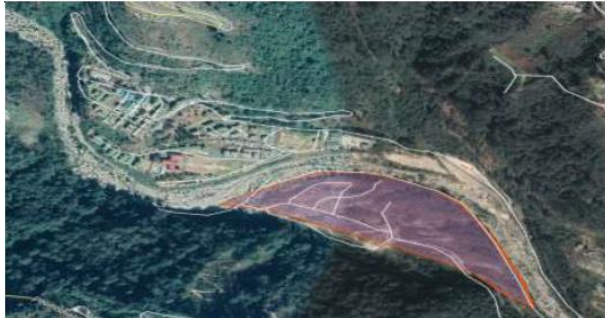
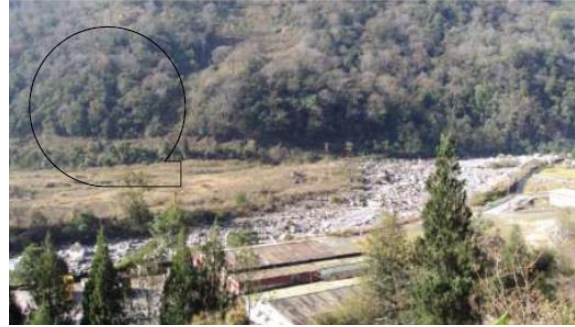
**Bjacho Gewog** center is located 10 kilometers away from Tsemasham town at global reference of 89°34'8.64" E and 27°3'22" N. The Gewog has a total population of 2300 with 212 households. Most of the people under this Gewog depend on agriculture farming and only few people rear livestock. Their main source of income is potato. Every year they grow potato in 350 acres of land and harvest about 10,000kg per acre. Since the place is located at a higher elevation with gentle slope, the settlements are not vulnerable to flood. However, the Gewog Administration pointed out some low-lying areas near Wang Chhu (River) as flood prone area. It was informed that the river has affected about 25 acres of agricultural land owned by 6 households as depicted in Figure 11 and Figure 12.

Figure 11: Location of the affected agricultural land.

Figure 12: Ground reality of the affected agricultural land.

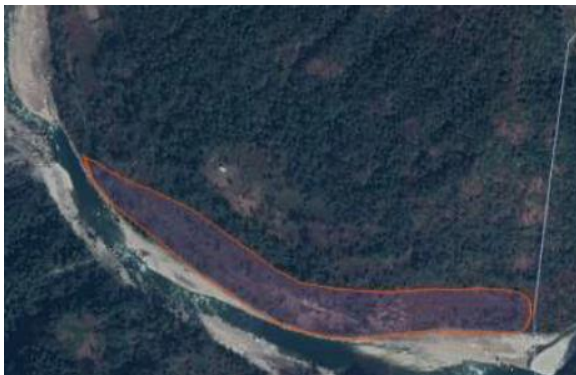
Figure 13: Settlements at the confluence of Wang Chhu and Jigme Chu.

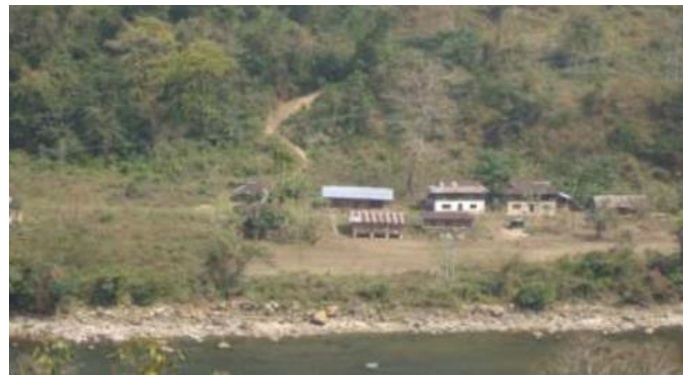
The Figure 14 shows that the fertile agricultural land is empty and there are about 9 household on the left bank of Wang Chhu and therefore, flood protection structure of about 1500 m length is required to protect the settlements.

Figure 14: Picture of Peeping (Jigme Chhu) under Bongo Gewog.

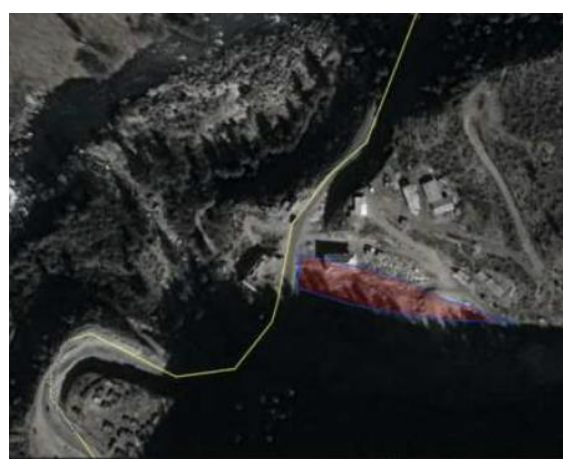
about 200 cattle only. The villages in this Gewog are not prone to flood as they are located at a higher elevation as shown in Figure 15.

Figure 15: Flood prone area near Damchu River in Chapcha Gewog.

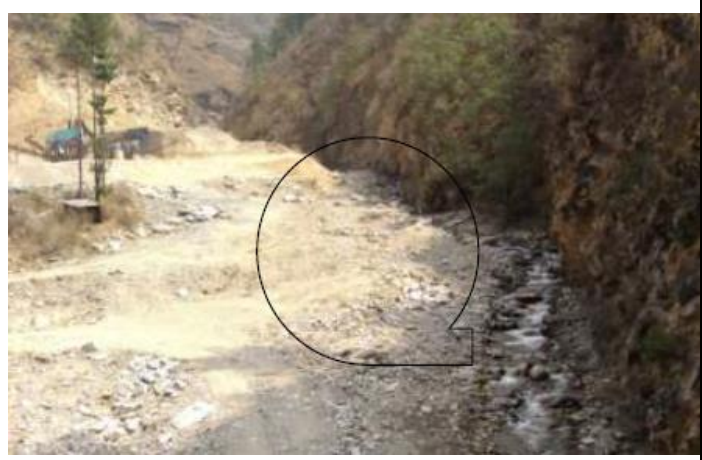
Figure 16: Damchu River in Chapcha.

However, a hotel at Damchu is vulnerable to flood from Damchu River as depicted in Figure 16. This hotel is located at  $89^{\circ}21'21''$  E,  $27^{\circ}14'10''$  N with elevation of about 2026 m above the mean sea level (msl). Damchu River flows directly towards the hotel. During the lean season, the river discharge is low posing no risk to the hotel. However, there is a threat to the hotel during the rainy season in future and therefore, the team proposes a flood protection structure of about 100m length along the left bank. Furthermore, there is a stone crusher above the hotel near the river leading to widening of the river flow path posing more threat to the hotel.

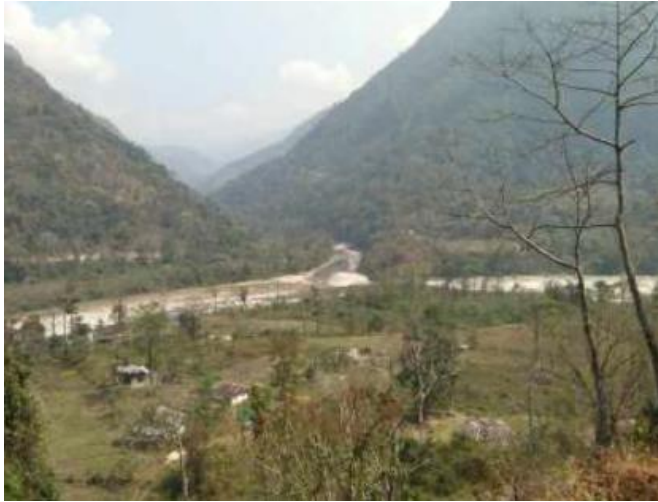
In Lamay Village under Darla Gewog, the team observed vacant agricultural fields near the river. This land is owned by 12 household. According to the shopkeeper from Lamay, his kitchen was washed away by Wang Chu (River) during 1990s flood. In order to protect the settlements on the right bank of the river, there is a requirement of 150 m length of flood protection structures.

Figure 17: Lamay (aka peeping) under Darla Gewog

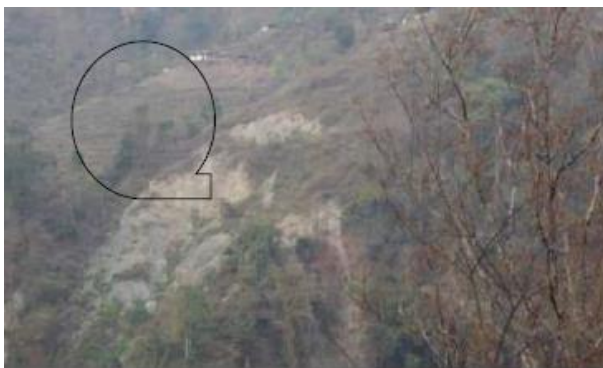
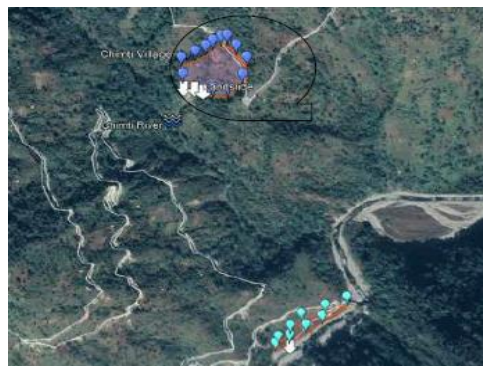
**Logchina Gewog** located 15 kilometers away from Phuentsholing town at global reference of 89°21'8.47" E and 26°53'49" N. The Gewog has a total population of about 3013 people with 397 households. The total agricultural land in the Gewog is around 1786 acres. Most of the people under this Gewog depend on agriculture farming and also rear livestock numbering about 1500. Their main source of income is ginger, cardamom and orange. Every year they cultivate around 40 acres of land for ginger only and harvest about 1000kgs per acre. This Gewog is usually inaccessible from Phuentsholing in summer due to swollen Ammochu. Most villages in this Gewog have no flooding threat as it is situated at a higher elevation. However, as per Gup, the Chimti Khola has eroded base of Chimti village and also affected 8 acres of agricultural land owned by 8 households as depicted in Figure 19 and Figure 20.

Figure 19: Flood prone area in Chimti village at Lokchina Gewog.

Figure 20: Location of Pa Chu, Chimti Chhu and Landslide at Lokchina.

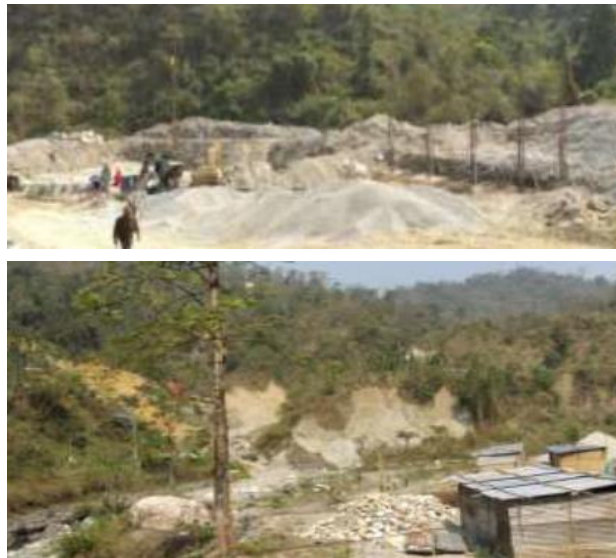
Figure 22: Construction on the left bank of a tributary of Dhoti Chhu (River).

During the site visit, it has been observed that the people are constructing houses within the flood plains as given in Figure 22 and thus, their vulnerability to the flooding is increased.

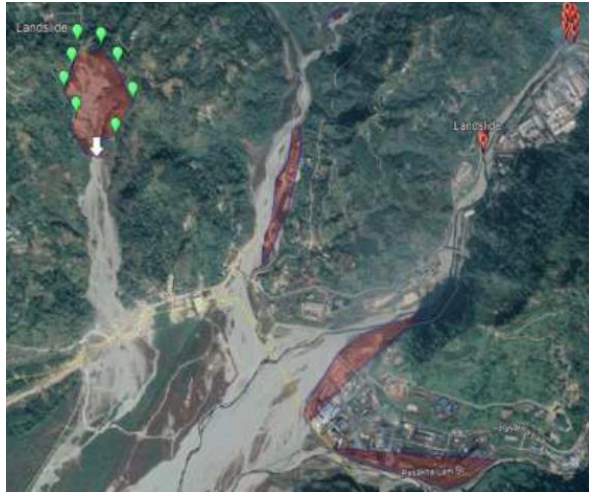
about 6 acres of land. Most of the industries are located in this Gewog, therefore the farmers own about 600 vehicles. There are three Rivers in this Gewog as given in Figure 23. In this Gewog, Balujora River does not pose threat to the settlements within the Gewog boundary. Similarly, the Barsa River poses minor threat to the communities within the Gewog boundary. The swollen Barsa River only poses threat to the village road during the rainy season as given in Figure 24. According to Gup, more than 40 vehicles ply the village road every week to transport milk from Gurung Dara to dairy farm. The team recommends construction of 200 m long wall to protect road erosion by the river at the base.

Figure 23: Location of three Rivers (Bhalujora, Barsa and Singye River).

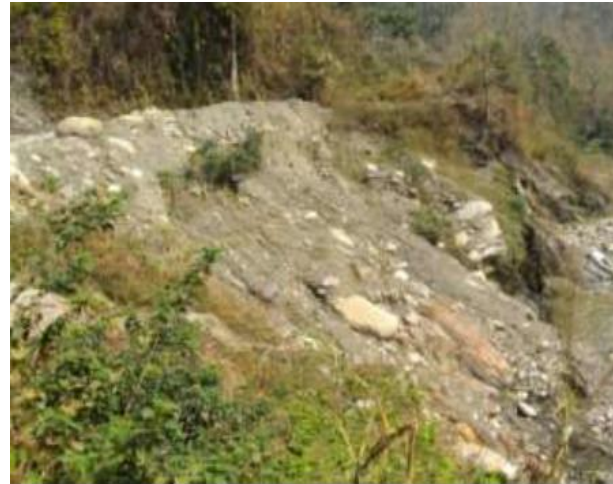
Figure 24: Erosion at the road base by Barsa chu above BPC sub-station at Pasakha.

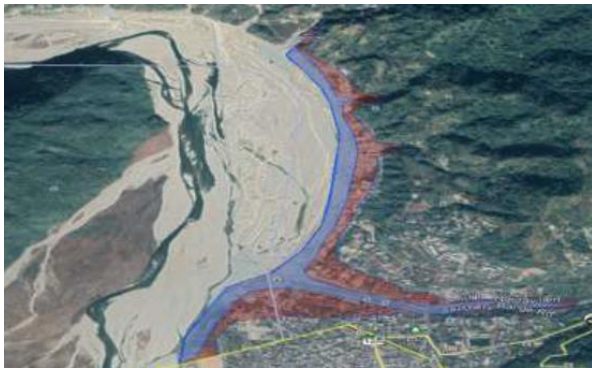
Ammo Chhu (Toorsa) and Om Chu are the two main rivers passing through the settlements in Phuentsholing Municipality as given in Figure 25. The rivers in summer bring lots of sediments and it is deposited within the city leading to change in the flow path of the river.

Figure 25: Satellite image of Amochhu and Om chu at phuntsholing.

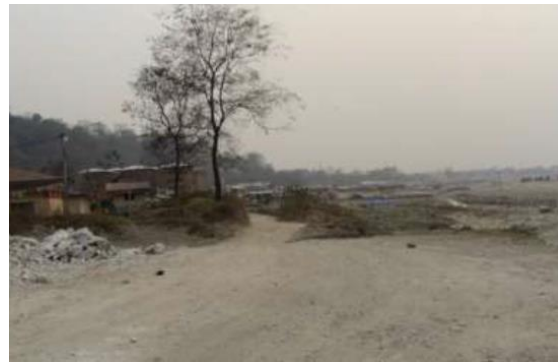
Figure 26: Settlement along Torsa river at Phuntsholing.

During the site investigation, it has been conveyed by the local residents that there is no difference in elevation between the river bed level and the settlements along Toorsa River as depicted in Figure 26. This is due to the deposition of the sediments by Amo Chu (Toorsa) River. However, there is an upcoming land reclamation project for Amochu and the LG officials are confident that the project is going to take care of flooding risk from Toorsa Chhu.

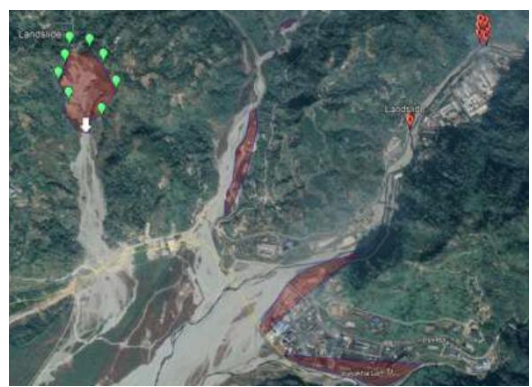
The Pasakha Industrial state is within the Thromde Boundary, therefore the three rivers such as Balajhola (seasonal), Barsa (perennial) and Singye Chu (perennial) as depicted in Figure 27 also is considered during the flood hazard assessment.

Figure 27: Image of Balujora, Barsa and Singye chu.

During the site investigation, it has been observed that the stream Balujora and Barsa affects the local communities and industries during rainy season. The rate of erosion on these two streams is quite high due to poor geology of the area. There is lots of sediment deposit in the river causing meandering of rivers every season.

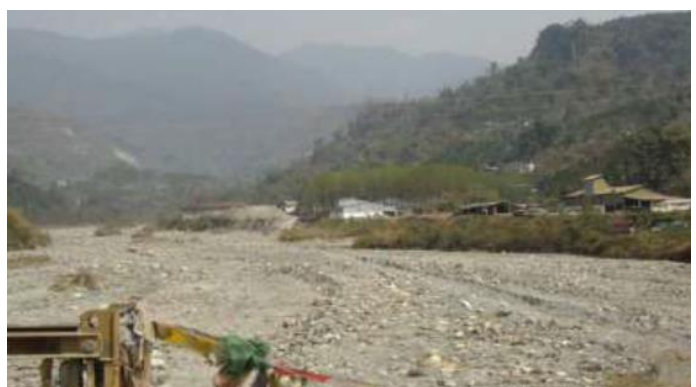
Figure 28: Balujora river posing threat to the BBPL factory at Pasakha.

The Balujora River causes flooding risks to factories, restaurant, roads and shops as depicted in Figure 28 and the river bed level has risen. This has increased the risk of flooding along the River and therefore, there is a requirement of 1 km flood protection structure on the left bank of the river to reduce the risk of flooding.

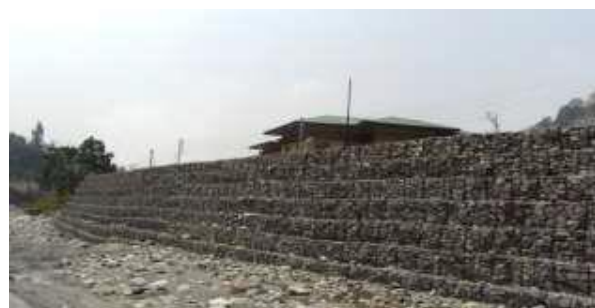
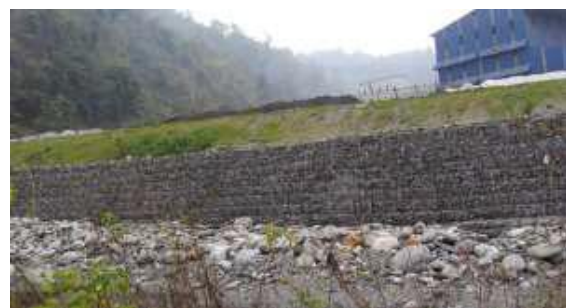
Similarly, the Barsa River also poses threat to the Bhutan Power Corporation (BPC) sub-station located opposite to BCCL factory. Further, there is possibility of the river affecting the BCCL and BFAL's lower colony and school area in future. As per the local community, these rivers have caused flooding in the year 2000, 2009 and 2016. The Figure 29 and Figure 30 shows newly constructed flood protection structures near the colony and factory under NAPA-II project respectively.

Figure 29: Flood Protection Works along Barsa chu.

Figure 30: Flood Protection Works along Barsa chu.

It has also been observed that due to excessive siltation, the river flow path is constricted and this might lead to river breaching the bank along Barsa Chhu. Therefore, it is recommended that the sediments be dredged after every rainy season to ensure that the river have enough flow path. The collected sediments after quality assurance can be marketed to recover the cost of
