FLOOD HAZARD ASSESSMENT FOR DAGANA DZONGKHAG

FLOOD ENGINEERING AND MANAGEMENT DIVISION,
DEPARTMENT OF ENGINEERING SERVICES
MINISTRY OF WORKS AND HUMAN SETTLEMENT

YEAR 2019

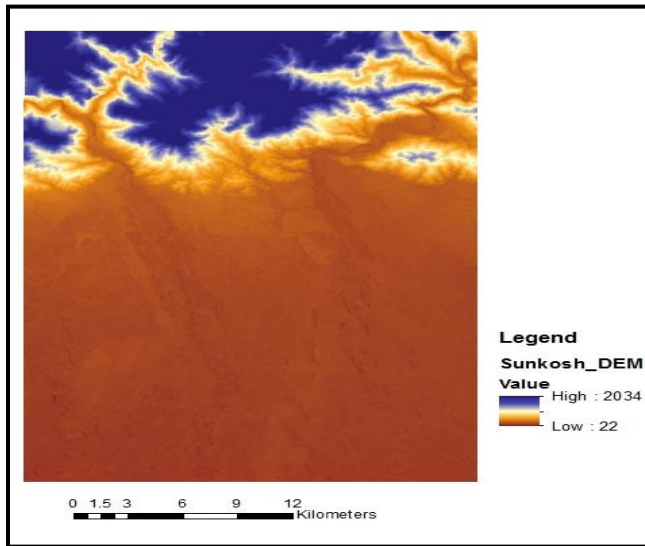
Figure 7: Aster DEM for the study area

The freely available ASTER DEM (30 m resolution) covering the study area was used for the hydrodynamic modelling. The DEM is shown for Figure 7 Sunkosh River. DEM in TIN format is required for HEC-RAS model. Raster DSM converted to TIN with the study stretch of river is shown in Figure 8 for the basin.

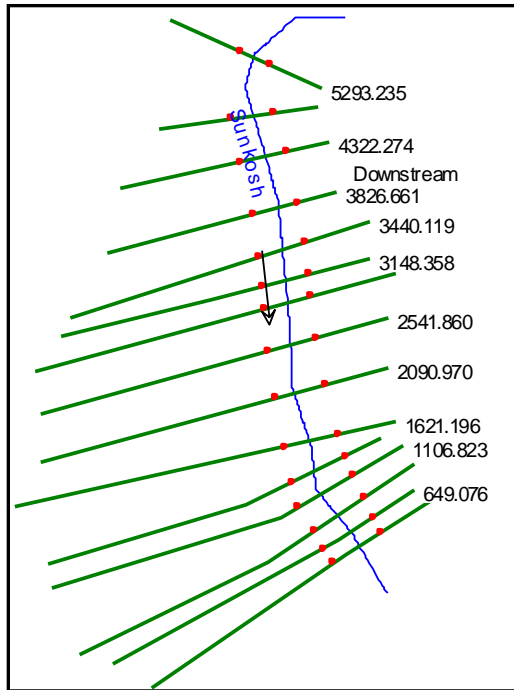
Figure 9: River system schematic for Sunkosh River

River centreline is sketched with the help of given river network. As observed cross-sections at different locations are not available for Sunkosh, the cross-section data is extracted from the ASTER DEM. Cross-section cut lines are assigned at appropriate locations from upstream to downstream for Sunkosh River. As the river is wide and the flow is large in Sunkosh River, cross-section data extracted from 30 m ASTER DEM will be applicable for hydrodynamic model. The schematic of geometry in HEC-RAS for Sunkosh is shown in Figure 9.

The cross-section station numbers increase from downstream to upstream. The cross-section consists of three parts: main channel, left bank and right bank. Manning's n value at main stream channel and overbank is assigned for each cross-section. A representative value of 0.03 is assigned for main stream and 0.05 for overbanks. Expansion and contraction coefficient is taken as default values (expansion = 0.3 and contraction = 0.1).

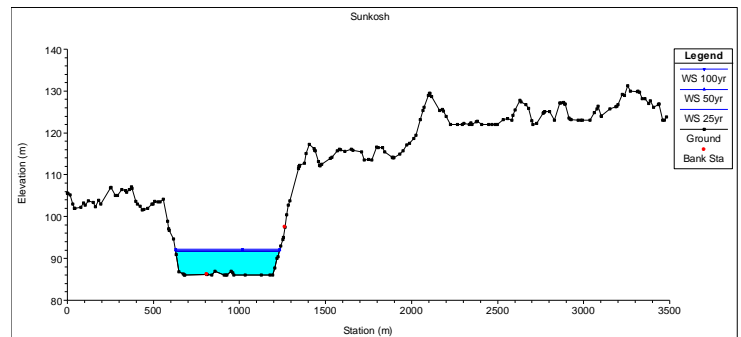
Figure 10: Sample Output of HEC-RAS for a cross-section of Sunkosh River

After setting up the HEC-RAS model, the model is run under steady flow condition for different return periods. HEC-RAS gives cross-section wise output. Sample of output is shown in Figure 10. The plot shows the cross-section along with the water level for 100 years return periods. The water surface profile obtained from HEC-RAS for Sunkosh River is given in Figure 11.

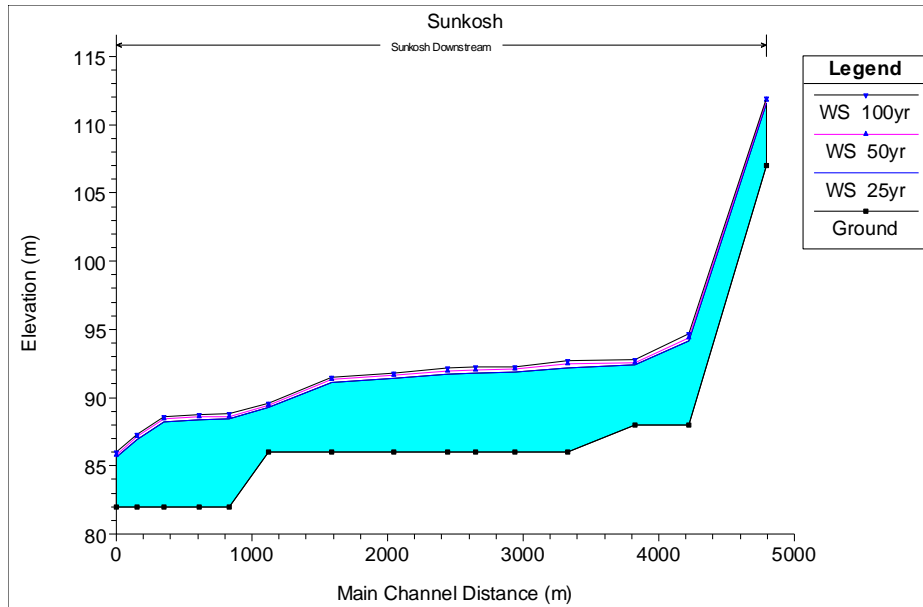
Figure 11: Plot of water surface profile of Sunkosh River

The maximum flow depth for the chosen cross-sections of Sunkosh River vary from 3.26 to 6.41 m for 25 year return period, 3.41 to 6.61 m for 50 year return period and 3.58 to 6.81 m for 100 year return period. The range of velocity for 25 year return period is 1.46 - 5.89 m/s, 50 year return period is 1.54 - 5.92 m/s and 100 year return period is 1.60 - 6.05 m/s.

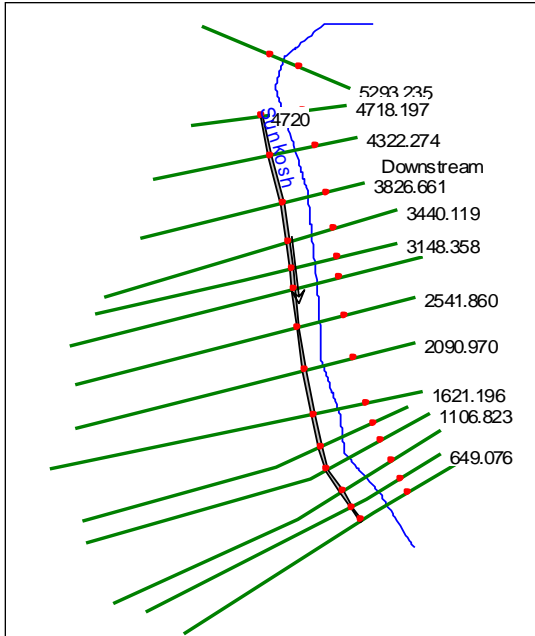
Figure 12: HEC-RAS model setup for the Sunkosh River with embankment at right bank

As left bank is in Indian side, embankment at only right bank side (Bhutan side) is considered for Sunkosh River while setting up HEC-RAS model as shown in Figure 12. The water surface profile for 25, 50 and 100 year return periods for Sunkosh is shown in Figure 13. The result shows that there will be no overtopping of right bank. Comparing the result it is found that there is change in water surface elevation and channel velocity as there is no any structure on the left bank and the width of the river is large.

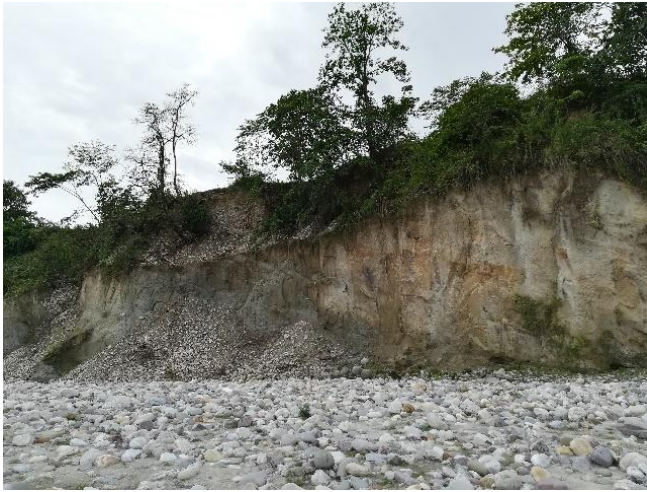
- Sunkosh River poses potential threats to the settlements and agricultural land of Hawajorey, Majagoan village and Kalikhola Town.
- As per the site investigation, it has been observed that the Sunkosh River has been washing away major Riverbank of land every year due to scouring.
- About 1 km of flood protection structures has been constructed till date. However, there are still some critical areas requiring immediate additional flood protection structures in the above-mentioned areas.
- Therefore, around 1200m of Flood protection structures is felt very essential along Sunkosh River.

Figure 15: Scouring at the base of Hawajorey village by Sunkosh river

The right bank of the Sunkosh River is being eroding at an alarming rate. So, the river training works are necessary along the right bank of the Sunkosh River to protect the four villages i.e. Kalikhola, Hawajhori, Lhamoizingkha and Majagaon in Bhutan. Based on the modelling results the design discharge recommended is $6,051 \text{ m}^3/\text{sec}$ (50 year return period discharge) for Sunkosh River.

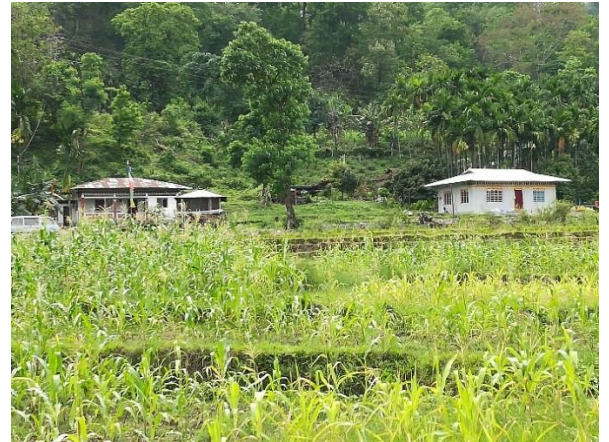
Figure 16: Agricultural land and settlement at risk along Sunkosh river

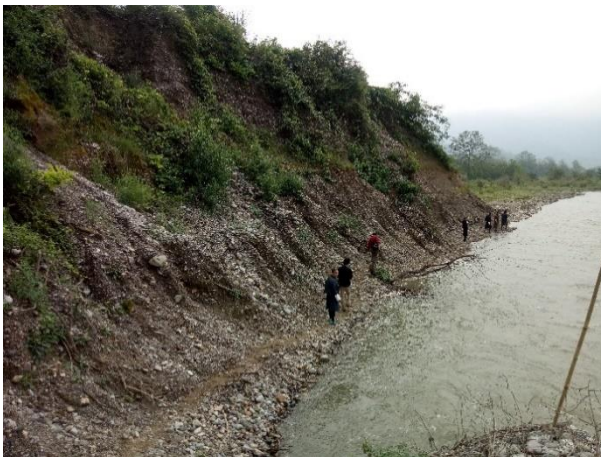
Figure 17: Scouring/Erosion by Sunkosh River at the base of Kalikhola

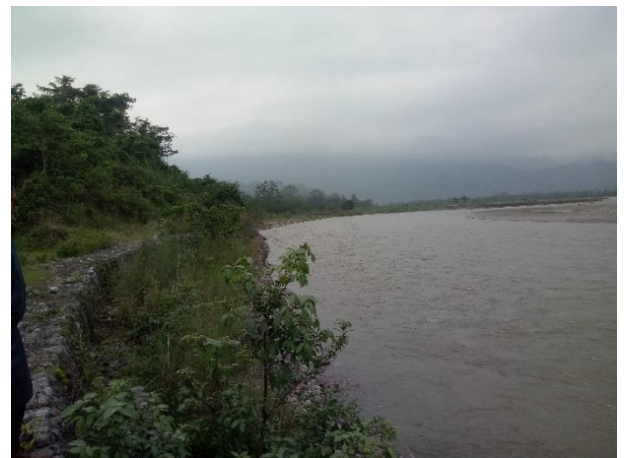
Figure 18: Scouring/Erosion by Sunkosh River in Majagoan village

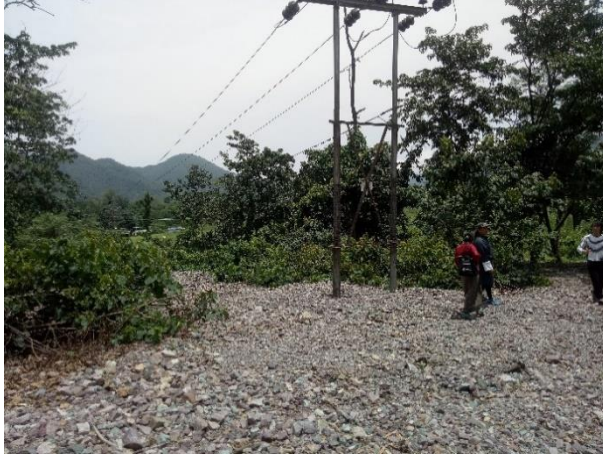
- Pairini Stream is seasonal in nature and it is completely dry during dry season. But during the monsoon, Pairini streams bring in large amount of debris and deposit it in the agriculture fields of karmaling village. It meanders as it passes through the settlement and does not have proper flow path. The river flow path and the settlement are at the same level.
- It also cut-offs the farm road leading to Homa village during the summer season.
- There were no past interventions carried out for the stream as it is formed from the runoffs during the rainy season.

Figure 19: Debris from Pairini stream affecting the electric pole in Karmaling village

- The team recommends check dam on the upstream portion of Pairini stream to trap the debris and prevent sedimentation in the agriculture field. Further, a flood way with enough flow path to divert the stream away from the settlement is also recommended at the downstream of Pairini stream.

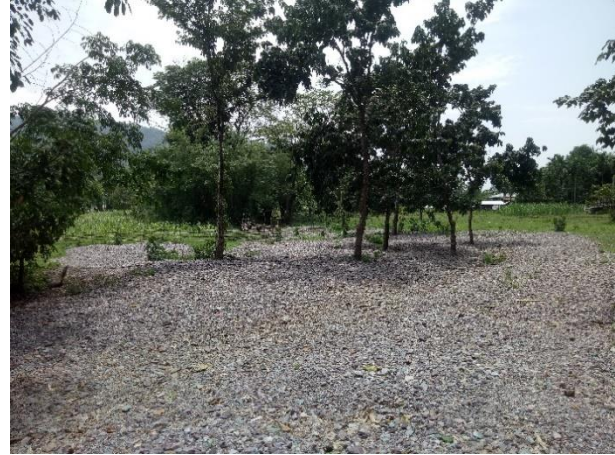
Figure 20: Debris from Pairini stream affecting the Karmaling village

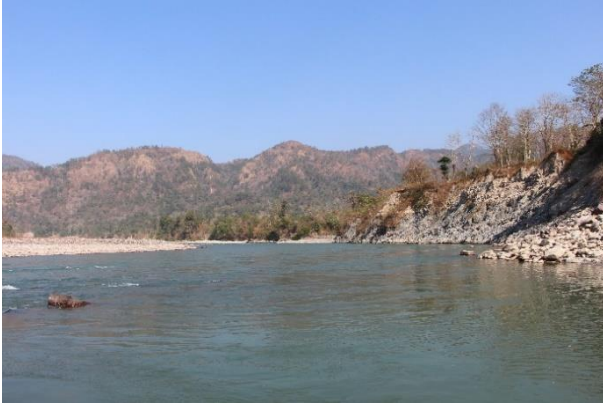
- ✓ As per the local government, approximately more than 10 acres of wetland has been washed away at Bararey village due to scouring at the base by Sunkosh River. In addition, it also poses threats to the Bichgoan village located at the downstream portion of the river. Most of the institutions of Nichula Gewog such as Gewog office, school and RNR office are all located in Bichgoan. The village has around 26 households with more than 40 acres of wetland and 20 acres of dry land.

Figure 22: Critical area at Barerey and Bichgoan under Damchena Chiwog

- ✓ Therefore, the team recommends around 300m of bank protection work along the left bank of Sunkosh at Bararey village. However, there is no immediate requirement of mitigation measures at Bichgoan village as the risk of flooding from Sunkosh River is low at the moment.

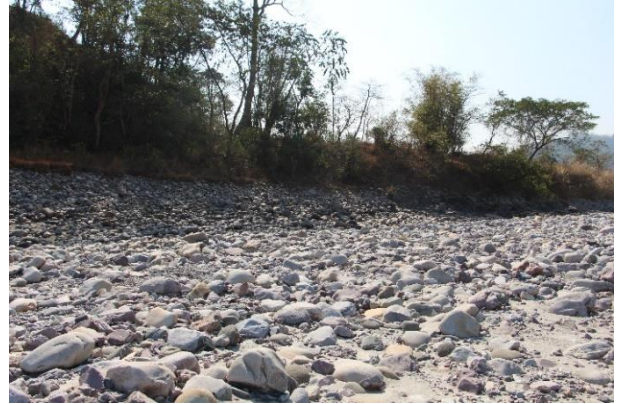
Figure 23: Critical area at Barerey and Bichgoan under Damchena Chiwog

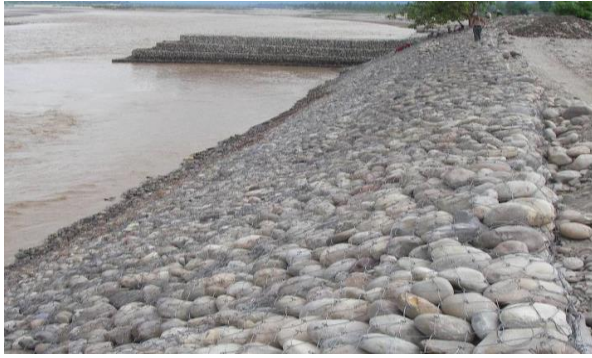
After weighing the qualitative advantages and disadvantages of the three methods discussed above, it is decided to adopt revetment along with spurs at critical locations along the right bank of Sunkosh River where there is erosion due to the concentration of the flow. A typical example of a combination of revetment and spur in Mahakali River, Nepal is shown in Figure 24.

Figure 24: : A typical combination of revetment and spur, Mahakali river, Nepal

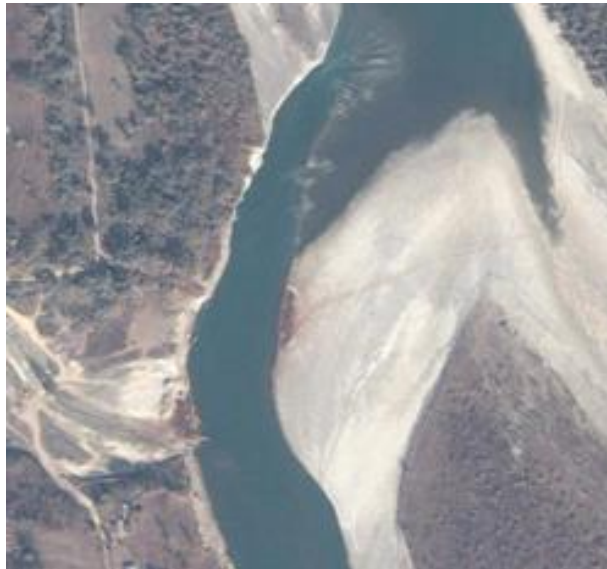
Figure 29: Sunkosh River in 2013 before intervention

The Department of Engineering Services, MoWHS, Royal Government of Bhutan have invested Nu. 110,641,623 in the 11th FYP for Dagana Dzongkhag. A combination of gabion revetment and spurs were designed by FEMD (Figure 27 and Figure 28) DES and implemented by Lhamoizingkhag Dungkhag along right bank of Sunkosh River. The location of the flood protection works along Sunkosh River can be seen in Figure 30. The Sunkosh River in 2013 before intervention can be seen in Figure 29 and the Sunkosh River in 2017 after construction of gabion embankment with gabion spurs at the right bank of the river can be seen in Figure 30.

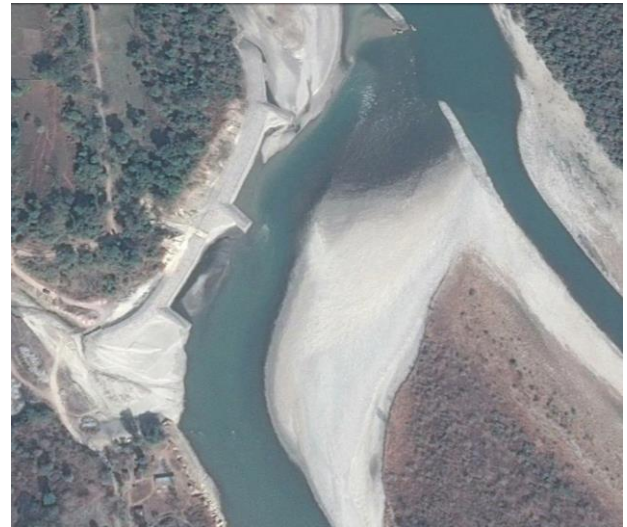
Figure 30: Sunkosh River in 2017 after the construction of gabion revetment and spur at the right bank of the river.
