FLOOD HAZARD ASSESSMENT FOR LHUNTSE DZONGKHAG

FLOOD ENGINEERING AND MANAGEMENT DIVISION, DEPARTMENT OF
ENGINEERING SERVICES, MINISTRY OF WORKS AND HUMAN SETTLEMENT

YEAR 2019

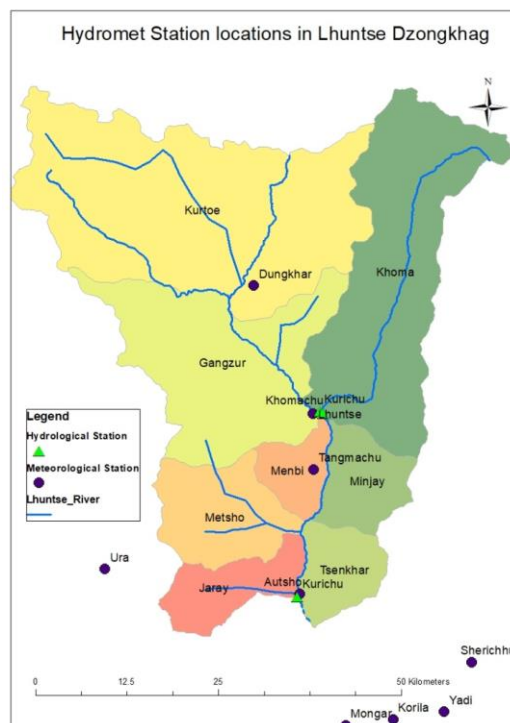
Figure 3: Location of the Hydro-met station in the study area

The hydro-meteorological data was acquired from the National Centre for Hydrology and Meteorology (NCHM). The location of the hydro-met stations is depicted in Figure 3 **Error! Reference source not found.**

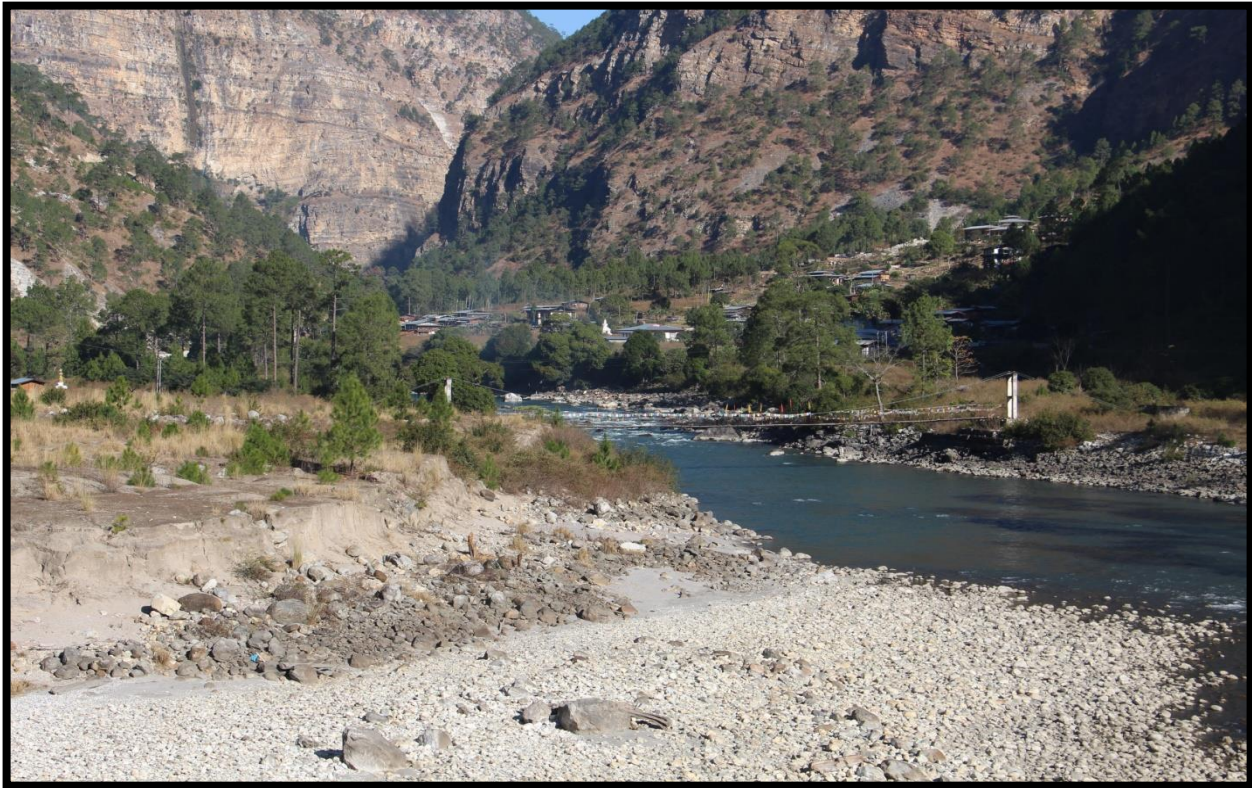
Figure 4: Autsho main study area.

Autsho is under Tshankhar gewog and it is located at 27°26'37.9" northing and 91° 10' 16.2" easting having elevation 860 m. Around 80 shops and approximately 300 people are residing in Autsho town, and it is the main commercial hub of lhuntse. Apart from town, agricultural land is also having threat from flood along the right bank Kurichu and is opposite to Autsho town. The ground profile is flat and quite vulnerable to flood. Autsho town is located at left bank of the Kurichu. Realising the importance of upcoming town and existing infrastructure, FEMD intervened and initiated to conduct the river cross section for developing flood hazard map.

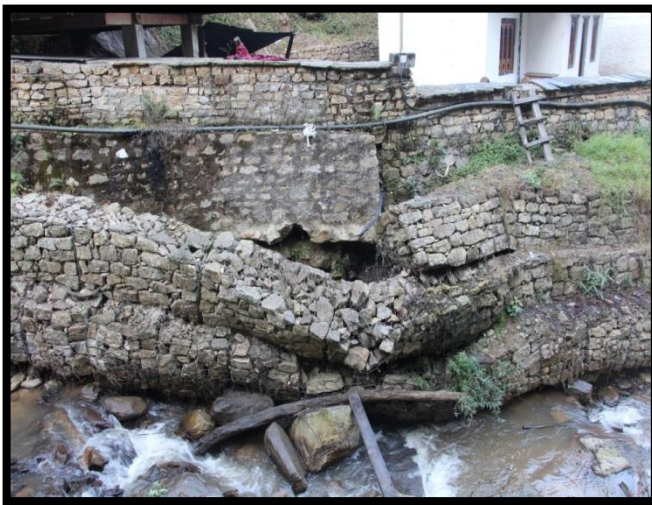
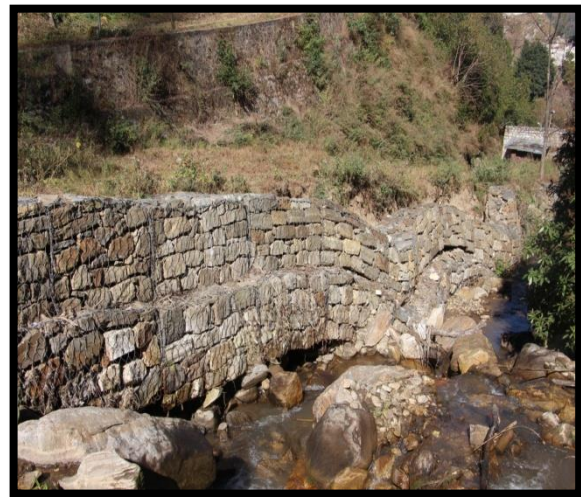
Figure 9: Partially washed away gabion wall at upstream

Existing gabion wall around 30 m at upstream or front of Drasha and 30 m downstream has been partially washed away/damage.

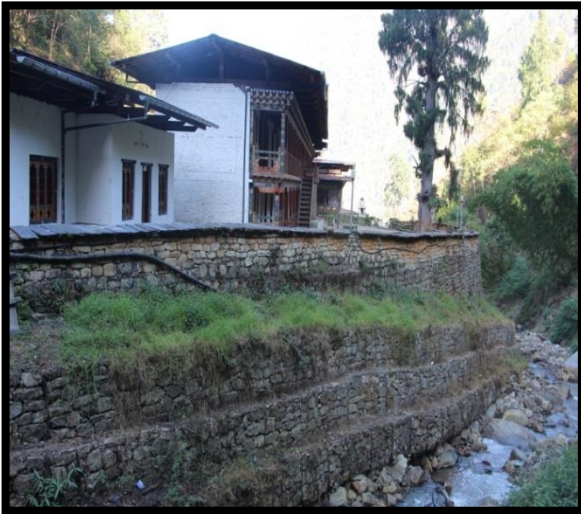
Figure 10: RRM wall in front of Drasha

Scouring has been observed at base of the foundation of another the 70 m gabion wall. The foundation of wall needs to restore by constructing additional structure like apron.

In front of Drasha 12 m RRM wall is on the verge of collapse due to scouring of the base of the wall and need to protect immediately for further damage.

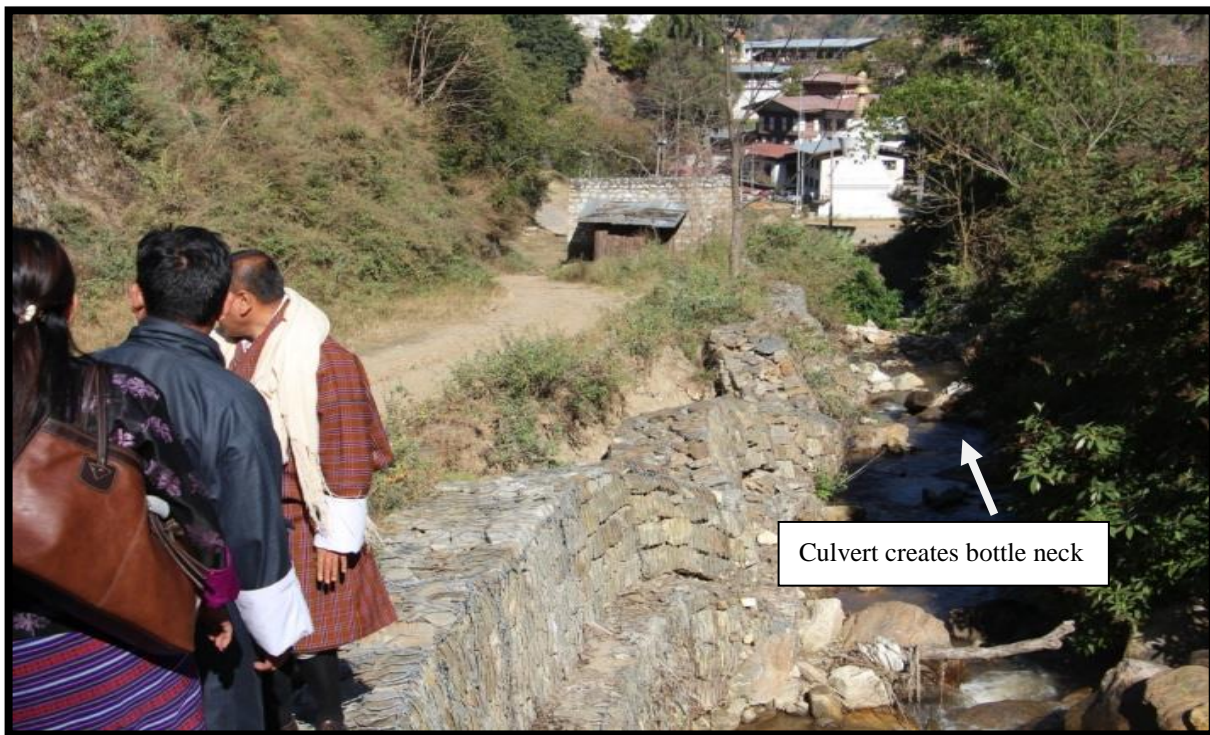
Figure 11: Culvert create bottle neck during heavy monsoon season and not able to accumulate whole discharge.

Bottle neck created by the culvert and not able to carry whole discharge during flooding and this will allow water to over top and flow towards to the chorten. Monsoon flood created few places scoring along the Lakpagangchu and needs to be protected.

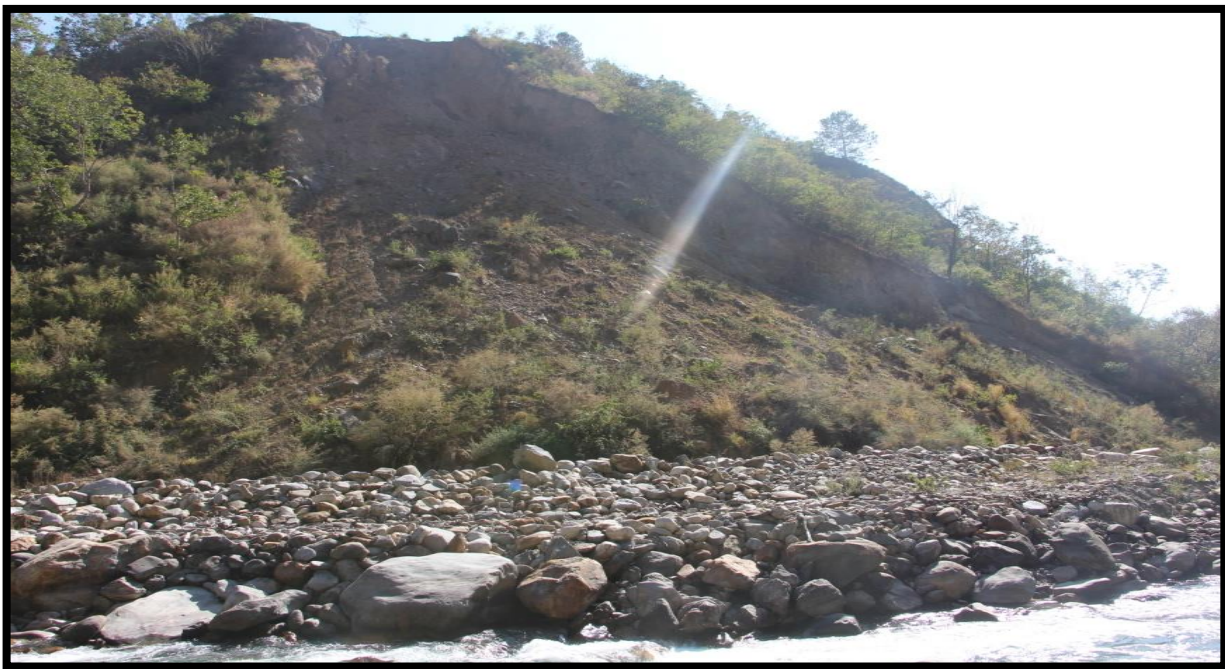
Figure 12: Souring creates landslide below the khoma L.S School.

Scouring at the left bank of Khoma River triggers the base of hill lock and creates threat to Khoma LS school. Gewog Administration, Khoma had carried out dredging work at scouring area, diverted the river and also constructed rip-rap at based of the landslide area. The area improved and found some vegetation had grown.

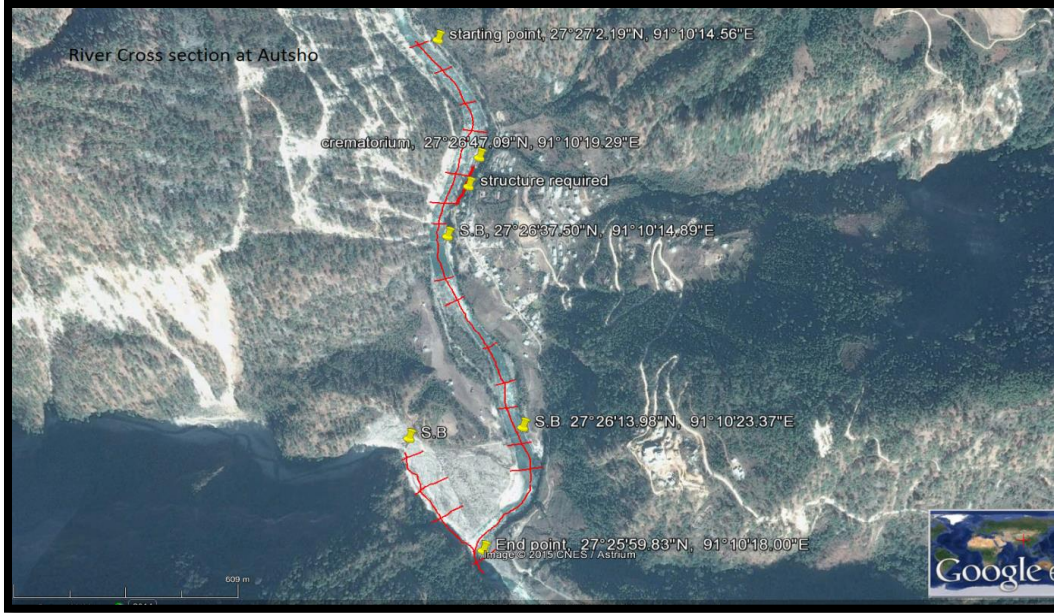
Figure 15: Digitize river cross section at Kurichu

Taking cross-section survey along the river study area is important for flood modelling and river analysis. Modelling of river helps to find out velocity, river profile etc. Cross-sections are required to represent channel geometry in a river hydraulic model. The accuracy of the simulated water levels and the floodplain delineation largely depends on the shape as well as extent of these cross-sections. For the assessment, the cross-section data was derived from DEM and also surveying using total station. The cross-section survey of Kurichu was carried out by FEMD, DES, MoWHS in December, 2015. About 20 numbers of cross-section data along Kurichu were collected.

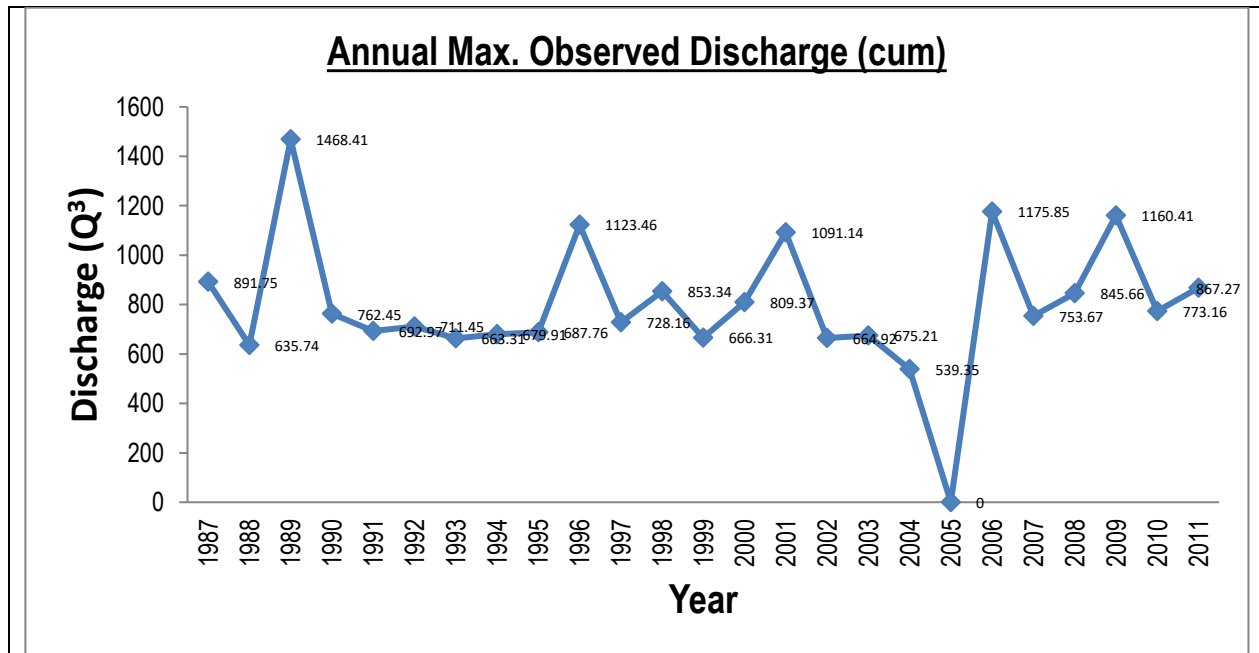
Figure 19: Observed discharge (Q³)

The flood studies regularly required the estimation of the peak discharge for annual maximum discharge from 1985 to 2011 at Autsho gauging station.

Gumbel method for success return period of 20, 50 and 100 years. The peak discharge observed to be 1502.0 Cumic and Gumbel peak discharge of 50-year return period, therefore we took 50 years return period discharge as given below:

Autsho		Probable Discharge (m ³ /s)
Year	Return Period	Observed /Calc Value
	20yr	1316.3
	50yr	1502.0
	100yr	1641.1
