FLOOD HAZARD ASSESSMENT FOR MONGAR DZONGKHAG

FLOOD ENGINEERING AND MANAGEMENT DIVISION,
DEPARTMENT OF ENGINEERING SERVICES
MINISTRY OF WORKS AND HUMAN SETTLEMENT

YEAR 2019

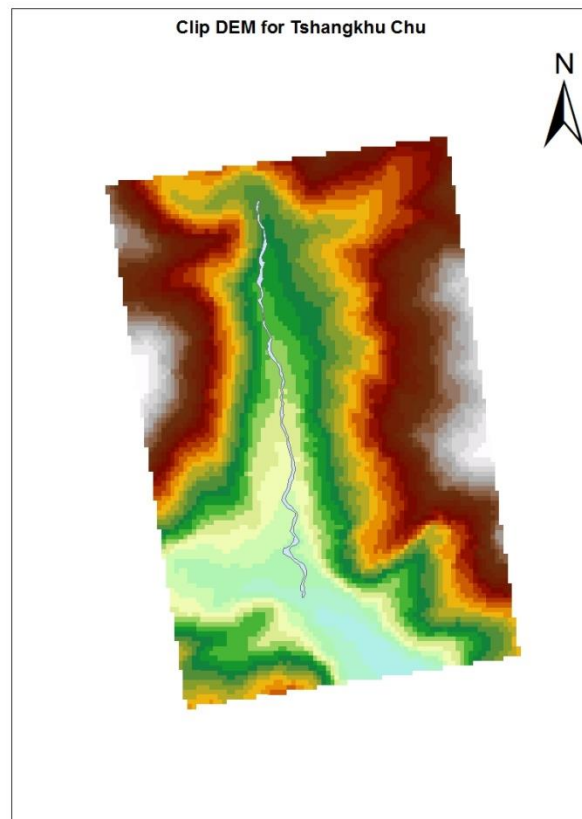
Figure 3: DEM showing Tshangkhu Chu

Digital Elevation Model with 10 meter resolution ALOS is used for this project. The Digital Elevation Model (DEM) represents the natural topography and manmade feature such as roads, embankments and buildings.

Along Sheri Chu under Sherimuhung Gewog, critical structure identified is crematorium only but in case of Saling Gewog, large areas of agricultural lands have been destroyed in the past. Therefore, in this assessment, preliminary flood hazard map have been prepared for Tshangkhu Chu in Saling Gewog. River shapefile was prepared by digitizing from the image extracted in QGIS software as shown in Figure 3.

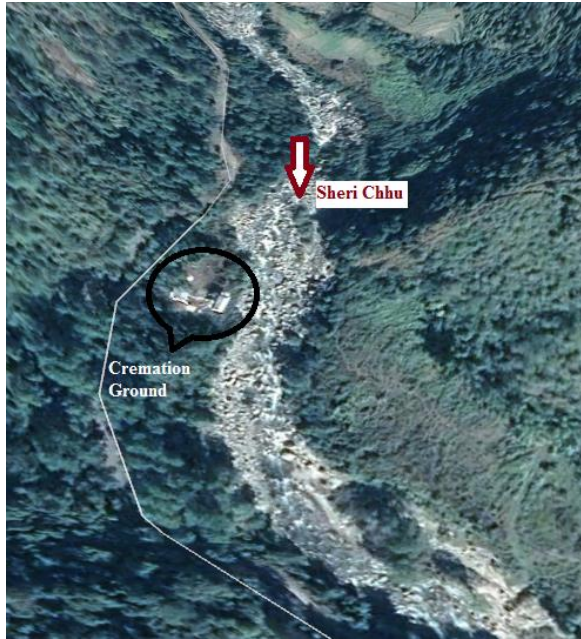
Figure 4: Location of crematorium along Sheri Chu

Sheri Chu is the main perennial river flowing along Pakala Shing village under Sherimuhung Gewog. The most critical structure along Sheri Chu is cremation ground which is under construction at Pakala Shing area. This cremation ground once completed will benefit to 5 Gewogs i.e. Ngatshang, Chaskhar, Thangrong, Balam and Sherimuhung Gewogs. According to the Gup, 20 years ago, some portion of the Sheri Chu water entered into the existing cremation ground area which we can see the flow path even today. Scouring along crematorium is taking place during high flow discharge in monsoon season. This situation might increase the vulnerability of the crematorium to flooding during extreme events. As per the Gup, there is no other suitable place which is accessible to road and benefits all five Gewogs other than this existing location. Considering the importance of the crematorium, Gewog Administration had requested an excavator from the private company and constructed some temporary boulder

barrier. As per the Gup, 200 metres gabion wall is required to protect cremation ground for permanent solution.

- **Sheri Chu:** Constructed temporary boulder barrier along crematorium.

- **Sheri Chu:** Along the banks of Sheri Chu there are plenty of boulders available, construction of boulder rip-rap wall at right bank would minimize the scouring effects and the crematorium will be safe from flooding. Additionally, 2 metres height gabion wall inside the boulder rip-rap wall would further stabilize the soil and avoid scouring.

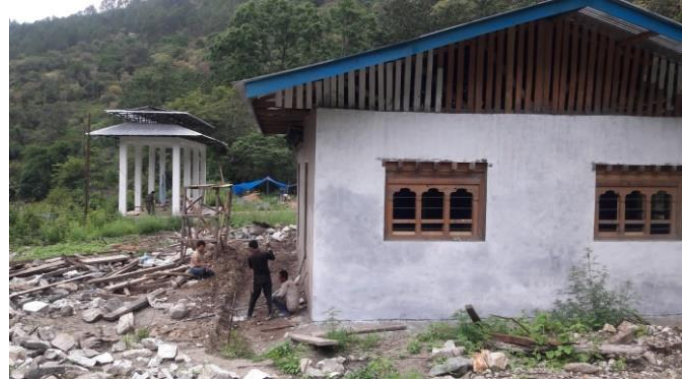
Figure 5: Crematorium under construction

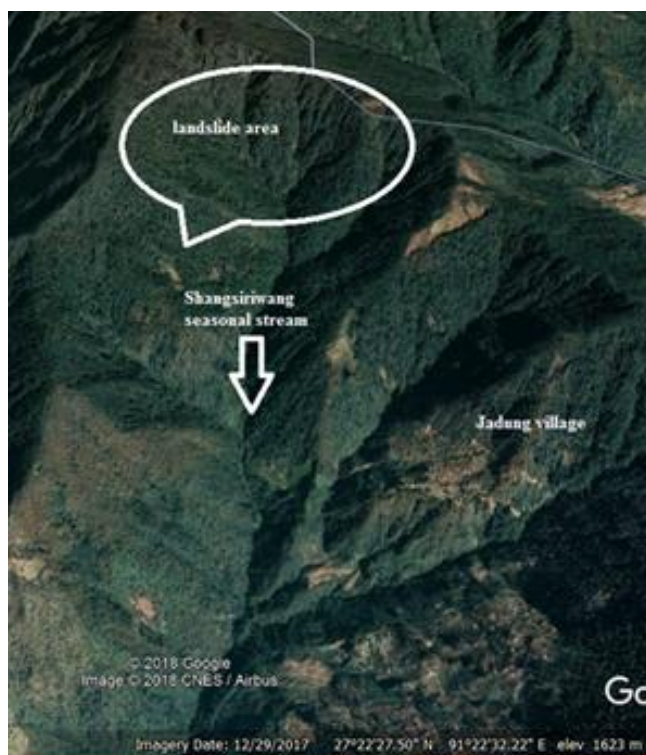
Figure 6: Google image of Shangsiriwang stream

Shangsiriwang Runoff: Jadung Chiwog is mostly affected by this seasonal runoff stream. According to the Tshogpa that, till now about 5 acres dry land consisting of walnut and hazelnut plants have been destroyed and washed away. In the past, with the assistance from the Dzongkhag forest, they have carried out land management works such as bio-engineering and constructed dry rubble masonry. During the site visit, it was observed that, area have been stabilized due to land management works carried out in past.

- **Shangsiriwang Runoff:** carried out bio-engineering works and dry rubble masonry wall.
- **Denporongdrang stream:** Constructed RRM wall

- **Shangsiriwang Runoff:** Providing gabion check dam and wooden creep wall at critical locations to control land slide debris and to streamline the flow path.
- Since the catchment area is small, bio-engineering works such as plantation of fast growing plants along both the banks would avoid scouring of cultivable lands. Bio-engineering works was tried in the past and found that it is functioning well till now.
- **Denporongdrang stream:** The profile of the stream is steep and scoring effect will be high in case of flash flood. To minimize further scouring, construction of gabion check dams at critical locations along the stream will collect debris and scouring effects will be reduced. Alternatively, locally available wooden creep wall will also reduce the impacts of flooding. Bio-engineering works such as plantation of fast growing plants in the sliding area can also minimize damage.

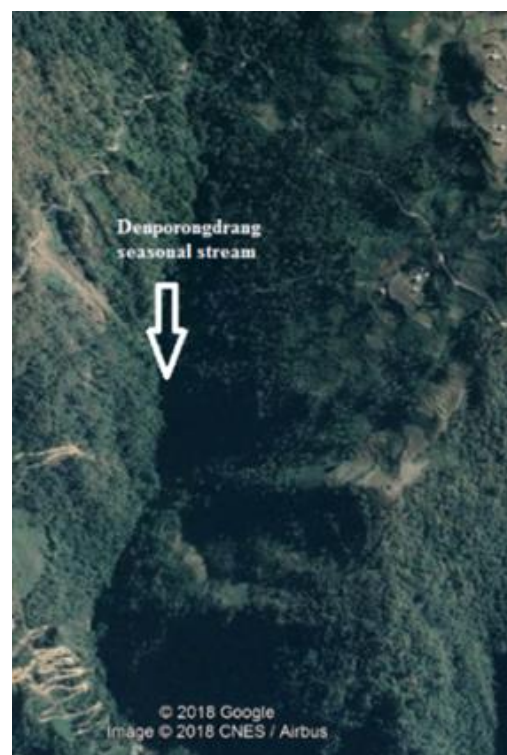
Figure 7: Google image of Denporongdrang stream

Denporongdrang stream: According to Balam Tshogpa that, prior to year 2016 flood was not observed under Balam Chiwog. Denporongdrang is a small stream which carries discharge in monsoon season only. In the year 2016 and 2017 during monsoon season 2 acres of dry and wet land was destroyed by the flash flood. Additionally 4 acres of dry and wet land was also destroyed in April-May 2018. In the past, Gewog have constructed RRM wall and we were informed that the wall is functioning well. However, Balam Tshogpa informed FEMD team that, they require additional 600 metres RRM wall to protect wet land in the area.

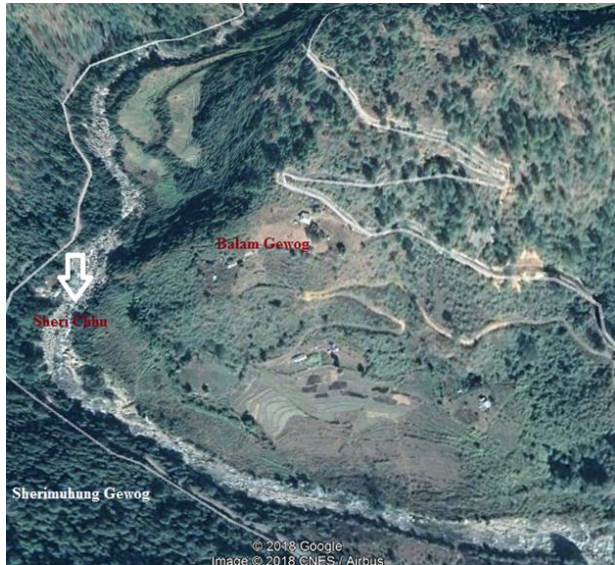
Figure 8: Google image of Sheri Chu

Sheri Chu: According to the Sheri Tshogpa, flooding along Sheri Chu occurs annually and till now about 10 acres of paddy field have been damaged by the Sheri Chu. Flood protection works have not been done in the past. The water level during our field visit was within the safe level below wet land. Tshogpa clarified that, during the rainfall events water level almost reaches equal to the height of paddy field and during extreme rainfall water enters the paddy field.

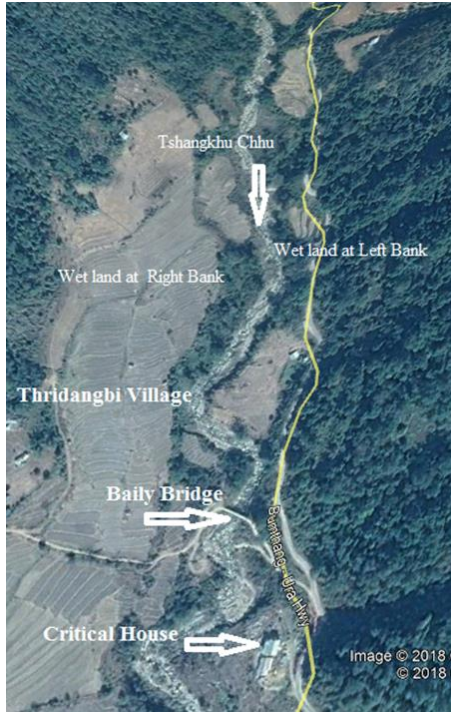
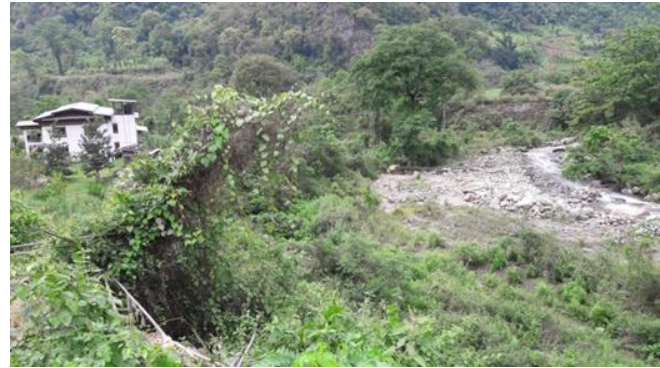
As per our assessment, Tshangkhu Chu along Thridangbi village is the most critical river under Saling Gewog. It is a small river which flows along agricultural land. There are only 4 houses located along Tshangkhu Chu. Out of 4 houses only 1 double story RCC building is at the risk due to flooding. According to the Gup, heavy flood occurred in 2012. Of course every year flood events take place but not like 2012 flood. In 2012, two oxen were washed away and 40 decimal wet lands were destroyed. Considering the importance of the agricultural land and settlement, we have conducted cross section survey along Tshangkhu Chu to find out the inundation areas along it. Till now, Gewog administration has not constructed any flood protection structures except 40 meters long gabion wall for the protection of Bailey bridge. Through visual inspection, it can be seen that the rivers during the rainy season has caused scouring along the river banks and also around bridge abutments as presented in figure 10. Similarly, it has been observed that the difference in elevation between the river bed level and top bank level is only about 1.0 m in

some stretches along the river. This situation might increase the vulnerability of the wet land to flooding during extreme events.

Figure 10: Tshangkhu Chu along Thridangbi village

Figure 9: Google image of Tshangkhu Chh

Therefore, if proper interventions are not done at this stage, then there is higher probability of river breaching their banks and damaging the agricultural land and settlement. Hence, it is highly recommended to construct flood protection structures along the left bank as well as right bank.

- **Tshangkhu Chu:** According to the Saling Gup, they require only financial assistance to meet expenditure for the construction of gabion wall at critical locations along Tshangkhu Chu. They want to propose for 600 metres length

gabion wall at left bank and 300 metres length gabion wall at right bank respectively.

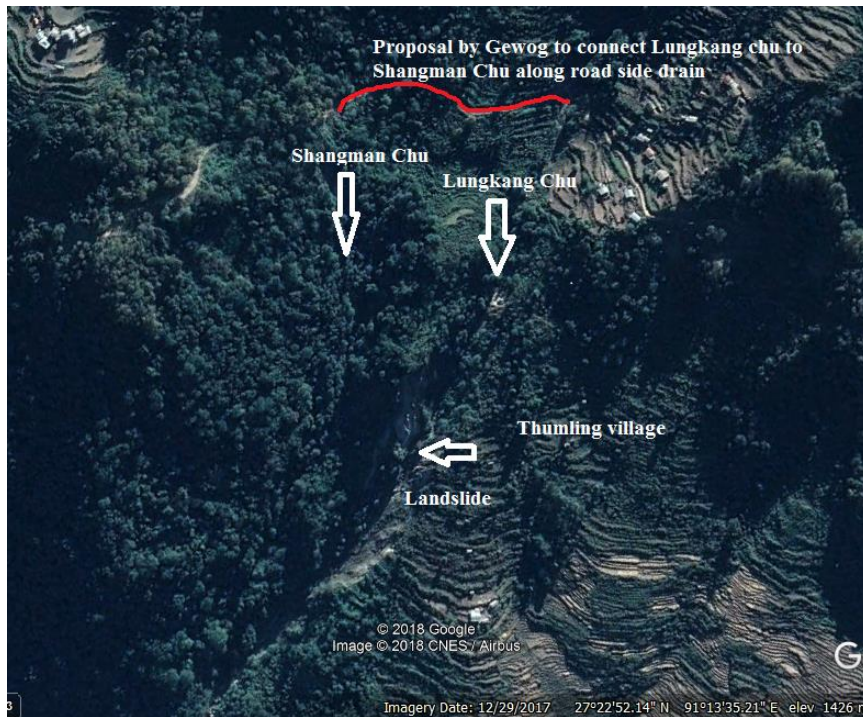
Figure 11: Google image of Shangman Chu and Lungkang Chu along Thumling village

Tsakaling Gewog: There are only two streams in Tsakaling Gewog. They are Lungkang Chu and Shangman Chu. These streams remain dry in winter season. There are settlements along the Lungkang Chu only. Thumling village is mostly affected by this stream due to landslide. According to the Gup, in the year 2011 and 2012 two household from Hisa village were relocated to Thumling village which is quite far from landslide area. However, if some land management works along landslide prone areas are not done, there is possibility of scouring and landslide reaching Thumling village. There are four households in Thumling village which are located very close to landslide and have threat. Along the Shangman Chu, there is no settlement.

- **Lungkang Chu:** There is settlement along Lungkang Chu only. Gewog is planning to divert Lungkang Chu to Shangman Chu by constructing drain along farm road to avoid further landslide along Thumling village.
- To avoid scouring at some portions of upstream along Lungkang Chu, gabion check dam at critical locations would control flow and debris.
- Bio engineering works such as planting of fast growing plants, providing wooden creep walls will also control landslide.

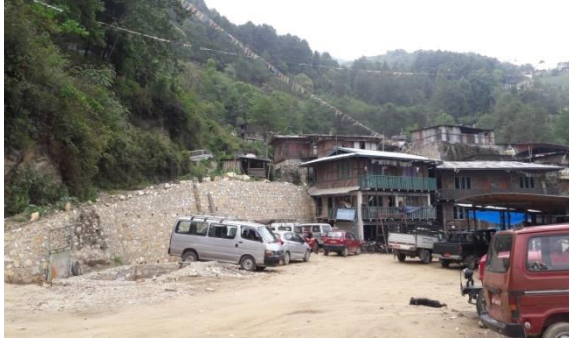
Figure 12: Location of automobile workshop

Runoff seasonal stream at automobile workshop area: The main source of runoff is due to water flow from road at upstream. Road is not having proper side drains. There is a risk to automobile workshop at the downstream. There are 24 workshops situated at this location. In the past Dzongkhag municipal have constructed gabion (hand woven) check wall. During the field visit it was found that, the check wall is functioning well to slow down the velocity and control debris. According to the municipal engineer, in the 12 five year plan, they want to propose for construction of 650 metres step fall drains and 1000 metres gabion side wall at both the banks to streamline the runoff flow. If the road side drain is managed properly, the runoff will be controlled and risk will be minimised at the workshop.

- **Runoff seasonal stream at automobile workshop area:** Dzongkhag have constructed gabion wall (Hand woven) check wall.

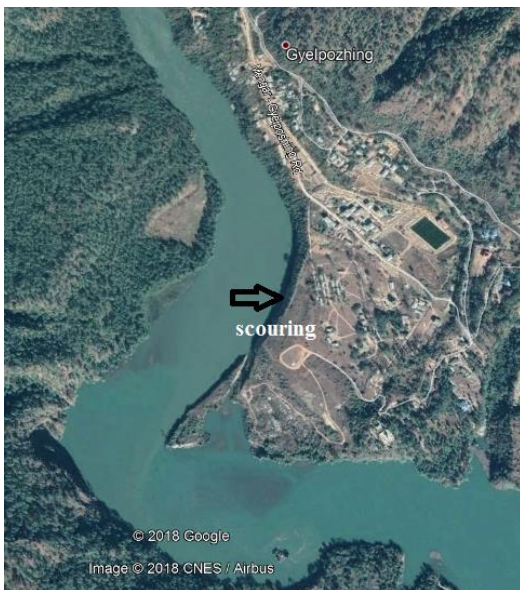
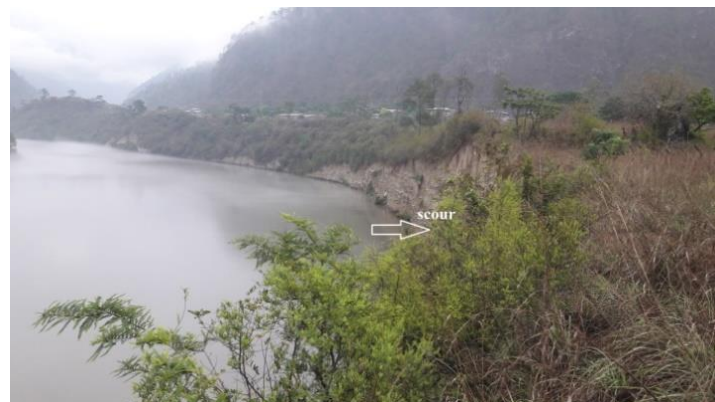
Kurichu at Gyalposhing: According to the Dzongkhag municipal engineer, scouring at the left bank of Kurichu happens every time during the cleaning schedule of the hydro power plant. During the field visit, we have observed some boulders and soil was falling at the left bank. There is a possibility of taking away the land in future if mitigation measures are not carried out. Thorough study should be carried out and come up with suitable measures to avoid further landslide due to scour.

Figure 14: Google image of KuriChu

Figure 15: Location of scouring area in Gyalposhing.

- **Kurichu at Gyalpothing:** Thorough study should be carried out and come up with suitable measures to avoid further landslide due to scour.

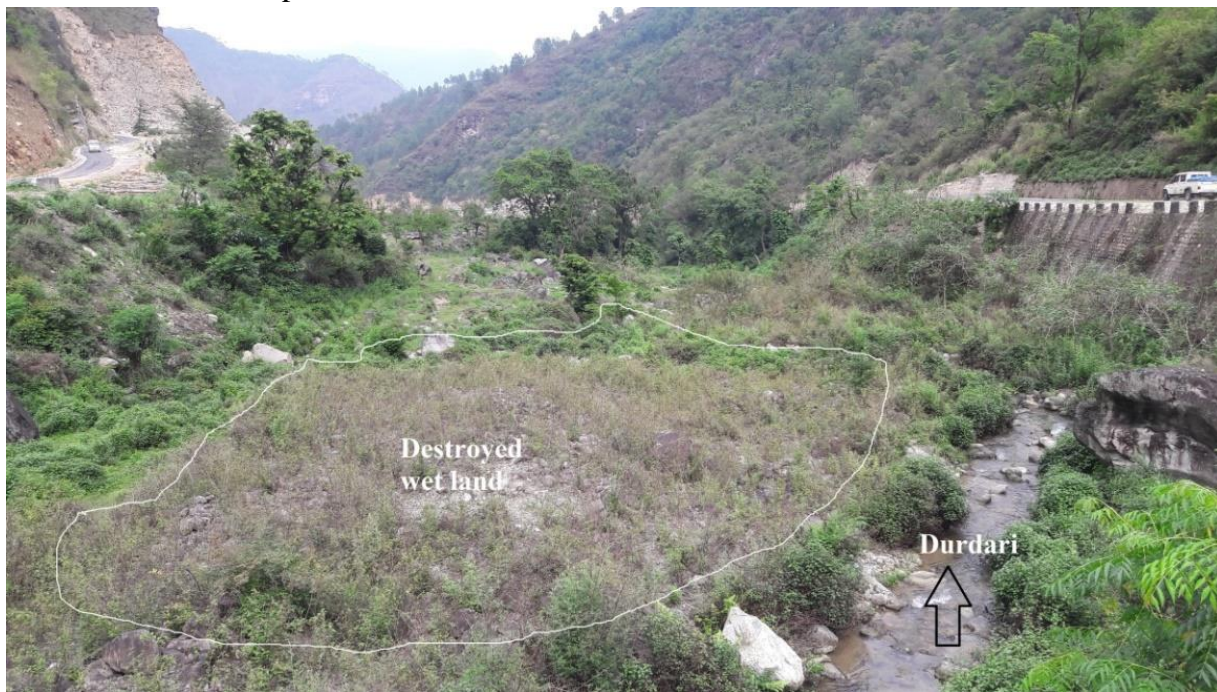
Durdari: This is a small and perineal river which passes through the Mongar – Trashigang highway. During the site visit, we have measured its discharge and calculated 0.36 cumecs. This river is having threat to only wet land. According to the Gup, last flooding occurred between 4-10 years ago which lasted about 1-2 days due to heavy rainfall. Till now 2 acres of wet land have been destroyed by the flash flood. In case of sudden flood in future, there is a risk to additional 2 acres wet land in the area. Gewog wants to seek both financial and technical assistance for the construction of flood protection structures.

Figure 16: Location of destroyed wetland along Durdari.

- **Durdari:** It was observed that the level difference between river and wet land is 1.50 metres only with gentle slope. Construction of 200 metres length gabion wall at the left bank will minimize the flood risk and helps in reclaiming destroyed wet land.
- **Morabri:** We have observed that, the area is prone to landslide with a steep slope. To stabilize the slope, entire landslide prone area should be managed properly by carrying out bio-engineering works such as tree plantations, construction of wooden creep walls and check dams at critical locations. There is a possibility of major landslide if mitigations works are not carried out.

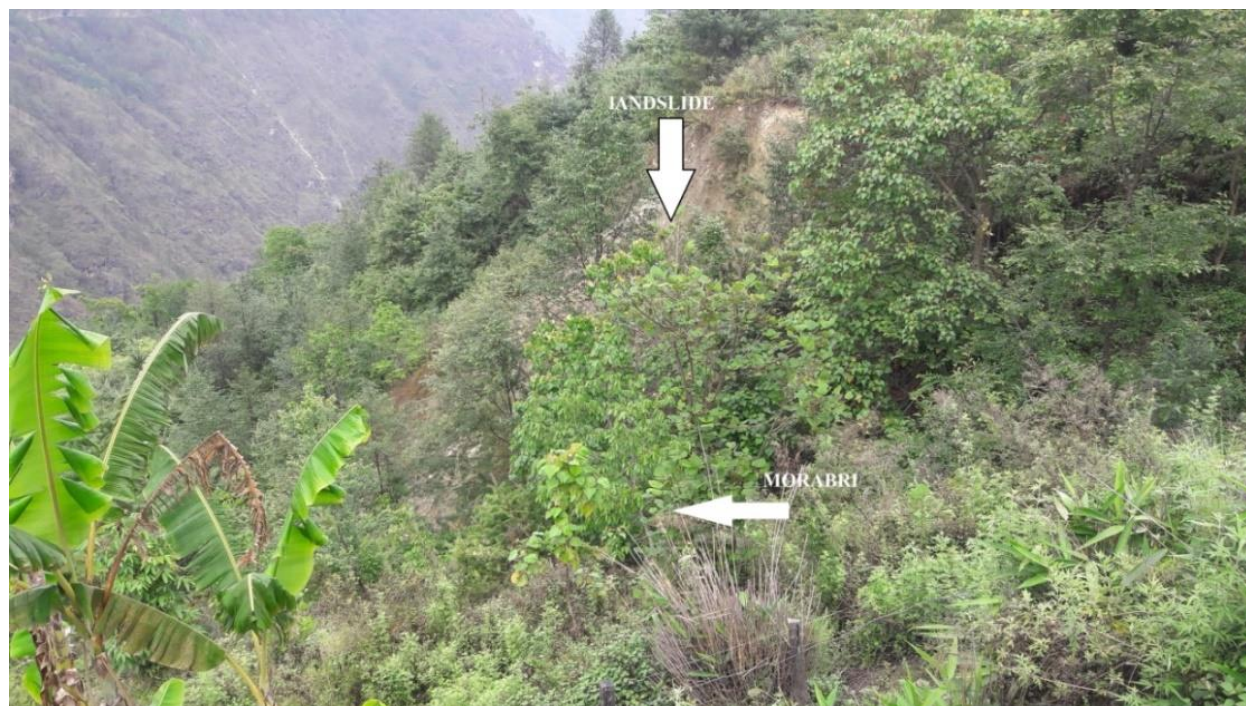
Morabri: This is a seasonal stream which collects runoff water from its catchment area. Till now, 8 acres dry land belonging to 7 households has been damaged due to landslide. It has not affects human till date. According to the Gup, there is a risk to another 5 acres dry land and 3 houses if mitigation works are not done in future. Gewog Administration is planning to put budget proposal in 12 Five Year Plan.

Figure 17: Landslide area along Morabri.

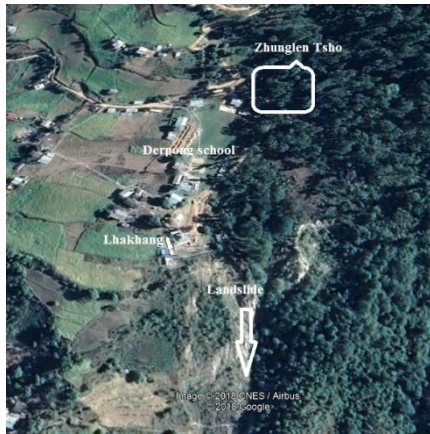
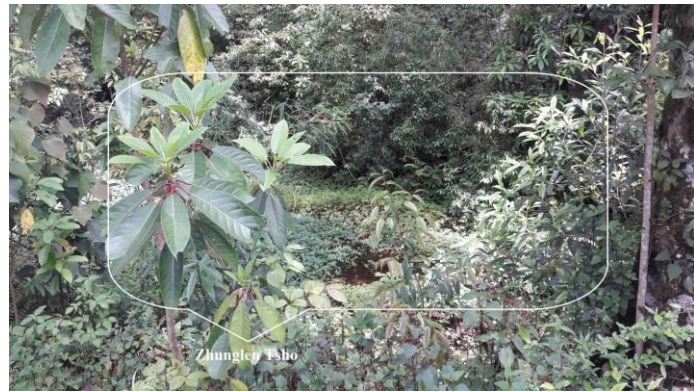
Drepong Gewog: According to the Gewog Mangmi, Drepong Gewog has no river along the settlement and agricultural land. Gewog have experienced only landslide due to overflow from Zhunglen Tsho in 2005. The team have visited the site and found that the lake is almost dry with little water remaining as shown in picture no.12 it has caused huge landslide at downstream of lake which has destroyed about 7-8 acres of dry land. There are 10 households and 20 acres dry land which are under risk in case of lake over flow in future. In the year 2013, Gewog Administration has constructed dry wall with the help from Dzongkhag Forest. To stabilize the slope, public have carried out bio-engineering activities such tree plantation and bamboo plantation. As per Gewog Mangmi, bamboo plantation is successful for slope stabilization and slope failure have stopped. To further stabilizing the slope, Gewog Administration is planning to carry out more bamboo plantation in future from Gewog fund.

As per the visual observation, it was found that, bio-engineering activities is working well and should be continued to protect losing agricultural land in case of lake outburst.

Figure 18: Landslide area below Zhunglen Tsho

- **Zhunglen Tsho:** Dry Rubble Masonry, bamboo tree plantation.

- **Zhunglen Tsho:** It was observed that, bio-engineering activities is working well and should be continued to protect losing agricultural land in case of Lake Outburst.
