FLOOD HAZARD ASSESSMENT FOR PUNAKHA DZONGKHAG

FLOOD ENGINEERING AND MANAGEMENT DIVISION,
DEPARTMENT OF ENGINEERING SERVICES
MINISTRY OF WORKS AND HUMAN SETTLEMENT

YEAR 2019

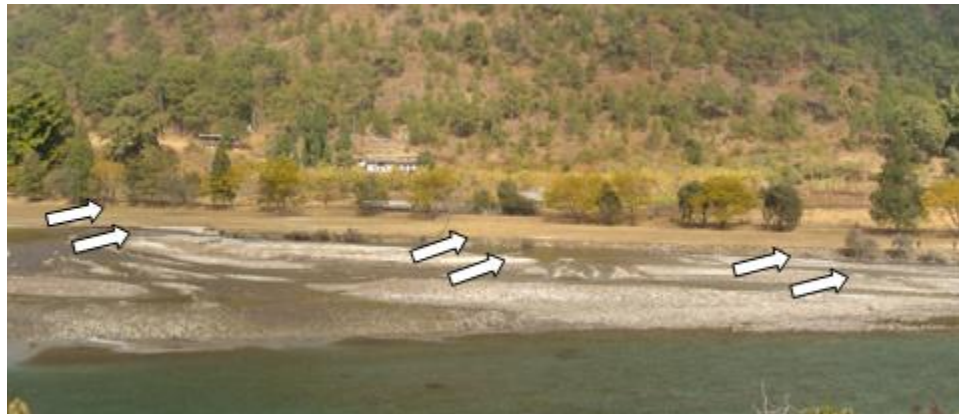
Figure 8: Sonagasa old zoo at the left bank of Mochu

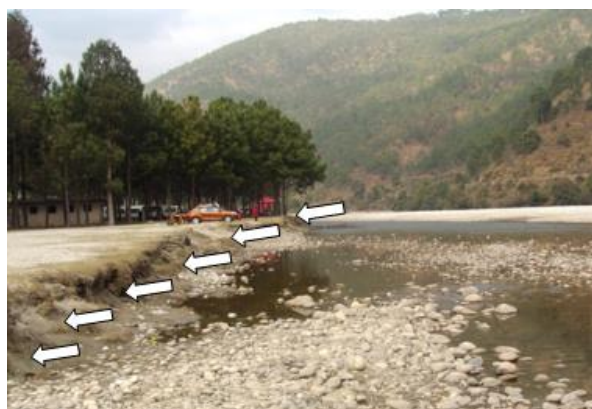
Figure 9: Zomlingthang at the right bank of Mochu

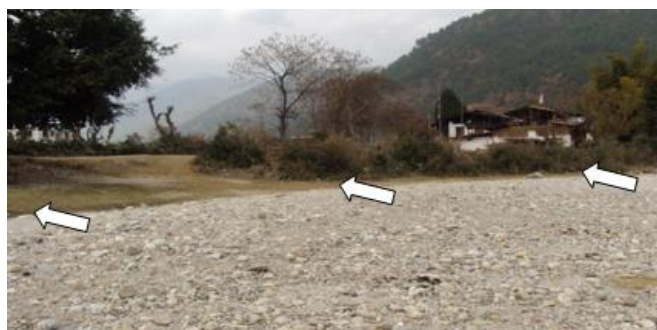
Figure 11: Changyuel at the right bank of Mochu

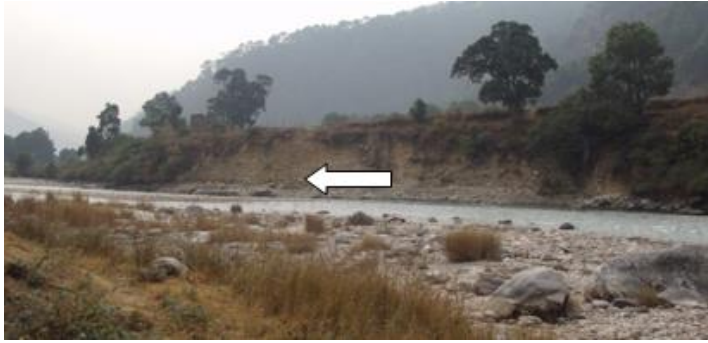
Figure 14: Samarzingkha at the right bank of Phochu

Gewog	Village	Stream/River name	Length of structure	Type of structure recommended
Kabisa	Serigang	SeriRongchu	200 m	Gabion revetment with apron
Guma	Zomlithang	Right bank of Mochu	1500 m	Rip Rap
	Downstream of Zomlithang	Left bank of Mochu	2000 m	Rip Rap
	Changyel (downstream of Changyel Bridge till the Dzong)	Right bank of Mochu	500m	Gabion revetment with apron
	Below Punakha High School	Right bank of Punatsangchu	150m	Gabion revetment with apron
	Near (TTI) Technical Training Institute and vegetable market	Right bank of Punatsangchu	Between the existing flood protection walls	Gabion revetment with apron
Toedwang	Samarzingkha	Right bank of Phochu	250m	Gabion revetment with apron

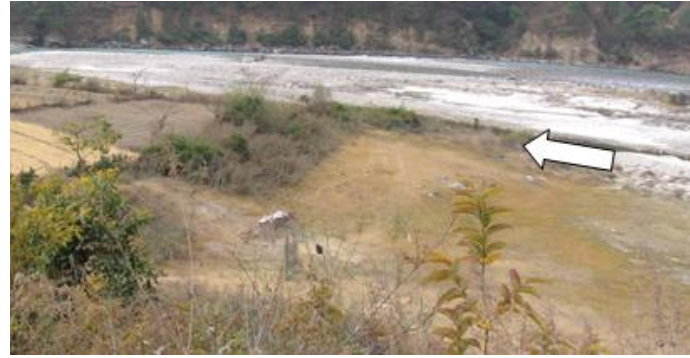
Figure 15: Khawakha at the right bank of Phochu

Khawakha village	Right bank of Phochu	200m	Gabion revetment with apron
Dzomi	Shangalungchu	Left bank of Phochu	Not measured	Gabion revetment with apron
	Mendagang(opposite to Lingkana)	Left bank of Phochu	Not measured	Gabion revetment with apron
Baarp	Soksokha(Village Hotel)	Left bank of Toebrongchu	Not measured	Gabion revetment with apron

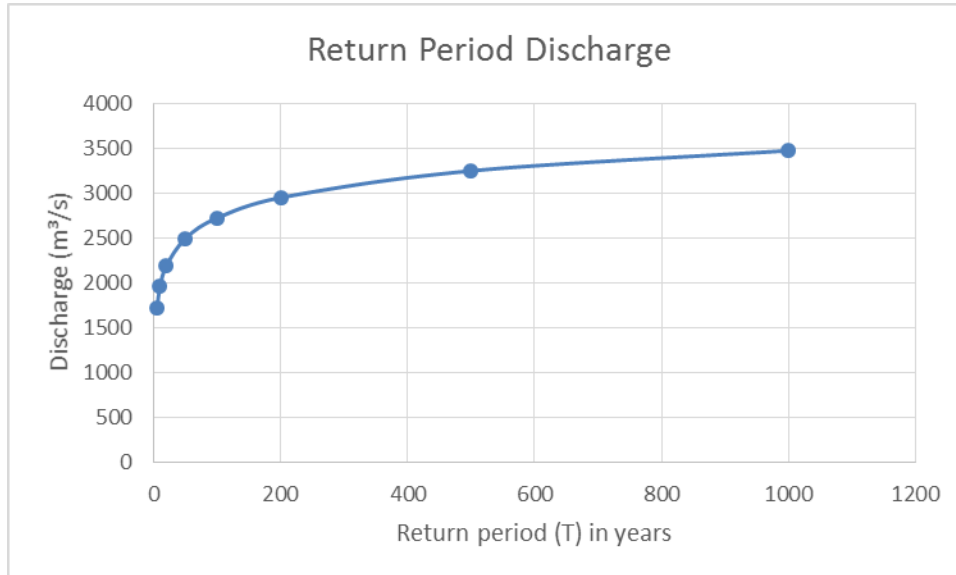
The return period discharge computed using Gumbel distribution for Punatsangchu is shown in Figure 22.

Figure 22: Return period discharge for Punatshangchu using Gumbel method

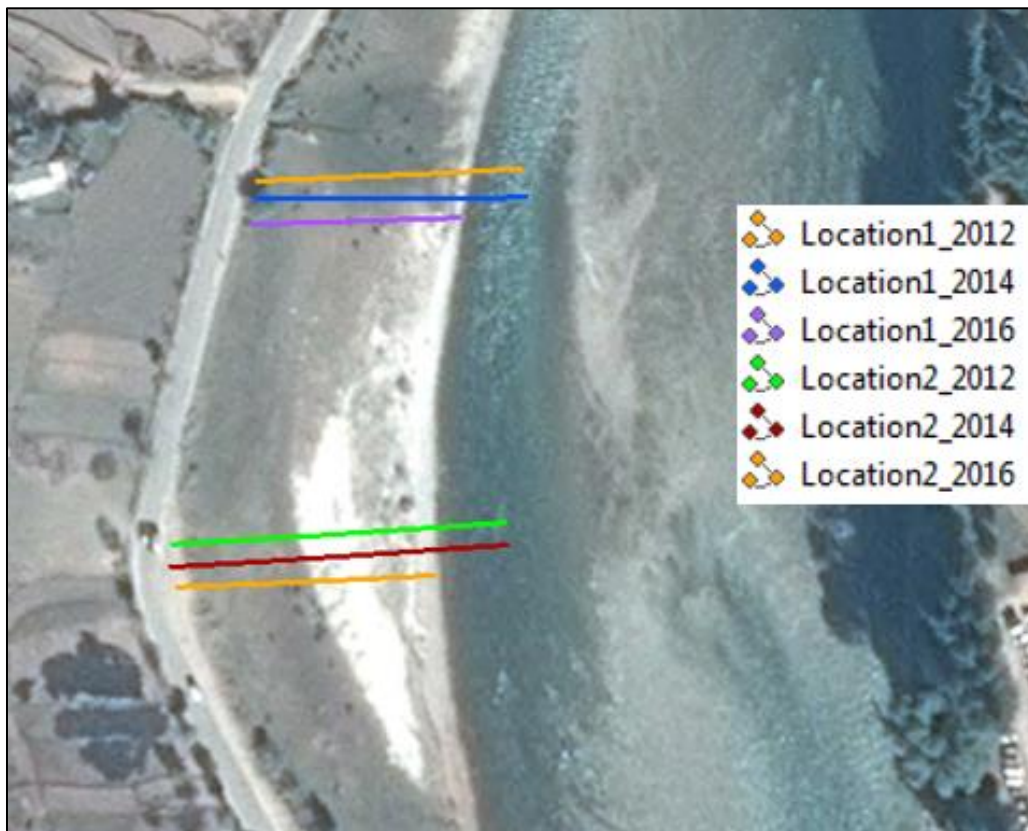
It has been proven that any bank protection structure constructed with have an erosive effect on the opposite bank. This kind of river morphology was seen in Mochu as well. In the left bank of Mochu lies one of the most historic Dzong, the Punakha Dzong. A huge investment was made to protect the left bank of Mochu upstream of the Dzong to protect it from being flooded. Although the flood walls have been successful in protecting the left bank, the residents have observed an increase in the erosion rate of Mochu at the right bank. And as per the measurement from Google earth images shown in Figure 24, the rate of erosion at right bank of Mochu from 2012 to 2014 was negligible while the rate of erosion over a span of 2 years (from 2014 to 2016) is approximately 15 m. The change in the floodplain width at two selected locations can be seen in Table 6. One of the reasons for the increased erosion could be the bank protection wall that was constructed along the left bank of Mochu in 2015.

Figure 24: Google image showing the erosion at the right bank of Mochu in a span of 2 years (2014 and 2016)

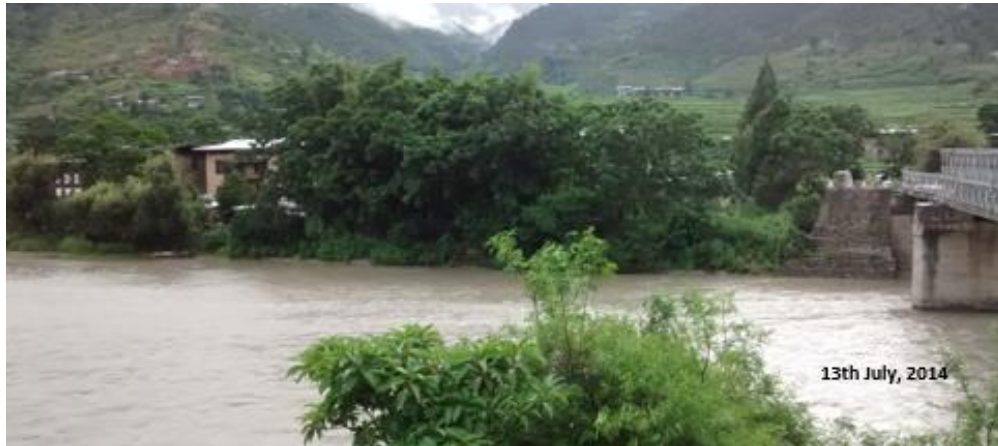
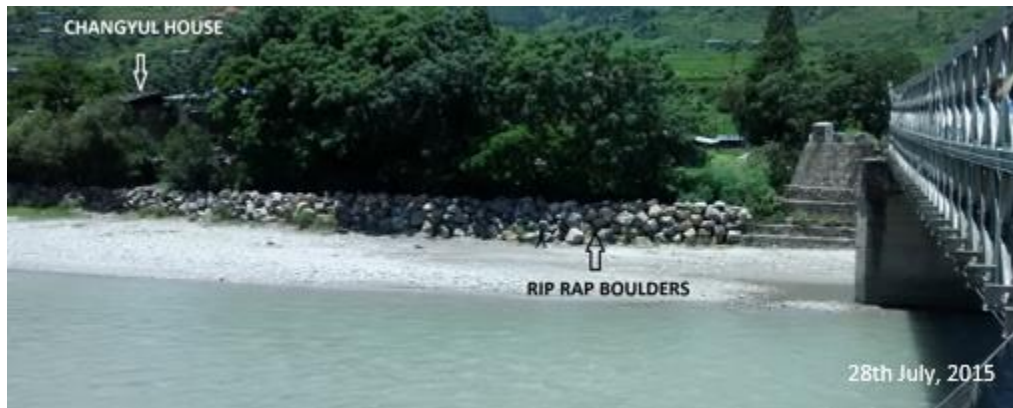
Figure 26: Near Changyel area before intervention in 2014

Figure 27: Near Changyel area after intervention in 2015

The Punakha Dzongkhag had requested the Ministry of Works and Human Settlement to incorporate budget for flood protection works in the Dzongkhag for the 2nd FY of the 11th FYP as per letter No. DAP/ENG-10/2013-14/423 dated 7th March, 2014. Accordingly, the Ministry allotted a total budget of Nu. 10 Million for flood protection works along Mochu for FY 2014-15. The FEMD, Department of Engineering Services provided the technical backstopping like design, estimate and drawing with specifications to the Dzongkhag and the flood protection works were executed in two packages. The 1st package was the Rip Rap Boulders along Changyul House and Sonagasa Palace road which was done by the Dzongkhag Departmentally. The work was completed on 30/06/2015 and the total cost incurred was Nu. 5,663,559.05. The before and after intervention image can be seen in Figure 26 and Figure 27.

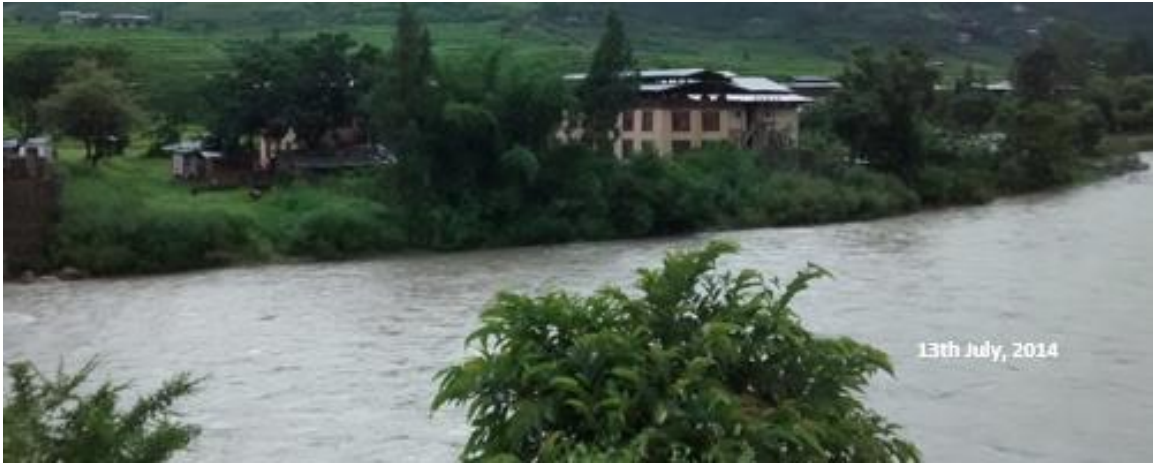
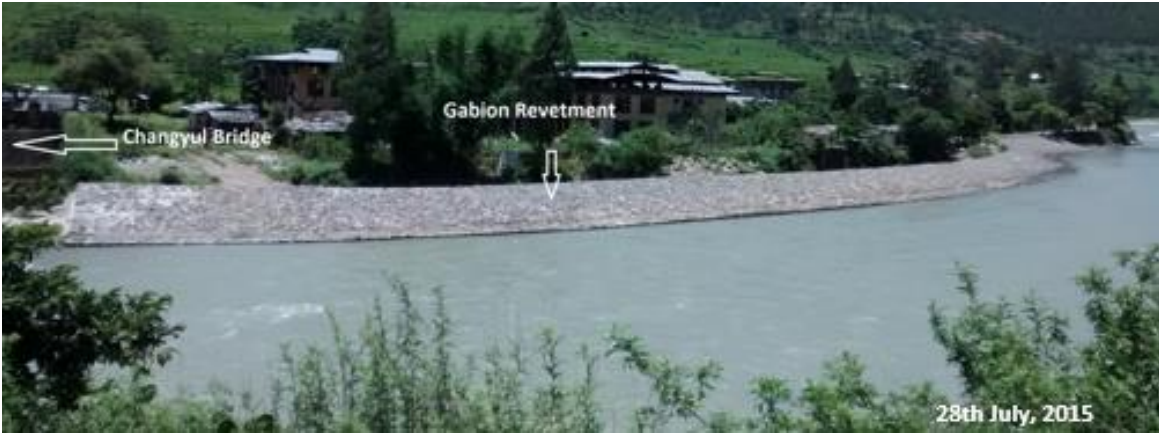
Figure 29: Upstream of Changyul Bridge before construction of Gabion Revetment in 2014

Figure 30: Upstream of Changyul Bridge after construction of Gabion Revetment in 2014

The 2nd package was the Gabion Revetment along Mochu, upstream of Changyul Bridge which was executed on Contract basis. The work was completed on 30/06/2015 and the total cost incurred was Nu. 4,336,450. The before and after intervention image can be seen in Figure 29 and Figure 30.
