FLOOD HAZARD ASSESSMENT FOR SAMDRUP JONGKHAR DZONGKHAG

FLOOD ENGINEERING AND MANAGEMENT DIVISION,
DEPARTMENT OF ENGINEERING SERVICES
MINISTRY OF WORKS AND HUMAN SETTLEMENT

YEAR 2019

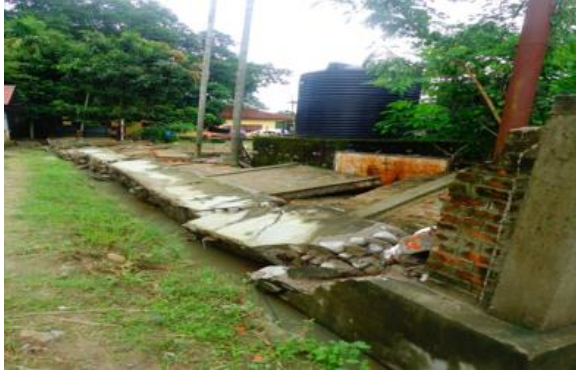
Figure 2: Compound wall damaged.

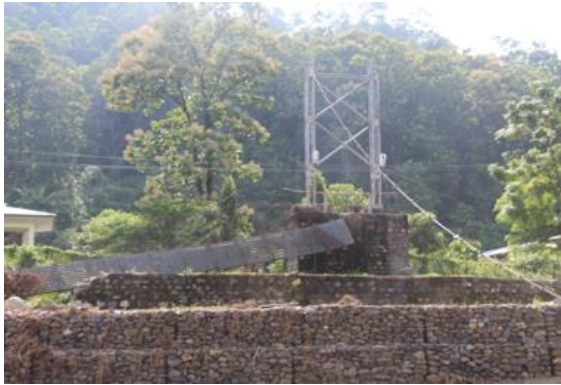
Figure 4: Suspension bridge damaged.

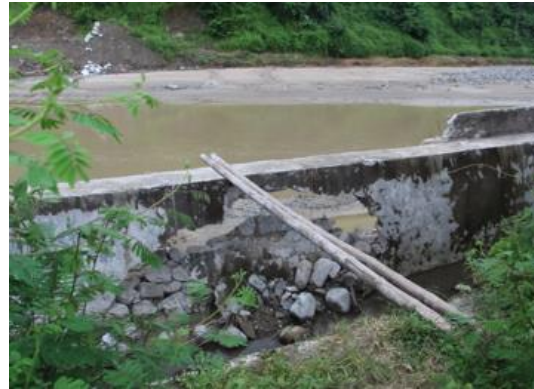
Figure 5: Flood protection structure damaged.

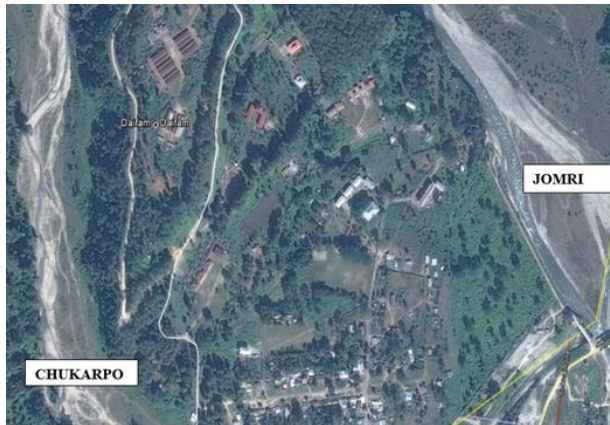
Figure 7: Map showing ChuKARPO and Jomri river in Jomotsangkha Dungkha.

There are two main rivers in Jomotshangkha area: Chukarpo on the left and River Jomri on the right side of the town. It was found that there is a high possibility of the rivers changing its course within the riverbank plains. This could pose a threat because the rivers cut away at the landforms little by little, reducing the total area of the site. The flood analysis report from *Getotechnical Report, Jomotshangkha* revealed that in every 100 years, peak value of 286.65 m³/s and in every 150 years, a peak value of 299.16 m³/s could hit the Jomotshangkha valley by

Chukarpo. For River Jomri, the values were $1256.81 \text{ m}^3/\text{s}$ for 100 years and $1311.65 \text{ m}^3/\text{s}$ for 150 years.

Jomri River causes bank erosion on the right bank leading to landslides. Jomotsangkha hospital, Mandir and forestry office is located on the top of the landslide area.

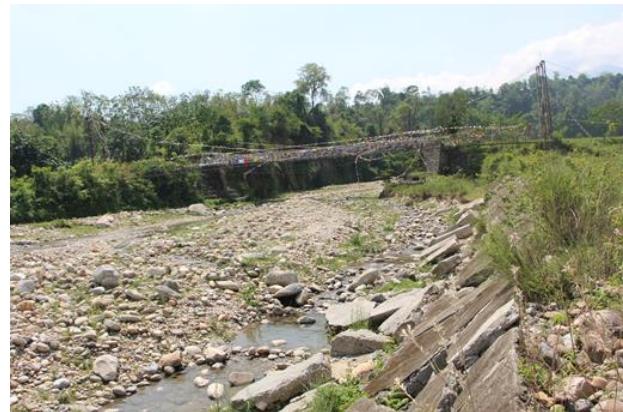
Figure 8: Existing RRC revetment was destroyed in 2016 flooding.

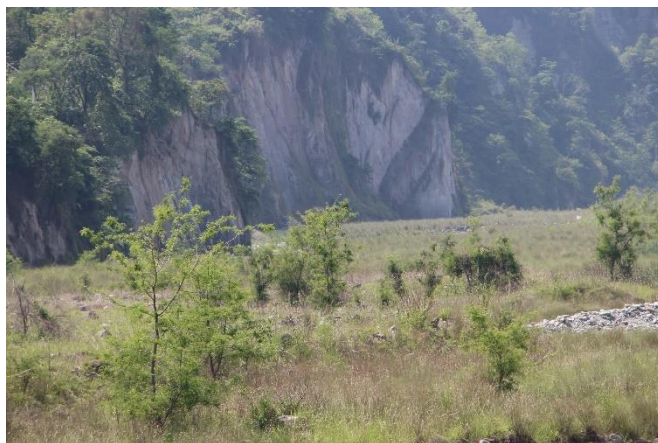
Figure 9: Jomri river causing bank erosion which leads to landslides in jomotsangkha.

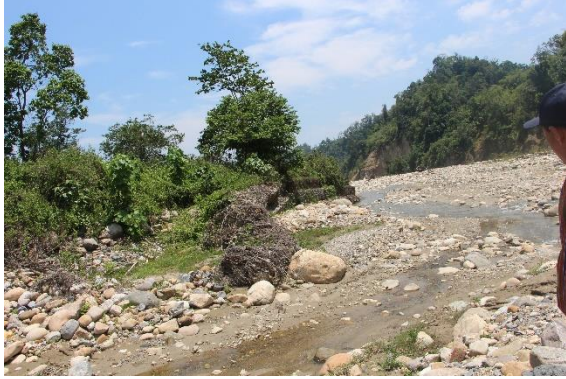
Rongchuthang River is a seasonal river which has river bed level equal to ground level, giving river all the freedom of flow in all direction, leading to change in river course during every heavy rainfall. This has resulted in washing away of Agricultural land in Rongchuthang village.

Figure 10: Ground level and river bed level is almost equal in Rongchuthang river.

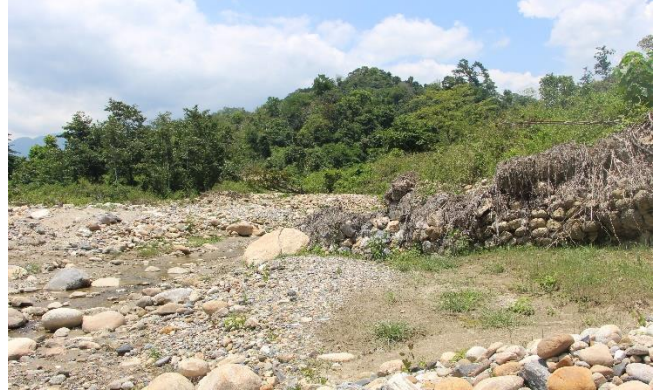
Figure 11: Existing Gabion wall has failed.

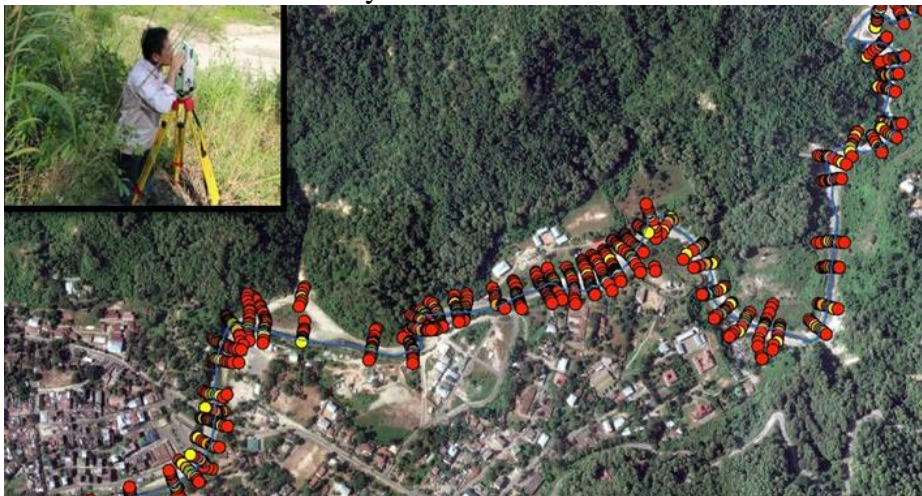
Taking cross-section survey of a river channel is important while conducting river analysis to find the river discharge, velocity, river profile etc. Cross-sections are required to represent channel geometry in a river hydraulic model. The accuracy of the simulated water levels and the floodplain delineation largely depends on the shape as well as extent of these cross-sections. The cross-section survey of Dungsumchu was carried out by FEMD, DES, MoWHS. About 57 numbers of cross-section data along Dungsumchu were collected in the first batch and then, depending on the critical areas and location of the structures, 52 numbers of surveys was carried out in the second batch. The dimension and location of the structures were also collected to be used in the model. The Figure 12 **Error! Reference source not found.** shows how the survey has been conducted for this study.

Figure 12: River cross-section survey.

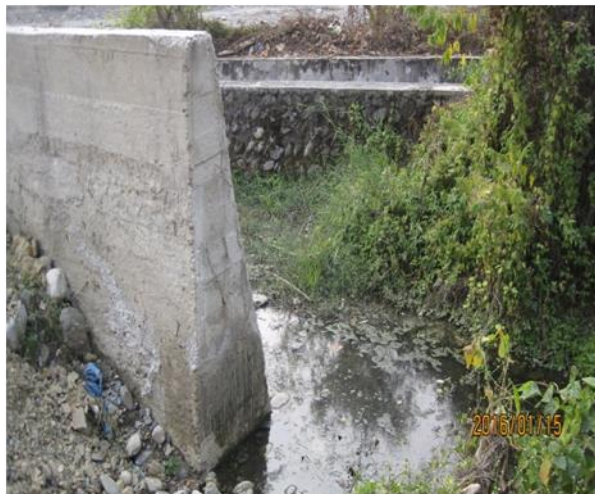
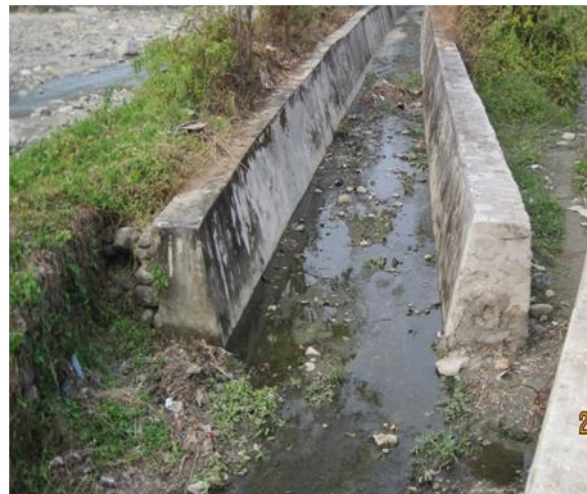
There is an outfall below the RSTA office as shown in Figure 14 to discharge off the runoff from the industrial area into the river. The storm water drain from the industrial area runs along the left bank of Dungsumchu till the outfall near RSTA. From visual inspection, it can be seen that the storm water drain only caters to some areas above the football ground. The outfall is located between the two flood protection walls and there is an opening in between to allow storm water runoffs from the surrounding areas (RSTA, bus booking etc.) to discharge into the river. During the flash flood in August, 2015, the back flow from the river into the surrounding area from the opening and the outfall caused inundation of the surrounding areas and collapsed of the compound wall around RSTA office. As per the site investigation, this area was found to be one of the most critical areas.

Figure 14: Outfall below the RSTA office.

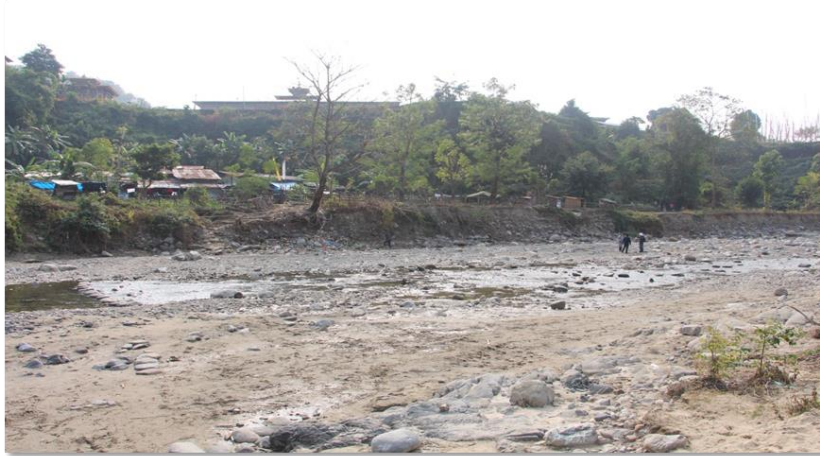
There are settlements in the area behind the Dzong and the area is situated at a much lower elevation than the Dzong area as shown in Figure 15. There are about 10 households living in the area and they come from low income group. The settlement area at present is acting as a buffer zone for Dzong against the flood. During the site investigation, it was found out that there was a major scouring along the left bank of the Dungsumchu behind the Dzong. The river has been meandering and the normal flow path of the river is towards the left bank. The flowing water in the river erodes the outer banks and deposits them on the inside. There is not much elevation

difference between the river bed level and the settlement area on the left bank (River bed level- Elevation 200 m, Latitude 26°48'25.7", Longitude 91°30' 15.1" and Settlement Area- Elevation 206 m, Latitude 26°48'25.7", Longitude 91° 30'9.1"). Therefore, there is higher chance of settlement area getting inundated by the flood posing risk to the lives of people. If this area is not protected immediately, then the scouring will take away the land acting as a buffer zone and further, it will increase the vulnerability of the people and infrastructure in the Dzong area to the flood. Since the river direction is towards the Dzong, the area behind the prison will also be affected if no immediate measures are done.

Figure 15: Area behind the Dzong.

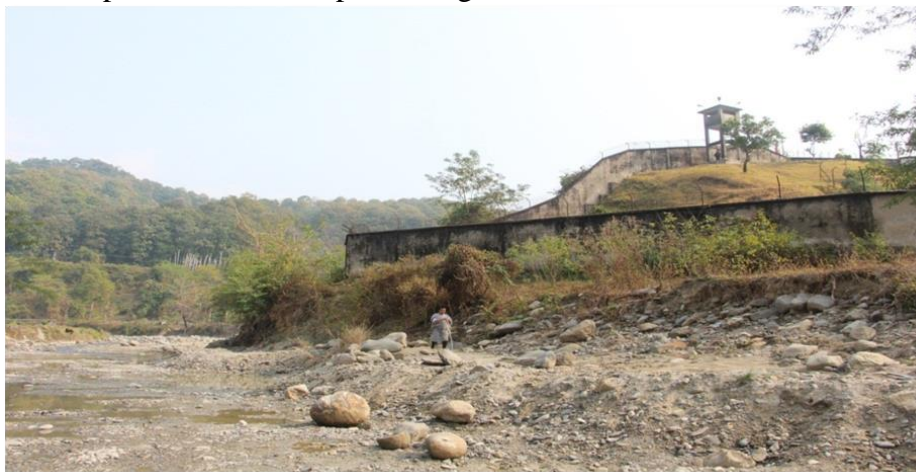
The area behind the Prison as presented in Figure 16 located on the left bank of Dungsumchu is also vulnerable to flood. The prison is located along the left bank of Dungsumchu and there are visible signs of scouring along the bank. If flood protection measures are not done immediately, the compound wall of the prison might fail.

Figure 16: Areas behind the prison.

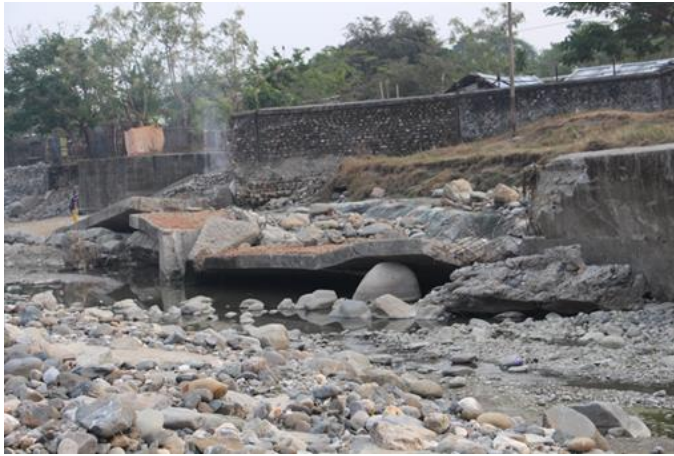
Some portion of the flood protection works on the right bank of Dungsumchu near the international border has collapsed due to scouring of the foundation by the flowing river as seen in Figure 17. However, there are some portions which are still standing intact and there are also visible signs of scouring in the foundation of the wall. The protection walls are preventing river breaching the bank and also erosion of the river bank.

Figure 17: Damaged wall near international border

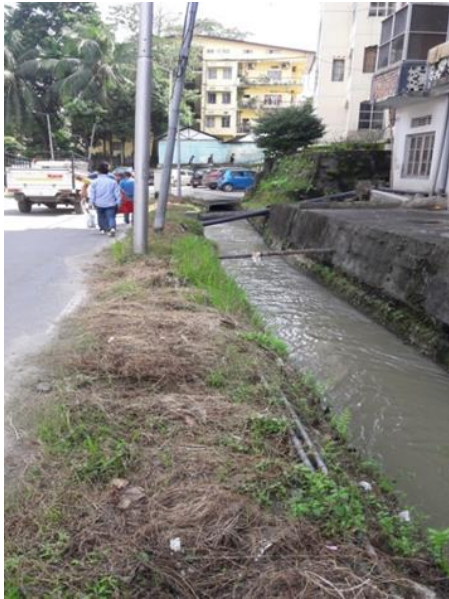
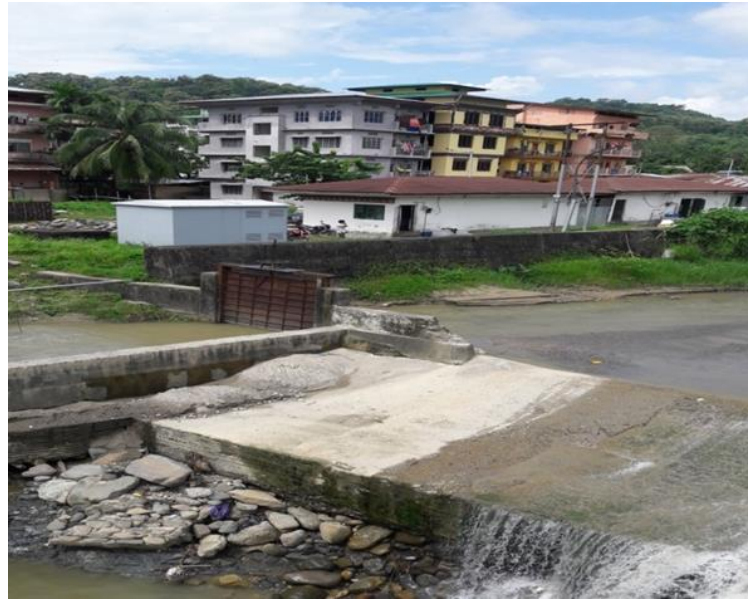
As per the local resident, the main source of flooding in Samdrup Jongkhar Municipality during the rainy season in lower town area is due to over flow of water from the irrigation canal. The canal takes water from Dungsumchu to the border town of India. There are two irrigation canals inundating roads and causing inconvenience to the people during the rainy season. The Figure 18 and Figure 19 show the irrigation canal and its intake point at Dungsumchu in the lower market.

Figure 18: Irrigation canal in lower market. **Figure 19: Weir and irrigation canal intake.**

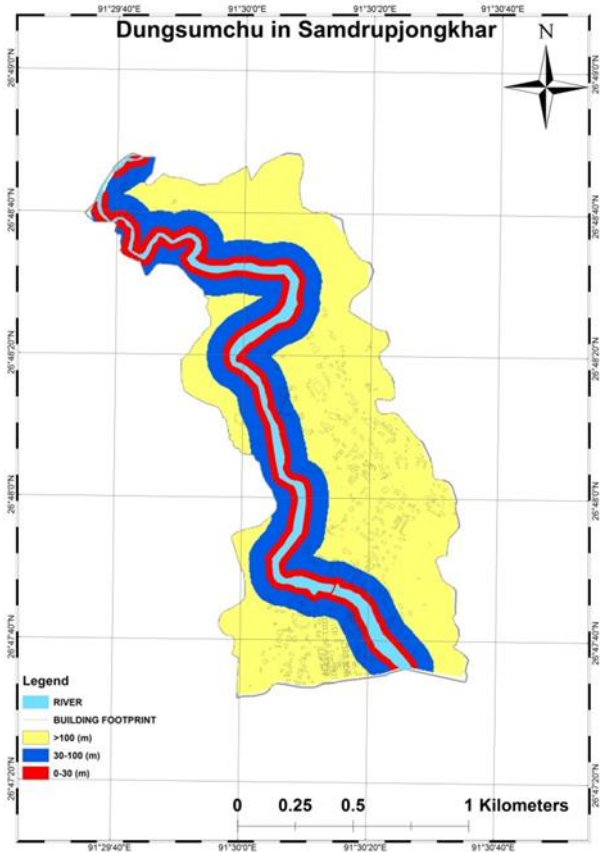
The elevation map in Figure 25 is generated from Digital Elevation Model (DEM) of 4-meter resolution provided by the Municipality. Similarly, the river buffer in Figure 26 is calculated using Euclidean distance in spatial analyst tools.

Figure 26: River Buffer for Dungsumchu.

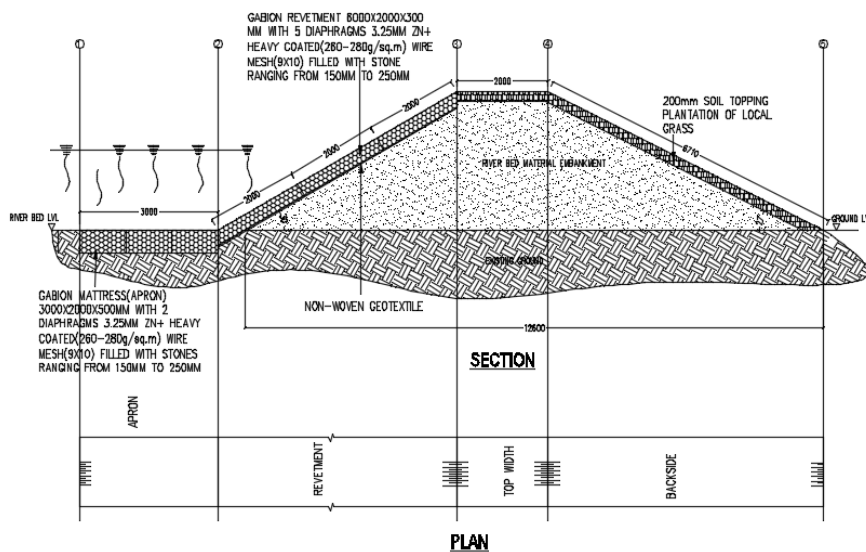
Similarly, in 2017, Design, drawing and detail specification for construction of flood protection structures along Rongchuthang river in Jomotsangkha was forward to dungkhag for implementation. The estimated cost of structure was **Nu. 14, 917,764.00**. The typical cross-section of Gabion revetment designed is shown in Figure 33.

Figure 33: Typical section of gabion revetment designed for Rongchuthang River in jomotsangkha.

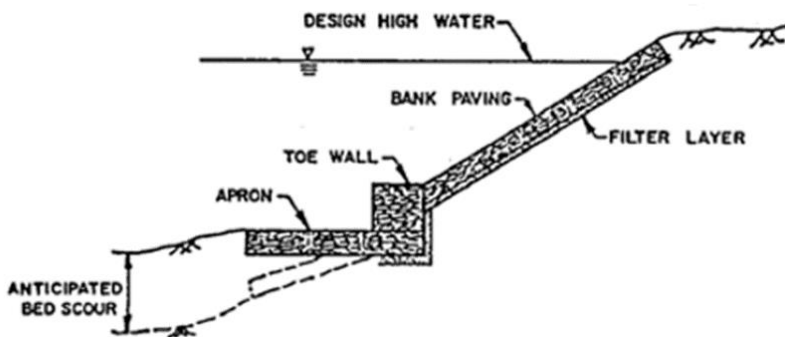
1) The apron as shown in Figure 34 should be provided at the base of the toe wall (width of the launching apron= $1.5 \times$ maximum scour depth) to prevent scouring of the base under the toe wall. The bed scour should be measured at site by the designing engineer. Further, it is recommended that the base of the toe wall should be deeper for more efficiency.

Figure 34: Requirement of apron for scour protection.

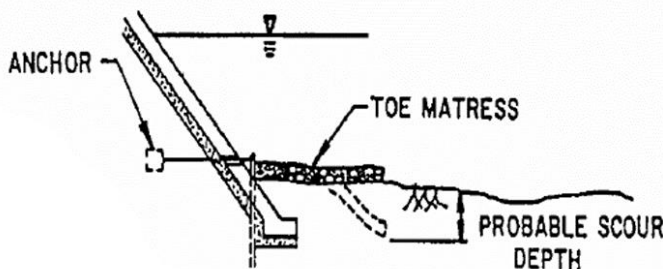
2) The toe mattress may be designed considering the maximum water level to protect the toe wall from failure due to scouring. It may be provided above the toe wall as depicted in **Error! Reference source not found.**

Figure 35: Requirement of toe mattress for toe protection.

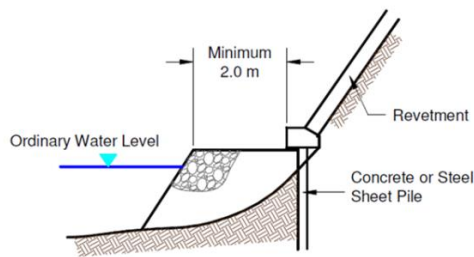
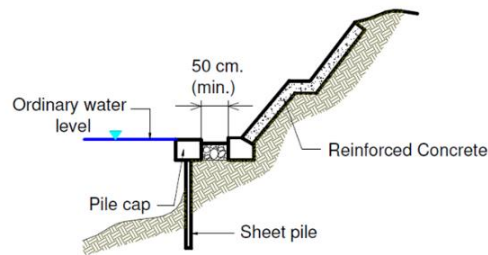
3) Appropriate counter-measures such as concrete piles or sheet piles may be provided as given in Figure 36 and Figure 37 to protect the foundation of the revetments and walls during high velocity flow when it is subjected to direct water attack resulting in scouring of the deepest river bed. In addition, the foot protection works should also be placed in front of the revetment foundation to prevent scouring at the base of a loose soil.

Figure 36: Concrete or steel sheet pile for scour protection. Figure 37: Alternative sheet piling for scour protection.

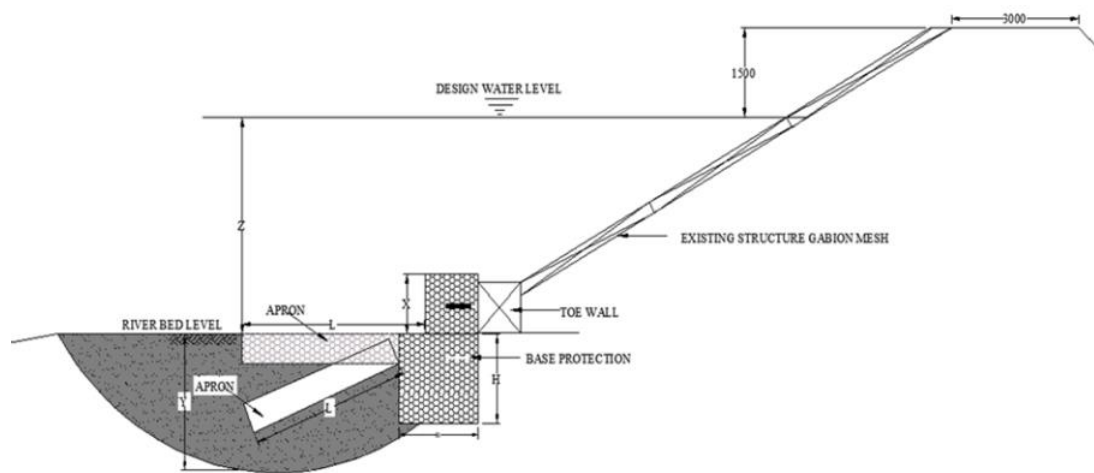
1) **Error! Reference source not found.** and **Error! Reference source not found.** show an interim measure to re-strengthen the existing revetment, reinforced cement concrete (RCC) wall and Random Rubble Masonry (RRM) wall for flood protection. The diagram shows that three elements (first gabion panel, second gabion panel and apron) will be constructed in front of the existing walls. The function of the first panel gabion box (height X) provided in front of the toe wall is to prevent the revetment/RCC wall/RRM wall from sliding and it will also provide better stability. Further, the second panel placed below the first panel will make foundation stronger and it will also protect against erosion. The apron provided will be launched in due course of time due to scouring. However, the launching apron will cover the face of the scour and it will protect further scouring, thus retaining the strength of the base of structures.

Figure 38: Apron for existing revetment.

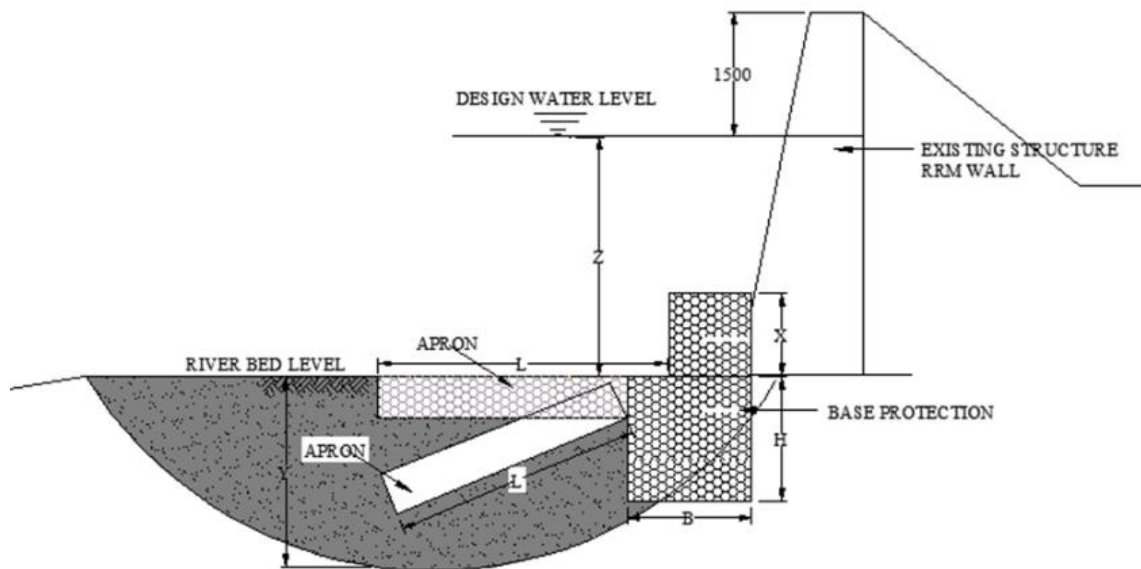
Figure 39: Apron for existing RRM/RCC wall.
