# FLOOD HAZARD ASSESSMENT FOR SAMTSE DZONGKHAG

FLOOD ENGINEERING AND MANAGEMENT DIVISION,  
DEPARTMENT OF ENGINEERING SERVICES  
MINISTRY OF WORKS AND HUMAN SETTLEMENT

YEAR 2019

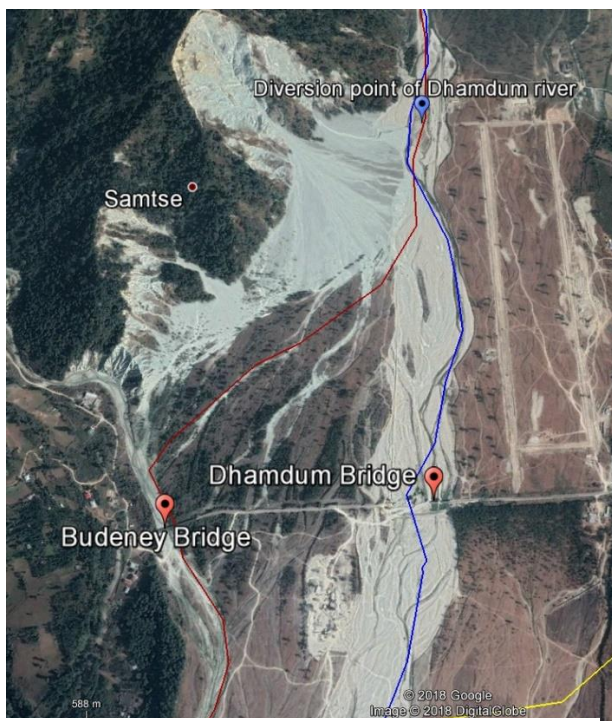
Figure 4: Google image of Dhamdum and Budney

**Budney River:** The FEMD team met with the Mangmis and the Tshogpas of Samtse Gewog and discussed about the threat caused by the Budney River. All the representatives present shared their concern over the increased flooding risk caused by the diversion of the Dhamdum stream to Budney stream. The diversion was done by the Department of Roads, Ministry of Works and Human Settlement through dredging works and construction of AB mattress which is still under construction as of date. The total cost for the dredging works and AB mattress can come up to Nu. 42 million. As per the Mangmi and the Tshogpas, the DoR had diverted the river since the Budney Bridge was unstable. DoR hopes that the Budney Bridge can accommodate both the discharge from Dhamdum and Budney streams during monsoon. However, the Gewog representatives fear for the worse during the coming monsoon with the added discharge from Dhamdum stream. The Gewog representatives also claimed that the DoR did not acquire any public clearance before the diversion works took place.

**Budeny and Dhamdum River:** A detailed technical study should have been conducted before the diversion of the Dhamdum River to Budeny River. A proper study with pros and cons of the diversion could have led to a different solution other than diversion. It is highly recommended to study the catchment and implement proper catchment stabilization methods to reduce the sediment deposits which fill up the river bed during monsoon.

The diversion of the Dhamdum River will increase the discharge flowing through the Budeny River flow path thus exposing the residents at the right bank of Budeny and the Budeny Bridge itself under increased flooding risk in the coming monsoons. Therefore it is highly recommended to implement counter measures for the diversion work that is currently under process. It is also highly recommended to conduct geotechnical and watershed assessment of the Budeny and Dhamdum and catchment for sustainable watershed management.

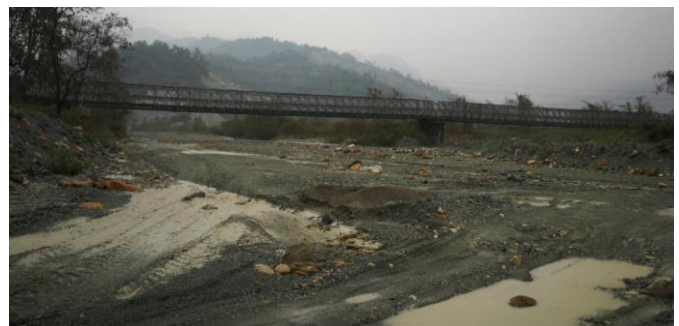
Figure 5: Budney Riverbed filled with heavy sediment deposits

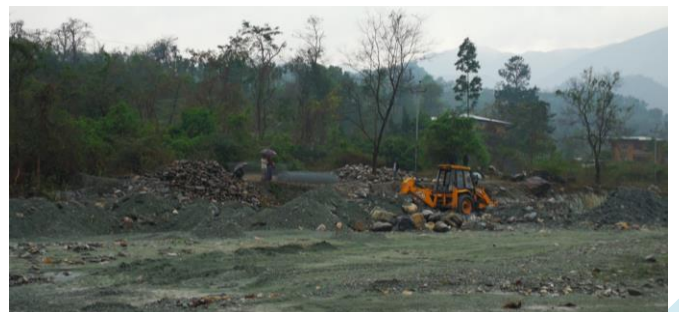
Figure 6: Ongoing flood protection works carried out by DoR

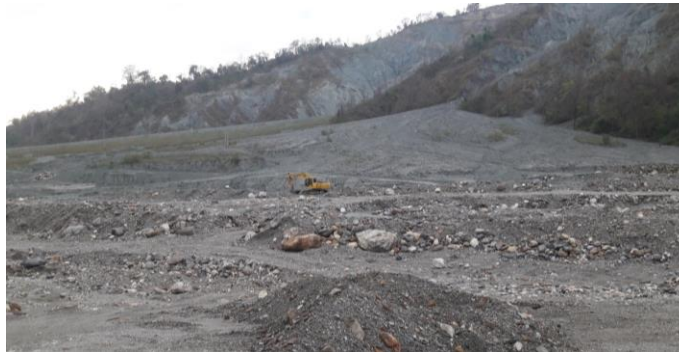
Figure 7: sediment deposit in the floodplain of Dhamdum River

**Dhamdum River:** The FEMD team met with the Mangmis and the Tshogpas of samtse Gewog and discussed about the threat caused by the Dhamdum stream. Dhamdum stream floods during monsoon season and dries up completely during dry season. The catchment of Dhamdum is very prone to landslides since the geology is composed mostly of loose Phyllite and Talc.

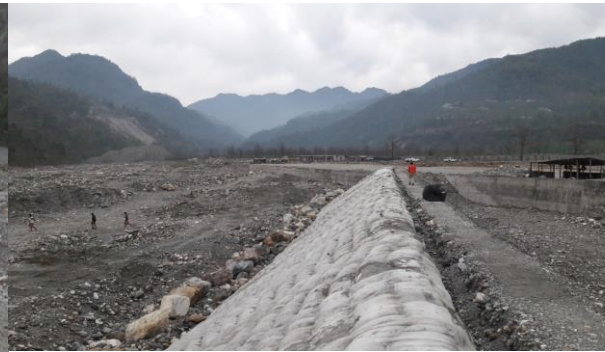
Figure 8: AB Mattress under construction for diversion of Dhamdum river to Budeney river flowpath

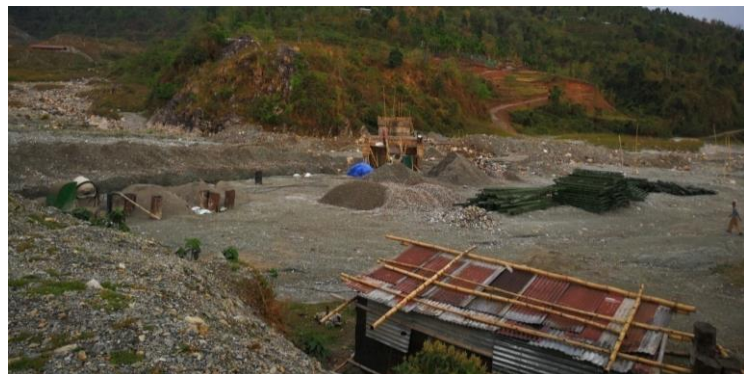
Figure 10: Sukriti Bridge abutment protection works

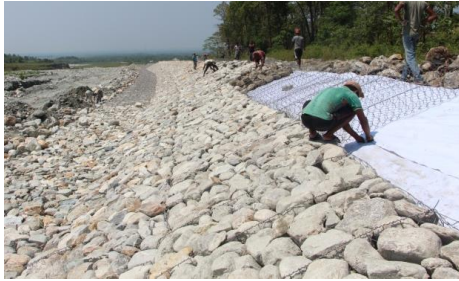
Figure 11: gabion revetment along right bank of Sukriti River during construction in June, 2017.

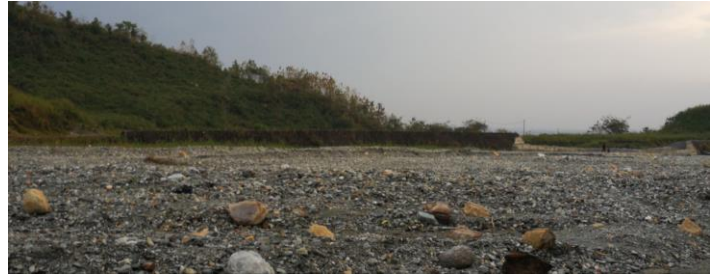
Figure 12: Agricultural lands on the left bank of Sukriti River being eroded

**Sukriti River:** The Samtse Dzongkhag Administration has carried out ample flood protection works along the right bank of Sukriti River where all the critical infrastructures are located such as NIE, School, Dzong. However, no study has been conducted to manage the landslide located in the upper catchment of Sukriti River. Therefore it is highly recommended to conduct geotechnical and watershed assessment of the Sukriti catchment for sustainable watershed management practices.

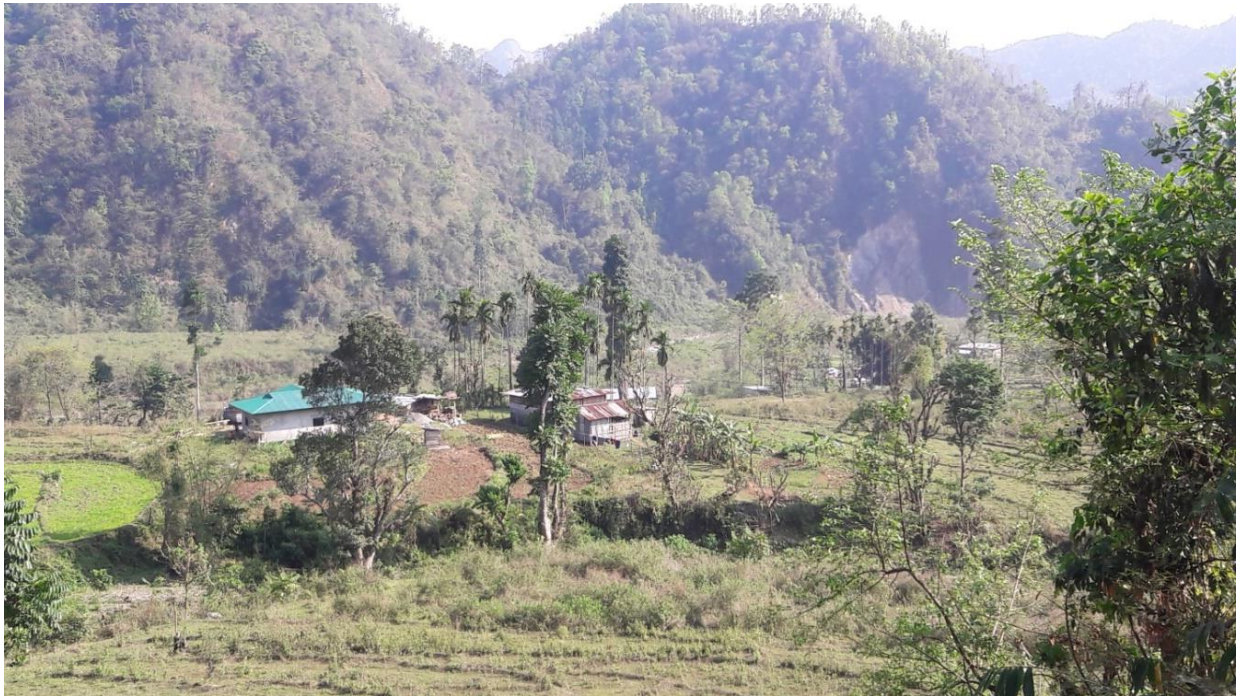
Figure 13: Settlement along Bukey Khola

**Bukey Khola:** Bukey khola runs through 3 villages, Bukey A, Bukey B and Khalingtar respectively. There are 12 households, 2 shops, a scholl and lhakhag along the Bukey River. During 1993 flooding, 6 Acres of wet land in Khalingtar and 3 Acres of Dry land in Bukey village washed away. Every year landslide occurs washing away agricultural land.

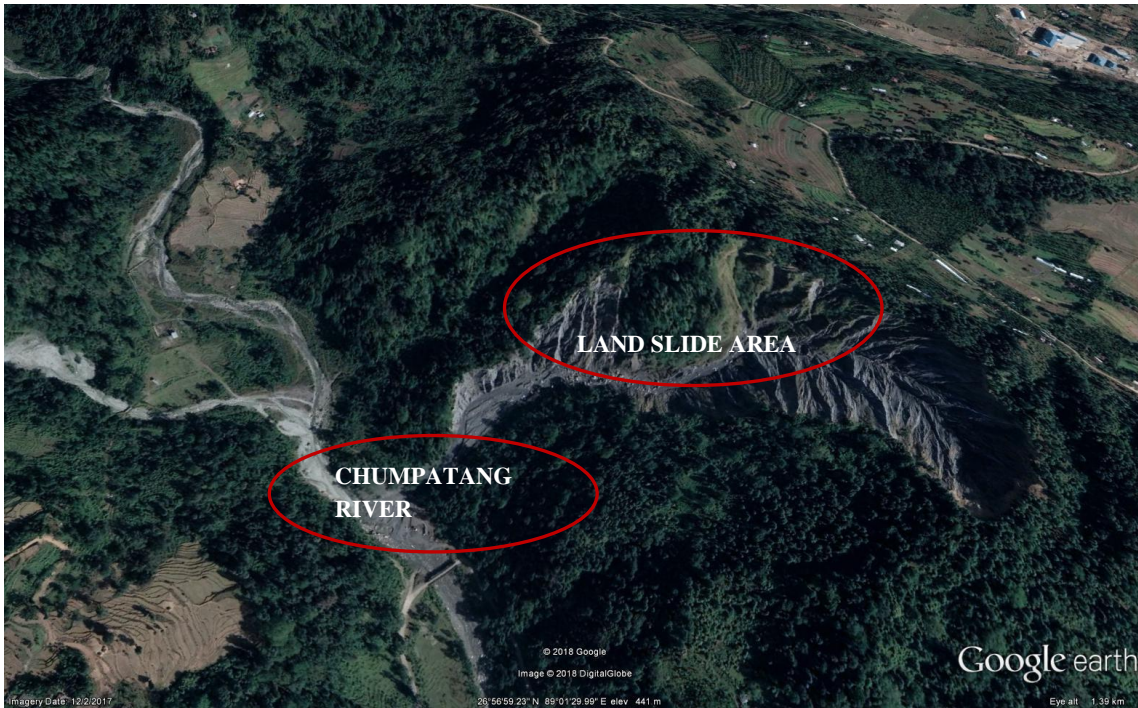
Figure 16: Google Image of Chumpatang slide Area.

**Chumpatang:** It is a seasonal stream with high flow during summer and little or no flow during dry season. During summer, stream swells up with lots of debris flow from hillside towards downstream. Mass slope failure occur every monsoon. In 2002 about 1.5 Acres of wet land and dry land was washed away

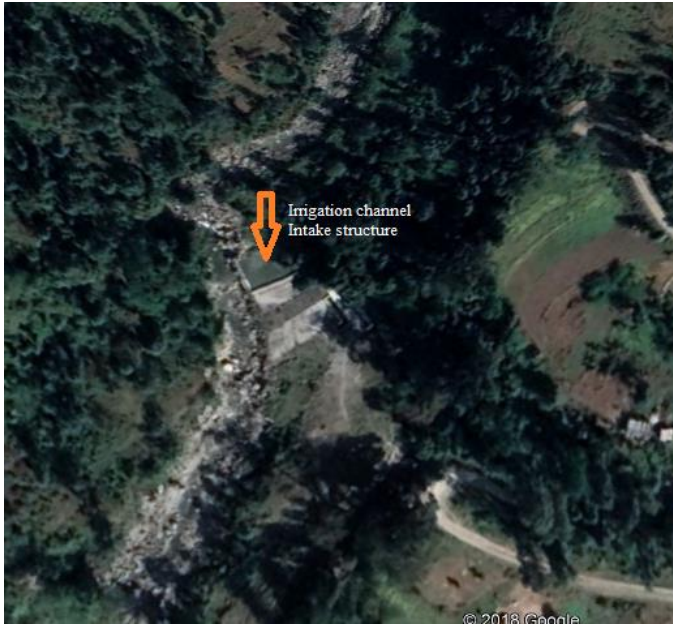
Figure 17: Google image of Irrigation channel in Kuchi Diana River.

**Kuchi Diana River:** Irrigation channel intake structure was constructed in 2016, but it is not well protected. There is a chance of breakdown of structure in case of severe flooding in future. This is also the concern for the Gewog administration too.

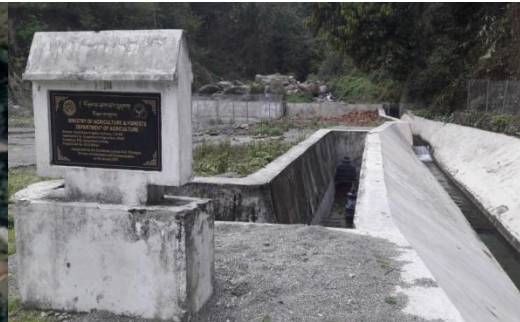
Figure 18: Irrigation channel in Kuchi Diana River.

**Kuchi Diana River:** Irrigation channel intake structure was constructed in 2016, but it is not well protected. There is chances of breakdown of structure incase of severe flooding in future. This is also the concern for the Gewog administration too. Therefore immediate flood protection structure at intake is highly recommended. To protect further destruction of wet land, there is a requirement of about 500 metres flood protection structures at the downstream of channel intake in critical areas along wet land.

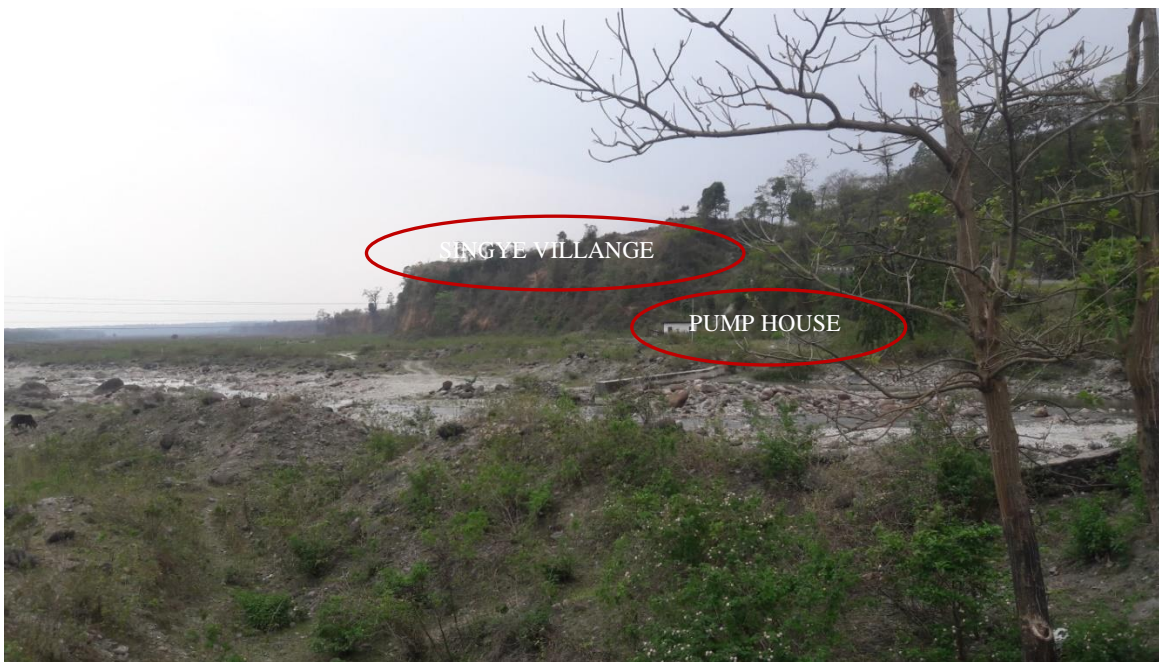
Figure 21: Image of Singye village and pump station along Jiti Khola

land and 400 acres of dry land in Singyegang village. Lift irrigation pump house is also located at river bed.

Previously river was diverted to its original course using gabion wall. But river changed its course every year affecting agricultural land on downstream. The motor able bridge was washed away for two consecutive years 2005 & 2006 respectively.

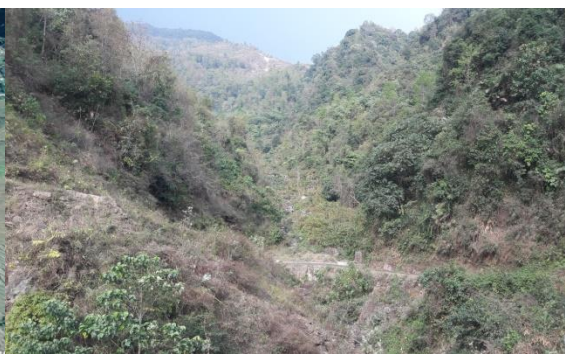
Figure 24: Image of Tendu Khola

**Tendu Khola:** Along Tendruk stream, there is no human settlement. The only structure constructed from the river is irrigation channel intake. Annually during monsoon season landslide takes place near the intake structure and causes frequent disruptions to the flow in the channel. Therefore, proper intake protection is required by constructing 50 metres flood protection structure.

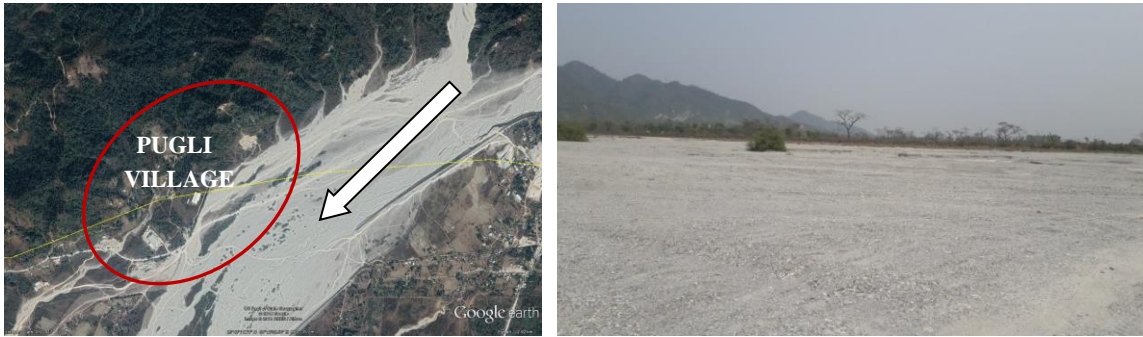
Figure 25: Images of Pugli khola

**Pugli Khola:** Existing river bed of Pugli Khola used to Agricultural land before 1993 flooding. During 1993 flooding, approximately 11 acres of wetland was washed away leading to the expansion of river bed. Today river bed level is as high as ground level and approximately 1500 metres in width. Mining in upstream leads to large deposition of river river bed materials on downstream. There is about 200 Acres of wet land along the river.

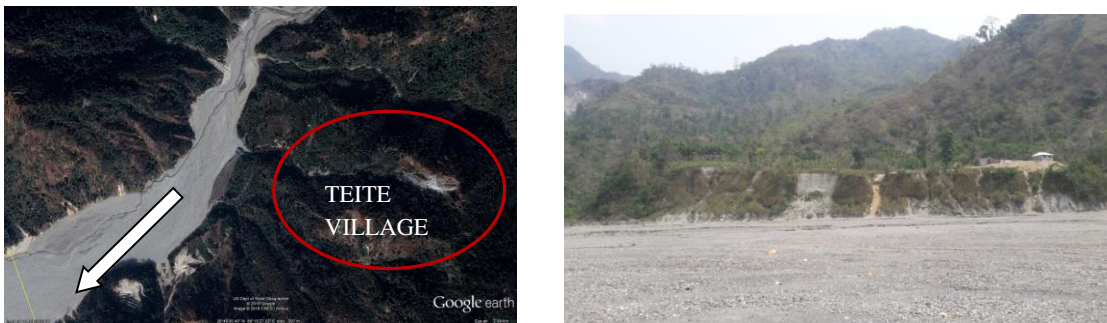
Figure 26: Image showing location of Teite village

**Teite Khola:** Two mining are located on the upstream of Teite Khola. Mining produces lots of gravels and sand which creates artificial pond in upstream which on breaking leads to flooding in downstream.

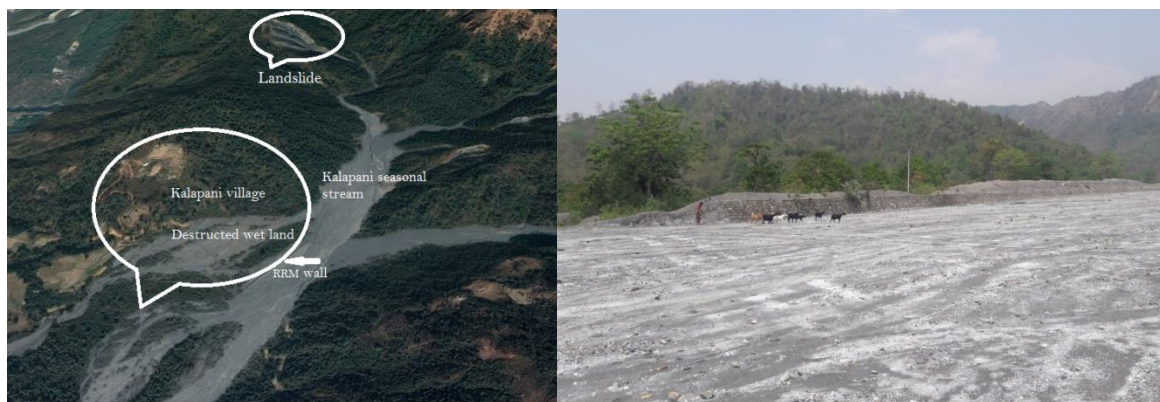
Figure 27: Images of Kalapani khola

**Kalapani Khola:** It has been observed that vast area of agricultural land was lost during previous floods due to deposition of landslide debris and sediments. Kalapani river is the ultimate drainage basin for various seasonal streams. Huge quantity of sediment deposited was caused by landslide of an entire hillock, two kilometers upstream of the village. According to the local people, in 1993 there was a big flood with landslide sediments which entered towards Kalapani village and destroyed wet and dry lands.

To protect the river entering towards settlement and agricultural land, Dzongkhag administration have constructed 500 metres of RRM flood defense wall. It was found by the team that, the wall is in good condition and functioning well. Sediment deposit have reached more than half of wall height.

**Kalapani Khola:** It has been observed that there is a requirement of additional 400 metres protection works at the downstream of existing RRM wall. Construction of embankment with gabion revetment in continuation to RRM wall would minimise threat of river entering towards settlement. To control diversion of flowpath due to sediment deposit, dredging along its centre line can reduce risk. Slope stabilization to control debris flow.

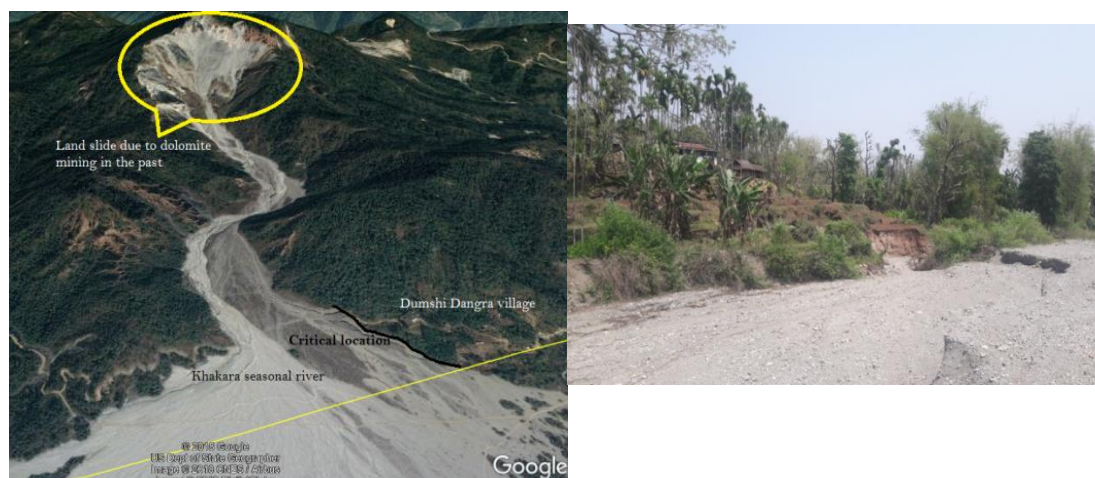
Figure 28: Image of Kharkara khola

**Kharkara Khola:** It has been observed that 2 acres of agricultural land was lost during 2017 flood. River bed level has increased due to deposition of landslide debris and sediments. This river is the ultimate drainage basin for various seasonal streams. Huge quantity of sediment deposited was caused by dolomite mining at the upstream. People have to cross this river to reach Gomtu. During monsoon season, school children, workers of cement factory are affected by this river. Most of the settlement are located at its left bank.

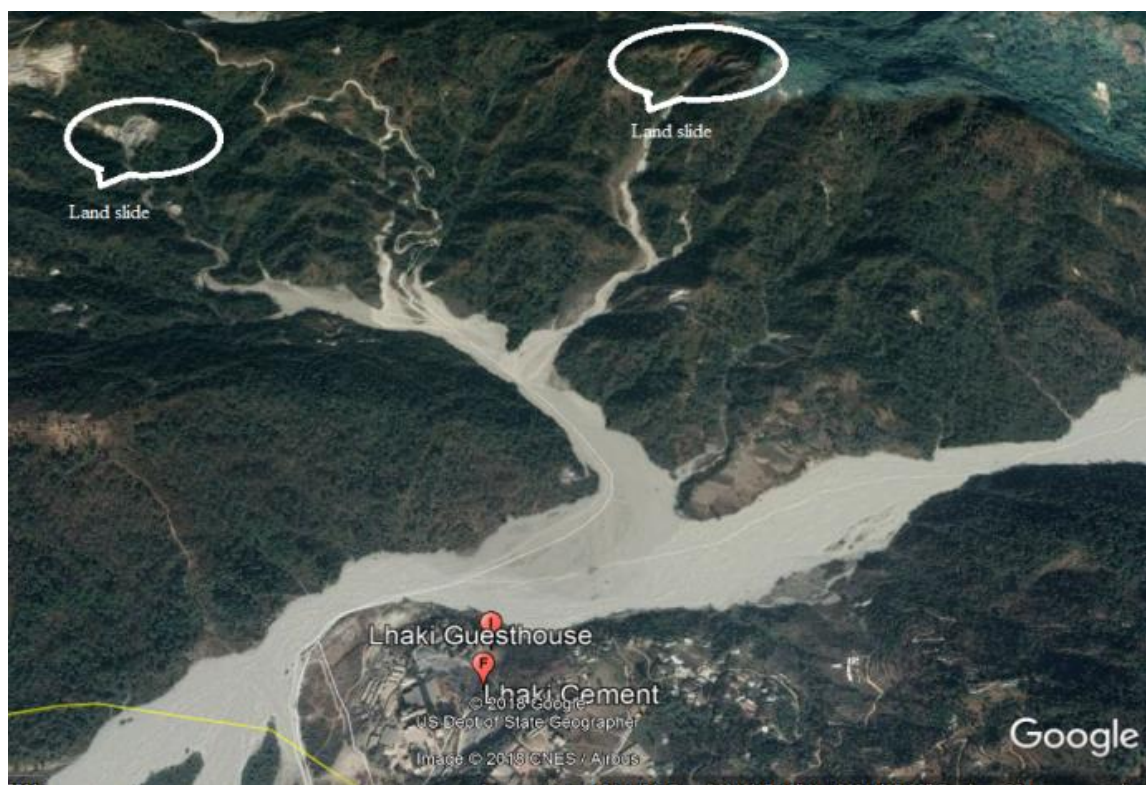
Figure 29: Image of Sukti khola

It has been observed that, the soil in the catchment area is very susceptible to erosion. During monsoon season, the eroded material is deposited along this river which leads to unpredictable shifting in the flow of the streams. In Sukti river, it is observed that due to excessive deposit of eroded materials, the bed level of the river is as high as the surrounding land. The agricultural land is getting destroyed by the deposition of eroded materials.

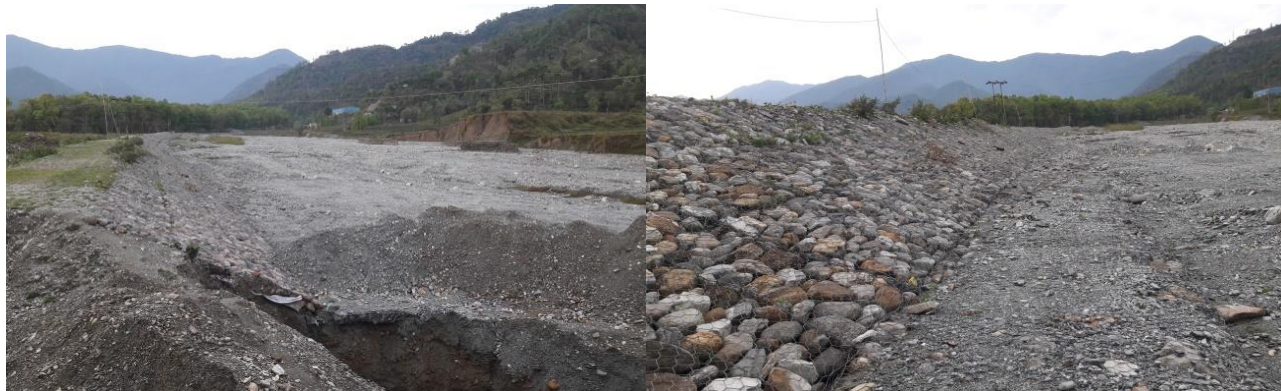
Figure 34: Embankment with gabion crate revetment at right bank along Sukreti River.

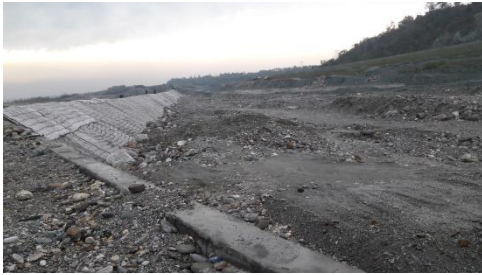
Figure 35: AB mattress construction along Dhamdum River

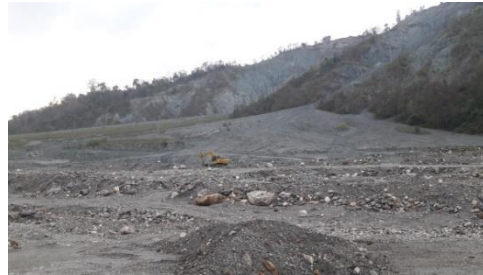
Figure 36: Debris floor towards Dhamdum River
