# FLOOD HAZARD ASSESSMENT OF THIMPHU DZONGKHAG

A detailed assessment of flooding problems in Thimphu  
Dzongkhag, Bhutan

Flood Engineering and Management Division

Department of Engineering Services, Ministry of Works and Human Settlement

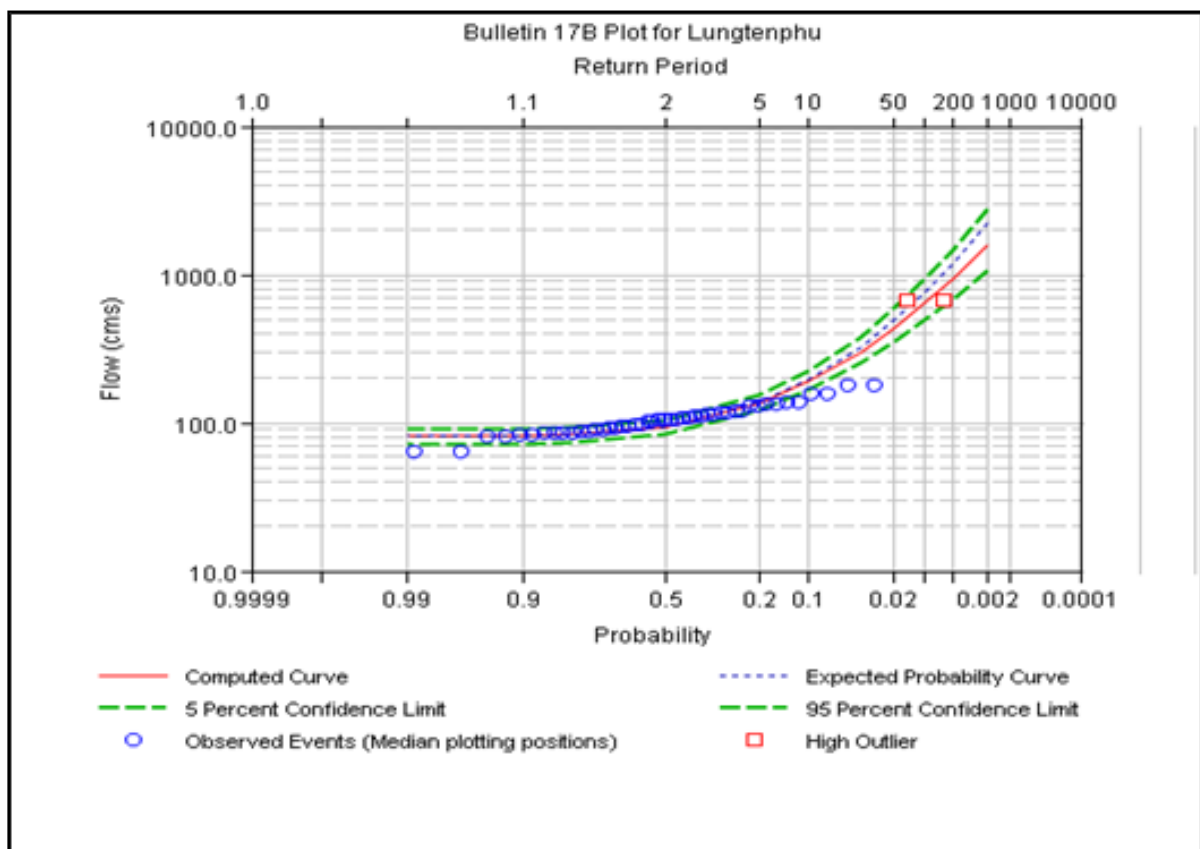
Figure 6: Graphical result from Log Pearson III distribution for Lungtenphu station

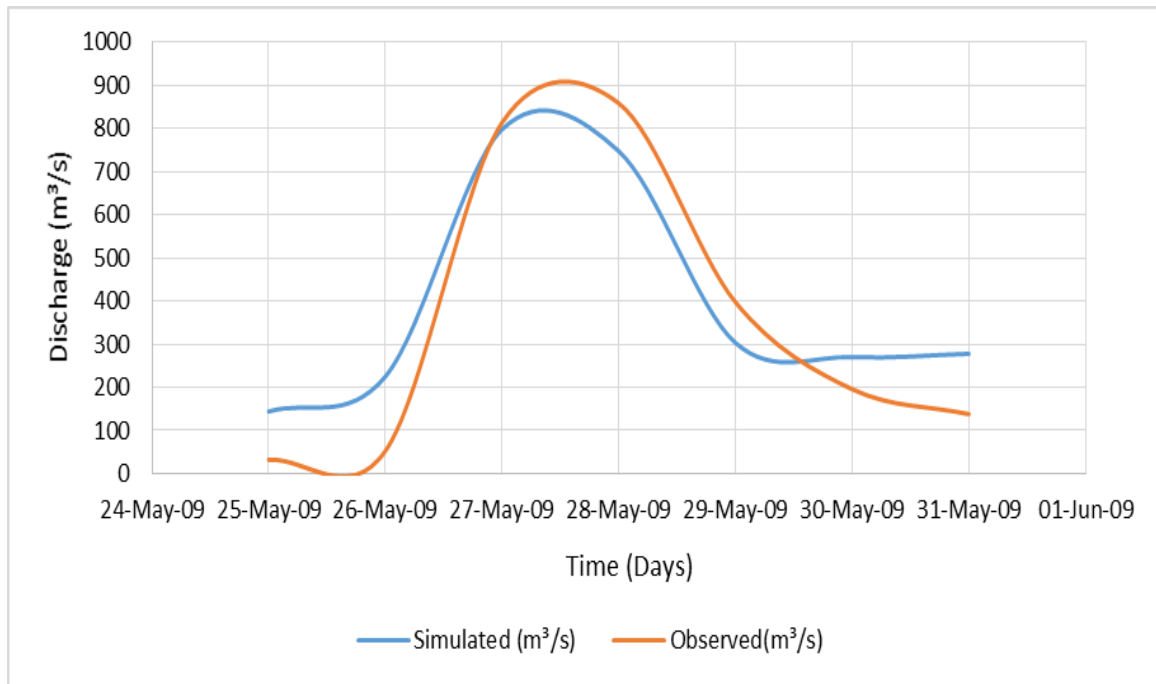
The calibration of the hydrological model at Chukha station was carried out a flood event from 25/05/2009-31/05/2009. The simulated and observed daily discharge is compared in Figure 12 and Table 6.

Figure 12: Graphical result of daily calibration at Chukha station

The results from calibration indicate that the peak discharge is simulated 7% lower than the observed peak discharge while the simulated volume is 6.3% higher than the observed volume which is not significant. The difference between the RMSE and MAE is only 9.8 m<sup>3</sup>/s which means that the error size is less inconsistent.

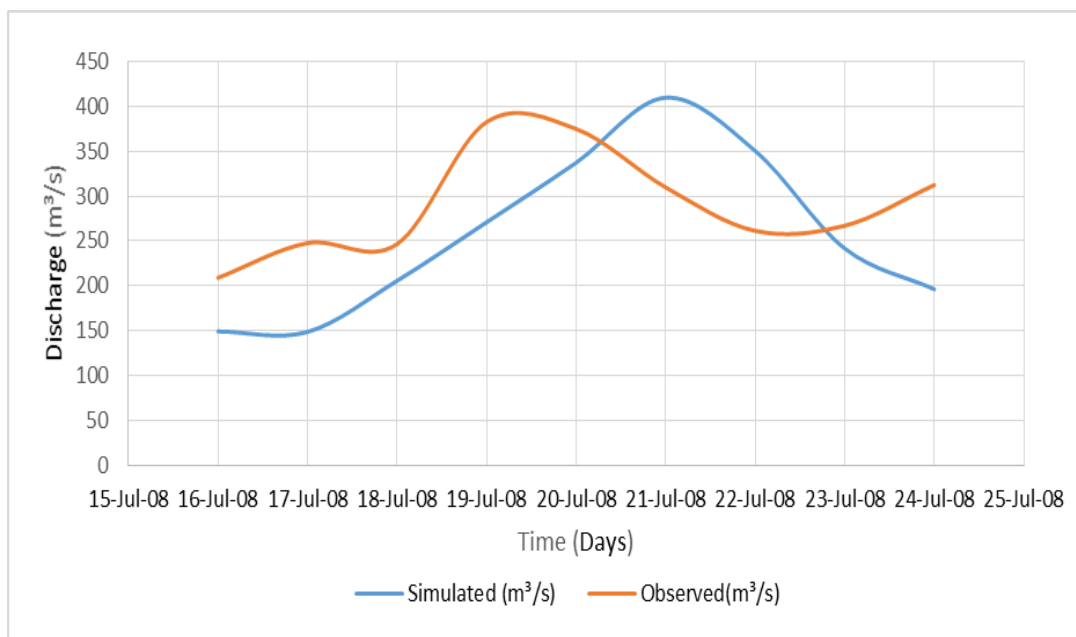
The validation of the hydrological model at Chukha station was carried out a flood event from 16/07/2008-24/07/2008. The simulated and observed daily discharge is compared in Figure 13-and Table 7.

Figure 13: Graphical results of daily validation result at Chukha station

During validation, the peak discharge is simulated higher the observed peak discharge by 6.6% while the simulated volume is 9.3% lower than the observed volume. The difference between the RMSE and MAE is only 6.8m<sup>3</sup>/s which means that the error size is less inconsistent.

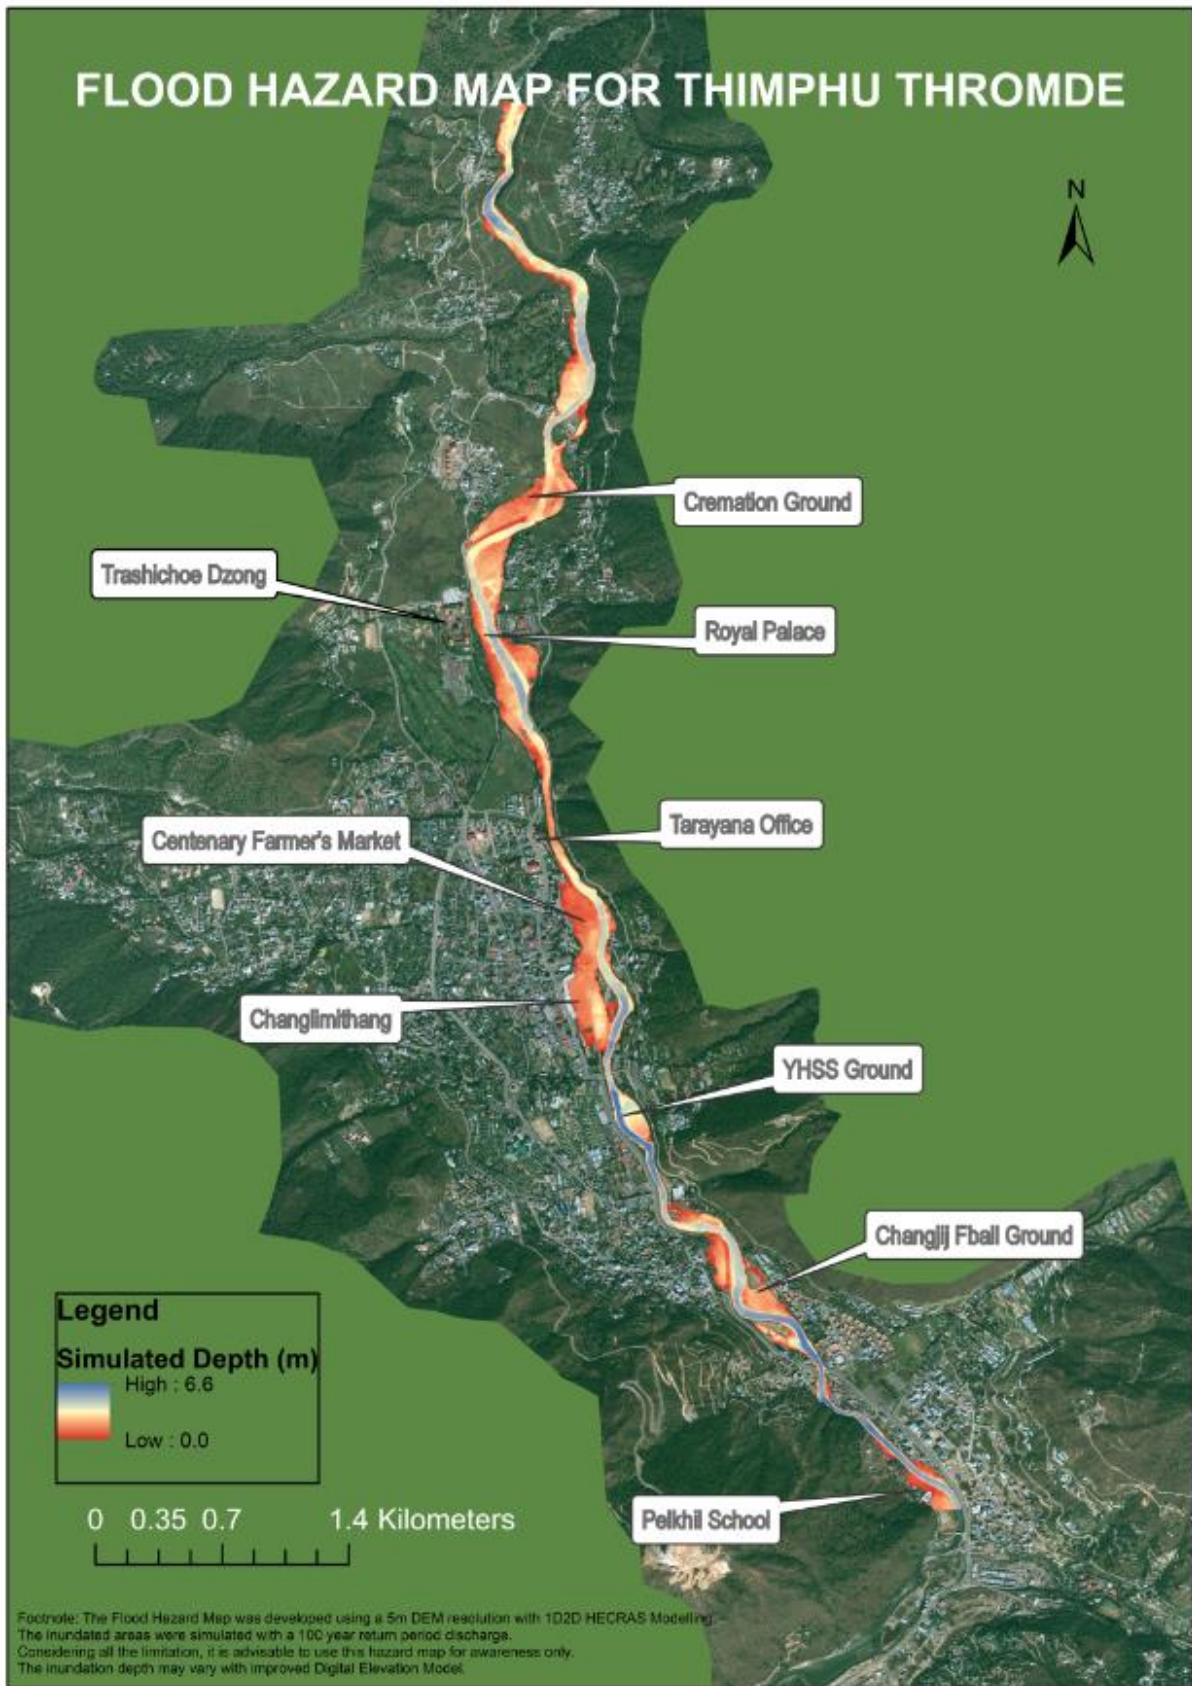
The combined 1D-2D Hydrodynamic model was developed for Thimphu River and the model was run for a 100 year return period discharge. The flood hazard map for Thimphu River is shown in Figure 14.

Figure 14: Flood Hazard Map for Thimphu Thromdey

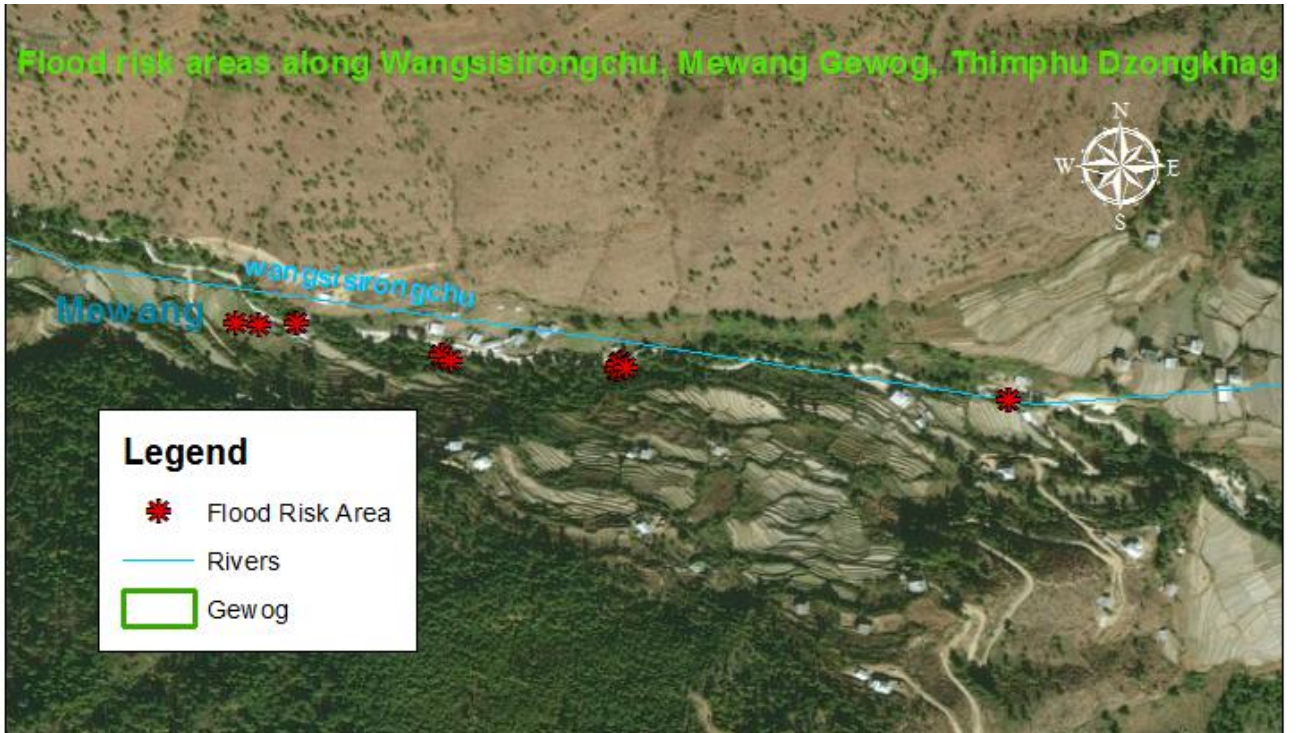
Figure 20; Flood risk areas along wangsisirongchu, Maedwang Gewog, Thimphu Dzongkhag

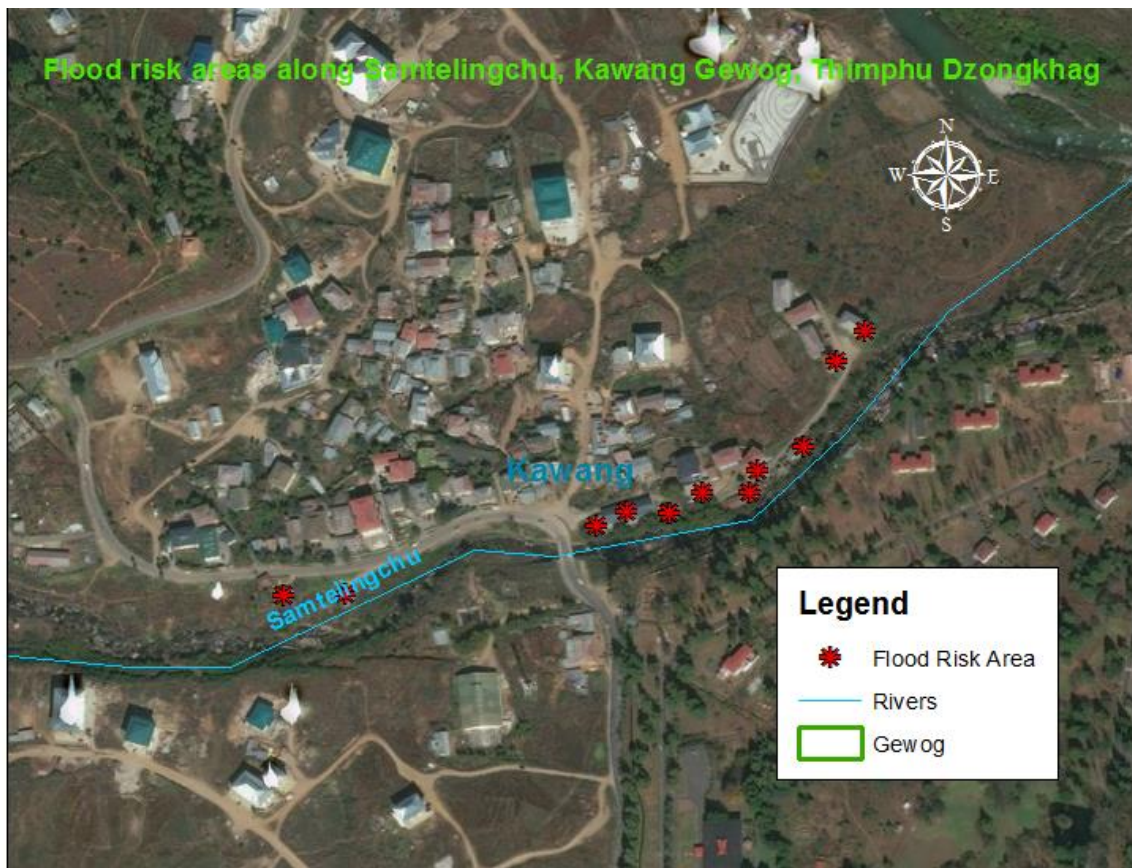
Figure 21: Flood risk areas along Samtelingchu, Kawang Gewog, Thimphu Dzongkhag

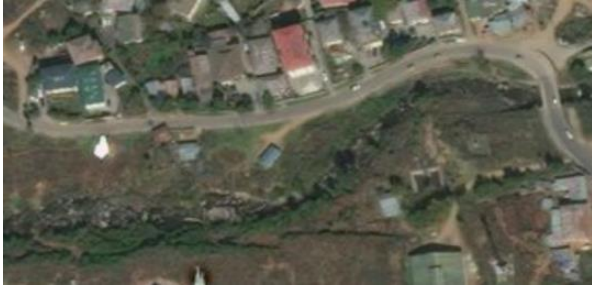
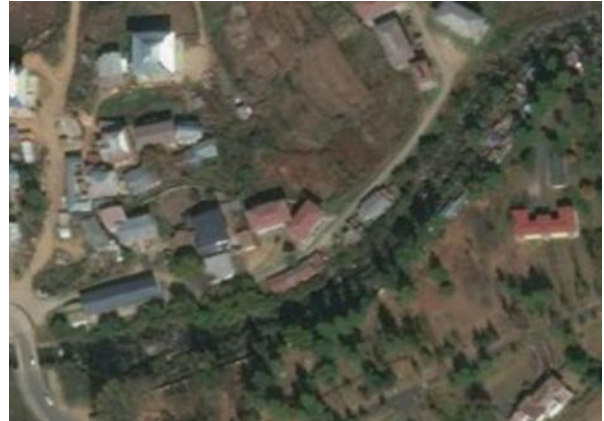
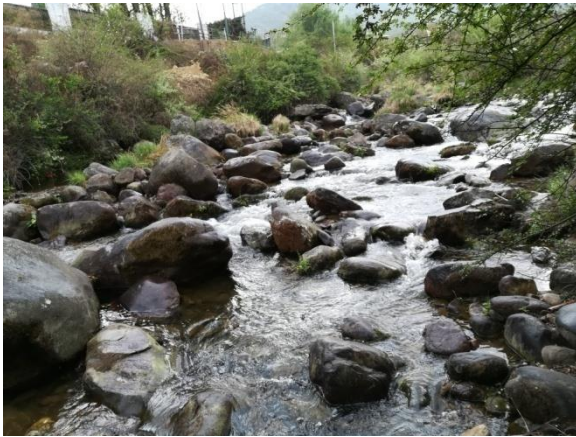
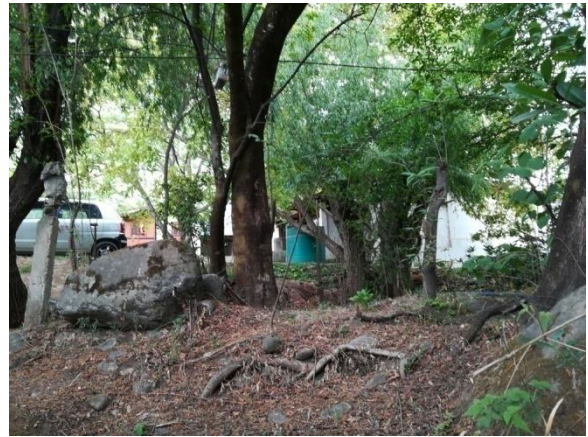
Samtelingchu passes along Samteling and Jushina village. The river flows from a high gradient which mostly covers Samteling villages and descends to Jushina village. The upper part of Jushina village which is located above Smateling bridge is at a higher elevation with lower flooding risk. However, the areas located below Samteling Bridge are at a low gradient thus exposing it to a higher flooding risk. There are few lakes located at the upstream of the catchment, namely, Simkota Tsho, Jagatsho, Dungtsho. Although the residents have no proper record of a lake outburst before, the flow path of the river is quite wide and deep indicating the possibility of an outburst in the past decades.

*Figure 22: Flood risk areas above the Samteling bridge*

*Figure 23: Flood risk areas below the Samteling bridge*

*Figure 24: Flood risk areas near India House*

*Figure 25: Flood risk areas located at a low gradient same as river.*

It is recommended to conduct detailed assessment along the areas identified through the preliminary assessment for the design of the flood mitigation works. It is also highly recommended for the concerned agency to study the possibility of Lake Outburst in the future since there has been no study conducted so far. Since the area falls under the jurisdiction of Thimphu Thromdey, it is recommended for Thimphu Thromdey to carry out the flood mitigation works along the critical areas.

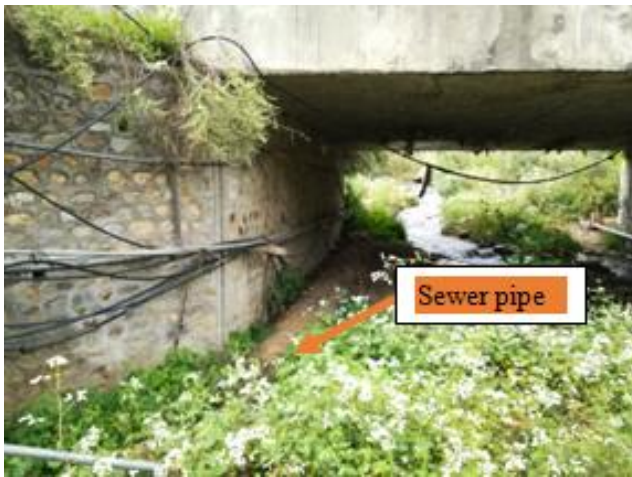
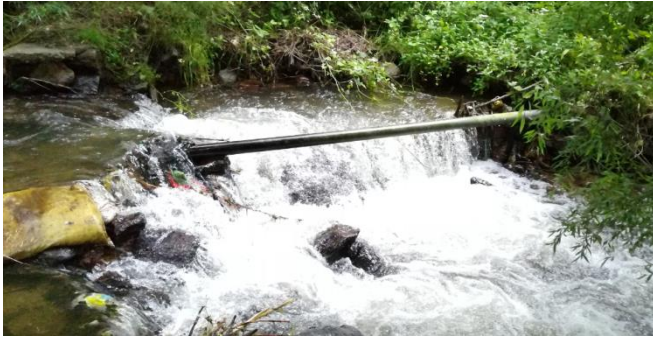
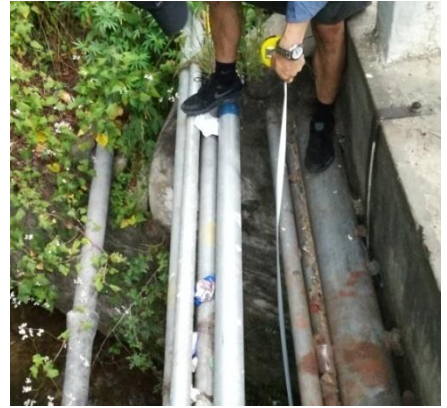
It is important to lay critical infrastructures such as water supply and sewerage pipes at locations where there is no risk of flooding or any other hazard. These infrastructures were however found to be laid on the stream bed and flood plain areas along Chubachu stream. It can be observed at Chubachu Bridge as shown in Figure 26 and Figure 27. Such improper laying water pipes can also be seen near Desi Zam as shown in Figure 28 and Figure 29.

Figure 26: Sewer pipe laid on the stream bed below Chubachu Zam

Figure 27: Water supply pipe laid across the stream on the floodplain area below Chubachu Zam

*Figure 28: A water supply pipe running across the stream upstream of Desi Zam.*

*Figure 29: Water Pipes laid at the same level as Desi Zam*

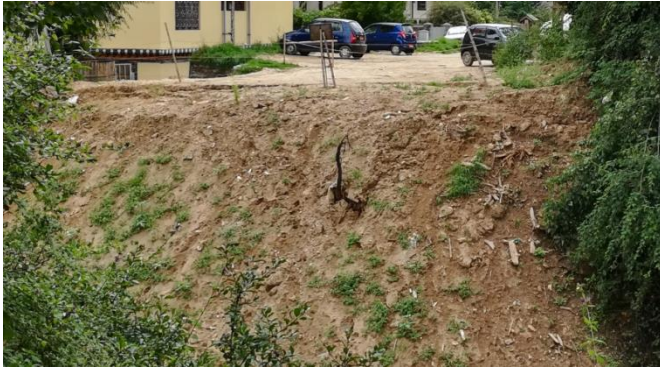
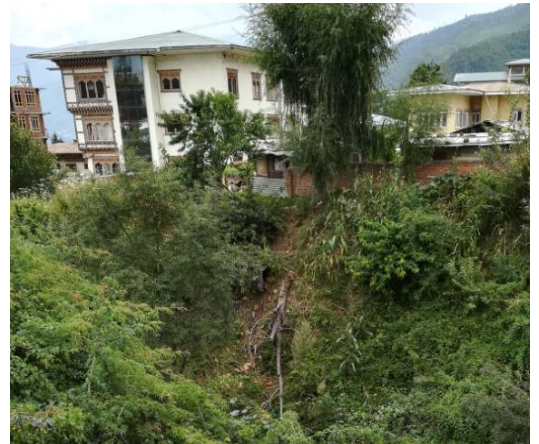
Intense rainfall can trigger landslide and cause damming of flow path which can lead to flooding nearby areas. Two locations were identified along Chubachu for landslide mitigation works. An area below the Early Learning Centre and an area near RENEW office is prone to landslide as shown in Figure 30 and Figure 31. It is highly recommended to carry out slope stabilization works in these two areas.

*Figure 30: Need for slope stabilization downstream of ELC school.*

*Figure 31: Need for slope stabilization below RENEW office.*

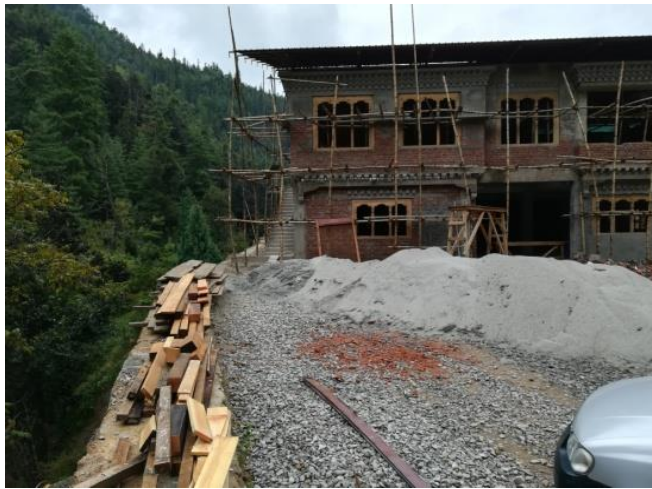
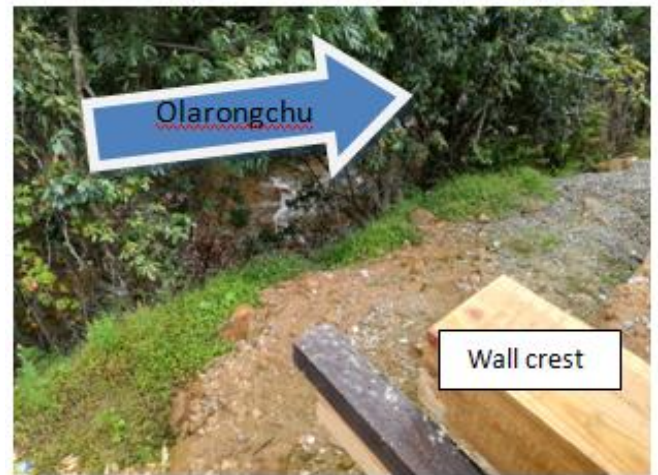
The water bottling Company called 'Living water Company' which is located upstream of Olarongchu. The infrastructure for the company is located very close to the stream at the right bank. Although retaining walls were constructed with height ranging from 4m to 6m, the area was still observed to be of high risk. It can be observed from Figure 33 and Figure 34 the high exposure of the structure to flooding. Such permanent infrastructures with high economic value need to be considered while managing flooding issues along the stream.

Figure 33: Living water company infrastructure under construction (October, 2017)

Figure 34: The distance between retaining wall crest and Olarongchu

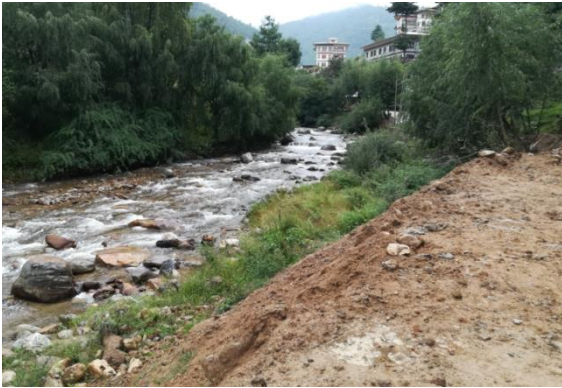
The areas near hydraulic structure such as a bridge need extra attention to mitigate flooding disasters. An area above the Semtokha Bridge is being reclaimed with soil deposit for widening of road as shown in Figure 35. There is a need for a retaining wall to retain the reclaimed land in order to prevent any possible blockage of the flow path during monsoon season.

Figure 35: Need for a retaining wall upstream of Semtokha Bridge

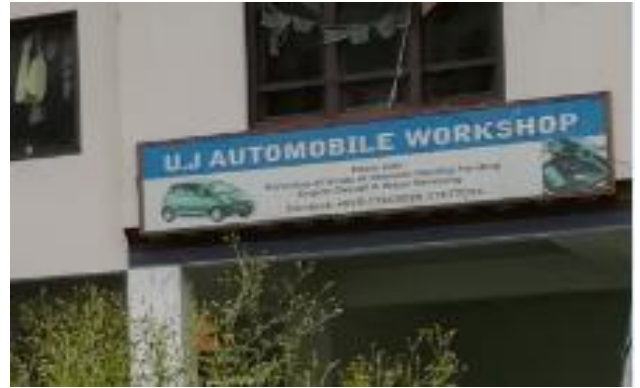
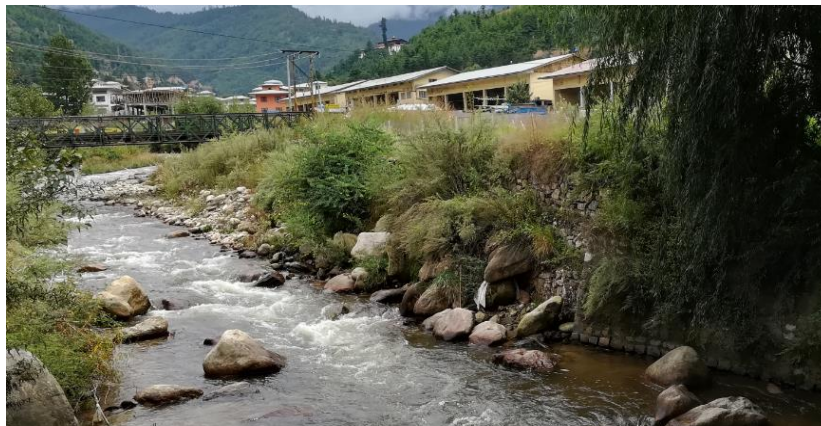
Figure 36: Workshop area without the gabion wall

The workshop area located at the left bank of Olarongchu is located at a lower elevation thus exposing it to high flooding risk. The Thimphu Thromdey has constructed gabion wall of height 2m along the workshop area thus lowering the risk of the area from flooding. However, there is a short break on purpose along the continuous gabion wall which might expose some of the areas. The short break is located few metres in front of U.J. automobile workshop (Figure 36). Although the reason for the break is not known so it is recommended to close the gap and continue the wall till RIM Institute to fully reduce the flooding risk in the Olakha workshop area. The highly exposed area below the newly constructed Bailey Bridge (as shown in Figure 36) also needs to be protected with gabion walls.

Figure 37: Exposed workshop area without gabion wall protection

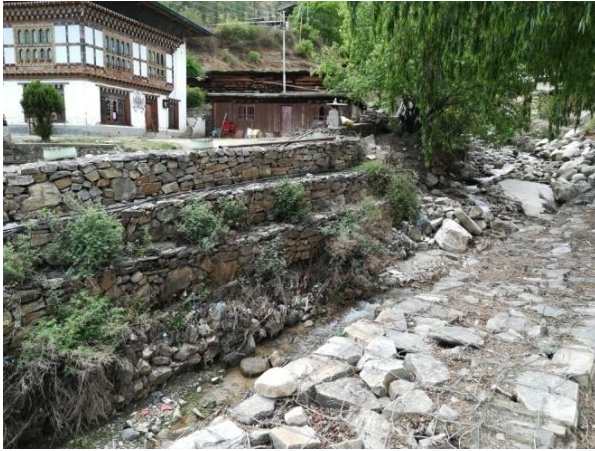
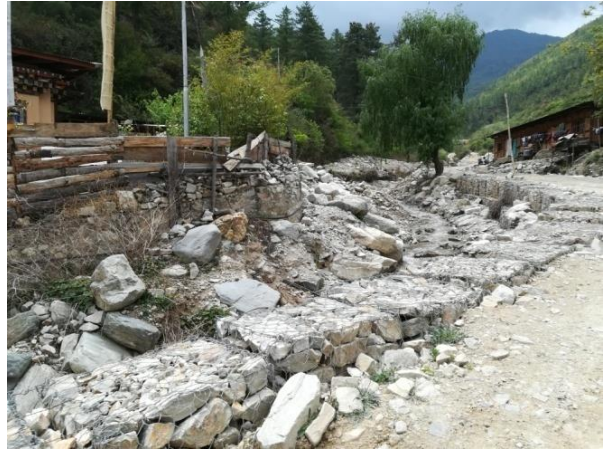
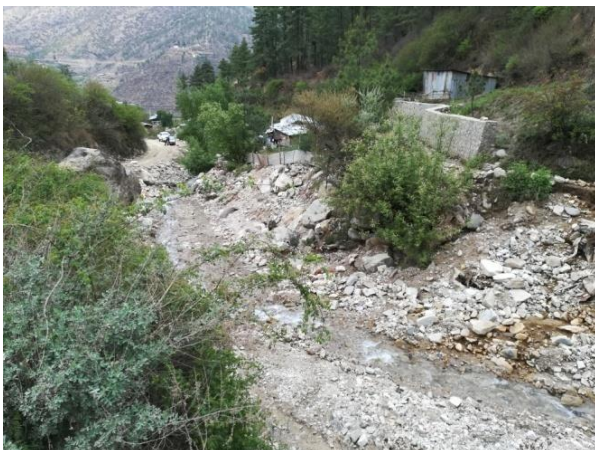
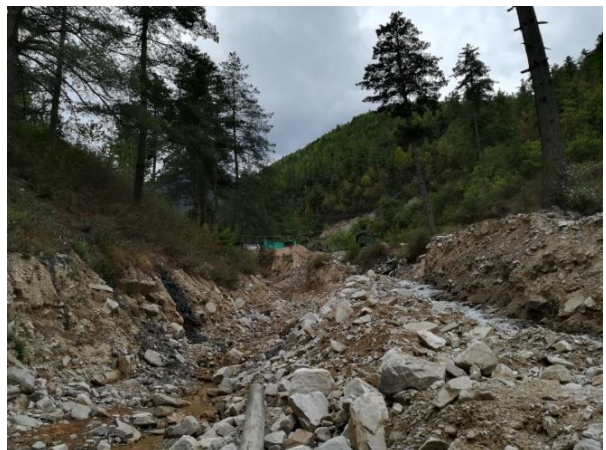
Jabmisa Rongchu flows through Namseling village in Maedwang Gewog. The village is exposed to very high risk of flash floods with heavy sediment content. The open air mining located in the upstream of the village has resulted in unstable slope thus causing huge sediment deposits along the Jabmisa Rongchu flow path. The sediment deposits along the

flow path raises the bed level of the stream thereby exposing the nearby areas to increased flooding risks.

Figure 38: Settlements along Jabjirongchu under flooding risks

Figure 39: Settlements along Jabjirongchu under flooding risks

Figure 40: Settlements along Jabjirongchu under flooding risks

Figure 41: Sediment deposits at the source of Jabjirongchu

It is recommended to conduct detailed assessment along the critical areas identified through the preliminary assessment for the design of the flood mitigation works. It is also recommended to explore way to arrest the sediments with check dams or other technology.

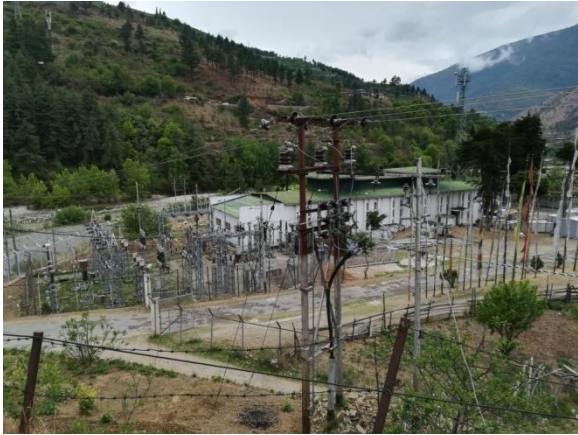
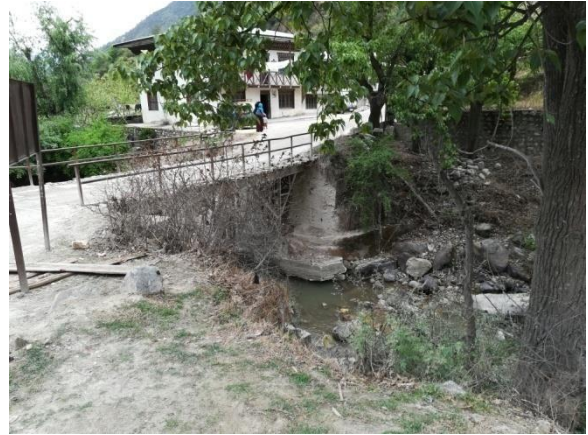
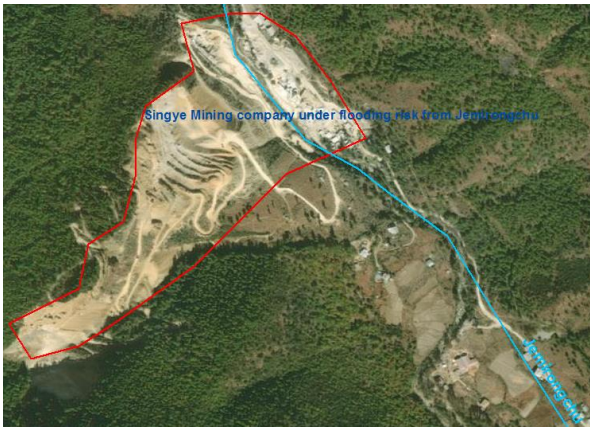
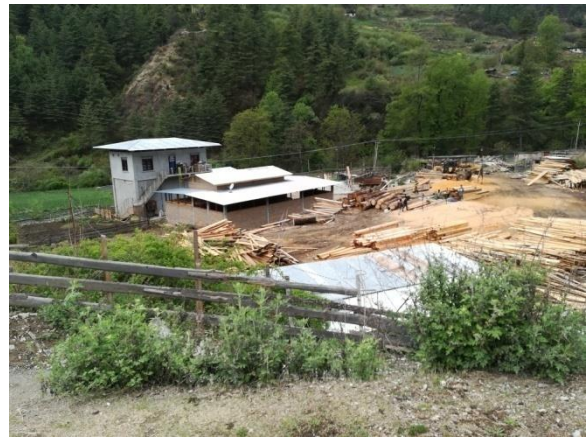
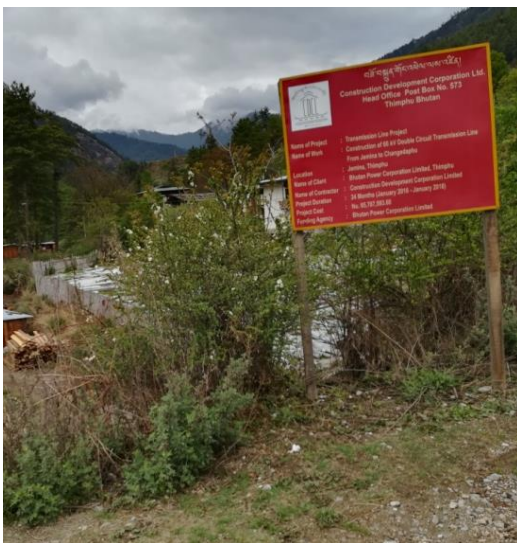
The stream is flooding almost every monsoon season exposing the identified areas under risk. There is a lake named Jemilangtsho in the upstream of the village which will cause havoc downstream if it outburst.

Figure 42: Area near the Begana Mini Hydel project

Figure 43: Gidagom area with 4 HH under high risks

Figure 44: Singye Mining area under risk of flooding from Jemirongchu

Figure 45: sawmill under risk along Jemirongchu

Figure 46: CDCL transmission line project under risk along Jemirongchu

Figure 47: Rehab centre under flooding risk along Jemirongchu

It is recommended to conduct detailed assessment along the areas identified through the preliminary assessment for the design of the flood works.

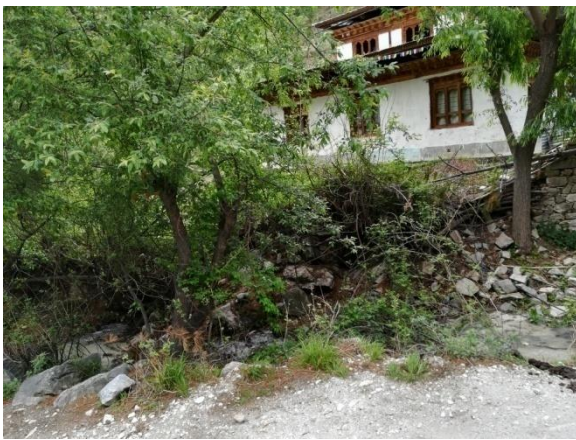
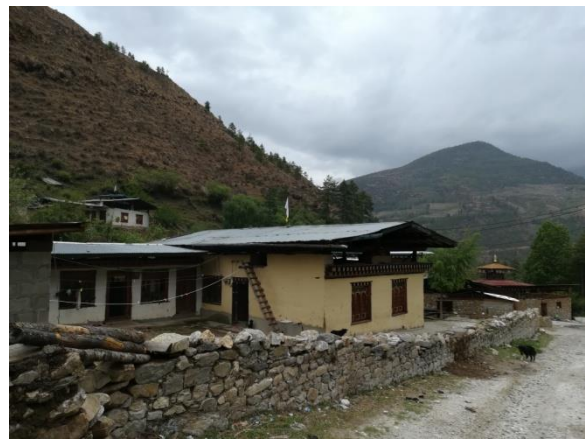
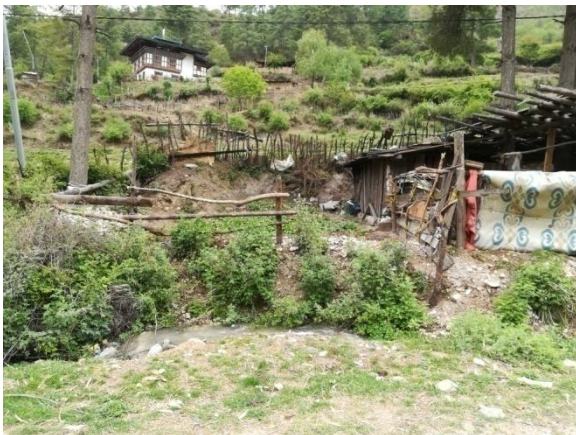
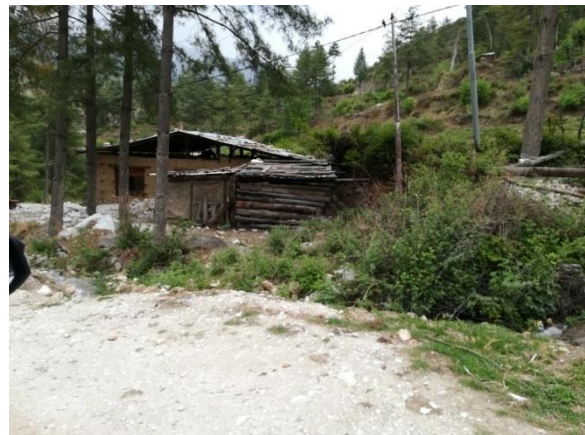
1. Khariphu (4 households under risk) located at the right bank of Wangsisirongchu
2. Khariphu lumbina (6 households under risk) at the left bank of Wangsisirongchu
3. Kharibji village (4 households under risk) the left bank of Wangsisirongchu

*Figure 48: Khariphu (4HH under risk) along wangsisirongchu*

*Figure 49: Khariphu Lumbina (6HH under risk) along wangsisirongchu*

*Figure 50: Kharibji (4HH under risk) along Wangsisirongchu*

*Figure 51: : Kharibji (4HH under risk) along Wangsisirongchu*

It is recommended to conduct detailed assessment along the areas identified through the preliminary assessment for the design of the flood mitigation works.
