FLOOD HAZARD ASSESSMENT FOR TRASHIGANG DZONGKHAG

**FLOOD ENGINEERING AND MANAGEMENT DIVISION,
DEPARTMENT OF ENGINEERING SERVICES
MINISTRY OF WORKS AND HUMAN SETTLEMENT**

YEAR 2019

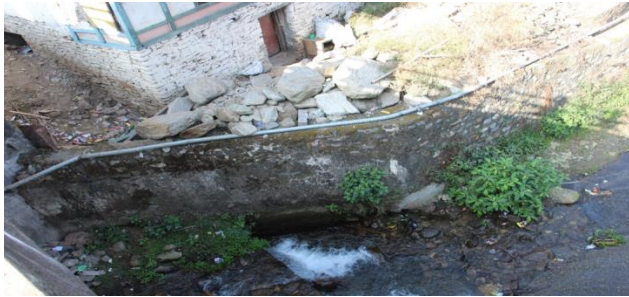
Figure 3: Downstream of highway bridge

Figure 3 is at the downstream of the highway bridge at the left where the stream usually hits directly. Here, the RRM wall is in curve shape because of the nature of the ground and the height is also quite low. During monsoon season when the water level is high, the river is hitting the curve portion of the wall directly and weakens the wall and sometimes overflow takes place. With existing building built close to the channel, there is no option of increasing the width of the channel. The Dzongkhag Administration have identified this area and proposed to demolish existing RRM wall spanning of 20 metres and replace with RCC wall.

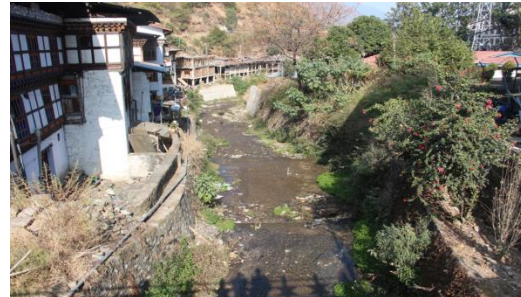
Figure 4: RRM wall at both banks.

Figure 4 shows the RRM wall at both the banks. This wall was constructed quite a long time ago. Average width of channel is 8 metres. Most of the channel surfaces are spoiled due to continuous flow of water. Therefore, Dzongkhag Administration have proposed to demolish the existing RRM wall at both banks spanning of 130 metres till the first wooden bridge and reconstruct the RCC walls at both banks including PCC channel. Average height for proposed RCC wall is 4 metres excluding first 20 metres span at left bank. At the right bank, on top of the RCC wall, they have also proposed to construct railing for the people to walk.

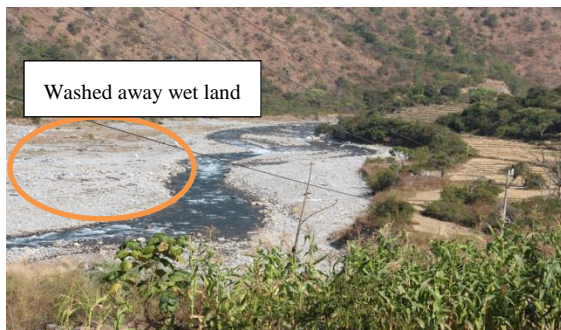
Figure 6: Location of washed wet land

Figure 6 above shows the starting point of the cross section survey. Before 2004 flood, river course was about 65 metres away from the present paddy field towards the river. According to the local people, about 20 acres of paddy field have been washed away by flood and river has meandered towards the paddy field and continued flowing through it. Presently elevation difference between river bed level and top of paddy field is 5.0 metres. However, maximum flood depth and areas of inundation will be shown in flood hazard map and accordingly appropriate mitigation works can be planned.

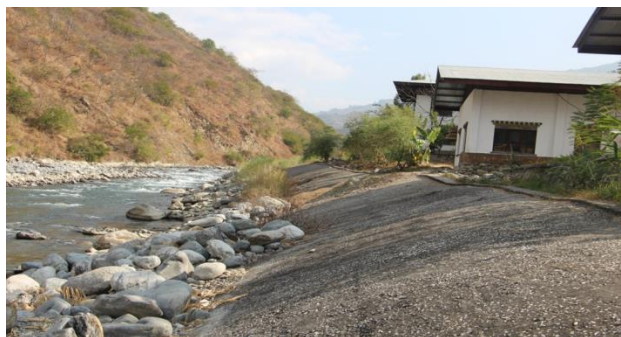
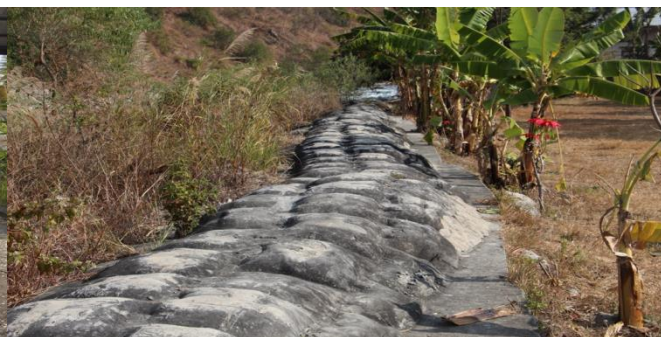
Figure 8: PCC revetment along Rangjung TTI

Figure 9: AB mattress along Rangjung TTI

Technical Training Institute is located at the left bank of GamriChu. There is only seven metres gap between TTI and river bank. AB mattress of span 215 metres and 85 metres have been

provided at two locations and PCC revetment of span 150 metres have been provided at one location. The condition of PCC revetment appears good but AB mattress is deteriorating slowly.

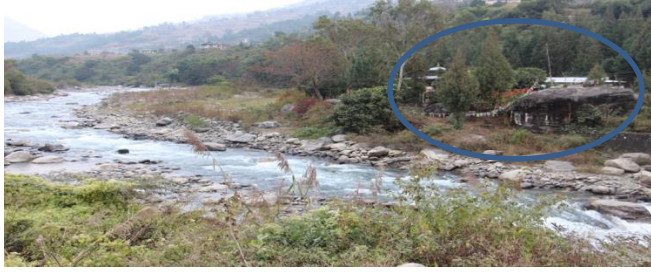
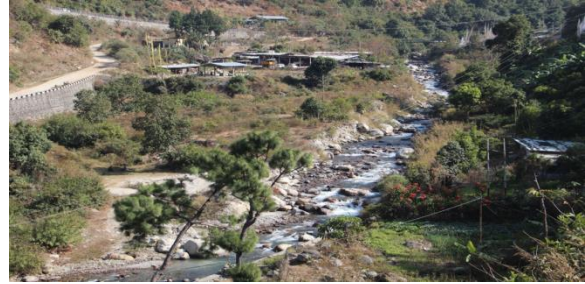
Figure 10: Location of crematorium along of Gamri Chu.

Figure 11: Khardi Chu

Gamri Bridge is crematorium, Gamri Bridge is sufficiently high. Crematorium is located at left bank of GamriChu and the area is quite flat which is vulnerable to flood. In this area above Gamri Bridge, we have done cross section survey of 365 metres upstream of Gamri Bridge which covers the crematorium area as well. Therefore, flood hazard map will show the exact areas of risk and depth of flood. Beyond 365 metres upstream of Gamri Bridge, the river is quite narrow and less risk of flood.

Before 2004, most of the areas at right and left banks of Khardi Chu were agricultural lands, after 2004 flood; it was completely washed away and caused huge losses to the land owners. Maximum flood depth at this area observed at site is 2 metres. Cross section survey of KhardiChu has also been done and realistic flood depth will be reflected in flood hazard maps.

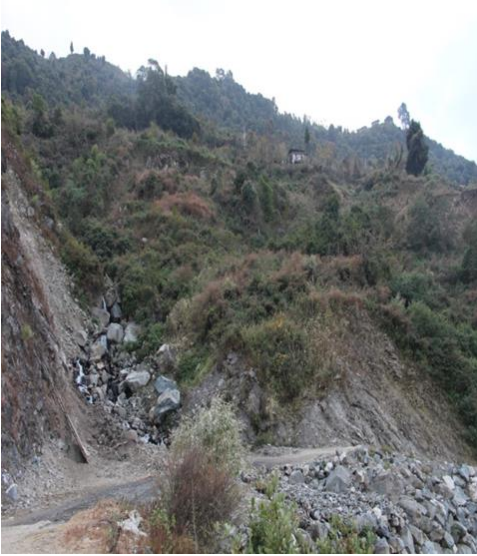
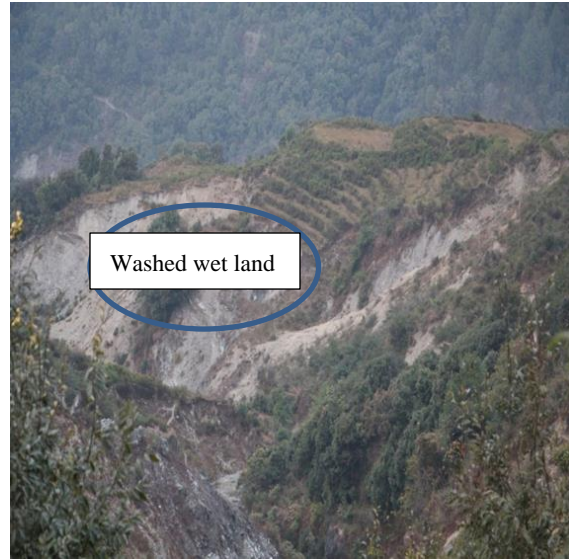
Dungju Ri: Possess major threat to paddy field and farm road. Stream looks very small at present. During monsoon run off water from nearby catchment area collects here and adds its discharge. During 2004 flood, it has washed away large area of paddy field below the farm road. After 2004 flood, every year scouring is taking place and its further damaging the paddy field. As per our field observation, soil is sandy and silty.

Figure 15: Dungju Ri flow across farm road

Figure 16: Dungju Ri below farm road

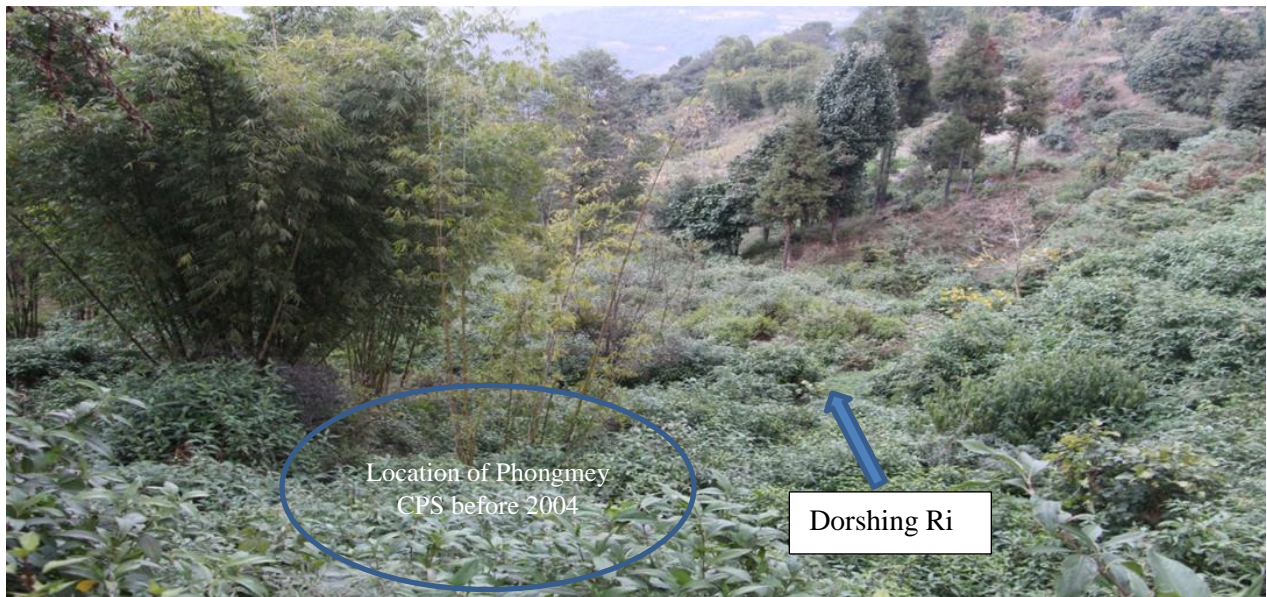
Figure 17: Location of Phongmey CPS before 2004 flood.

Dorshing Ri: At present, we cannot see big discharge from this stream, vegetation has grown and the area has been stabilised. In 2004, this stream washed away two houses along with 4 students. There are still 13 house holds residing at left and right bank of this stream. Phongmey CPS is relocated at 50 metres left from the previous location.

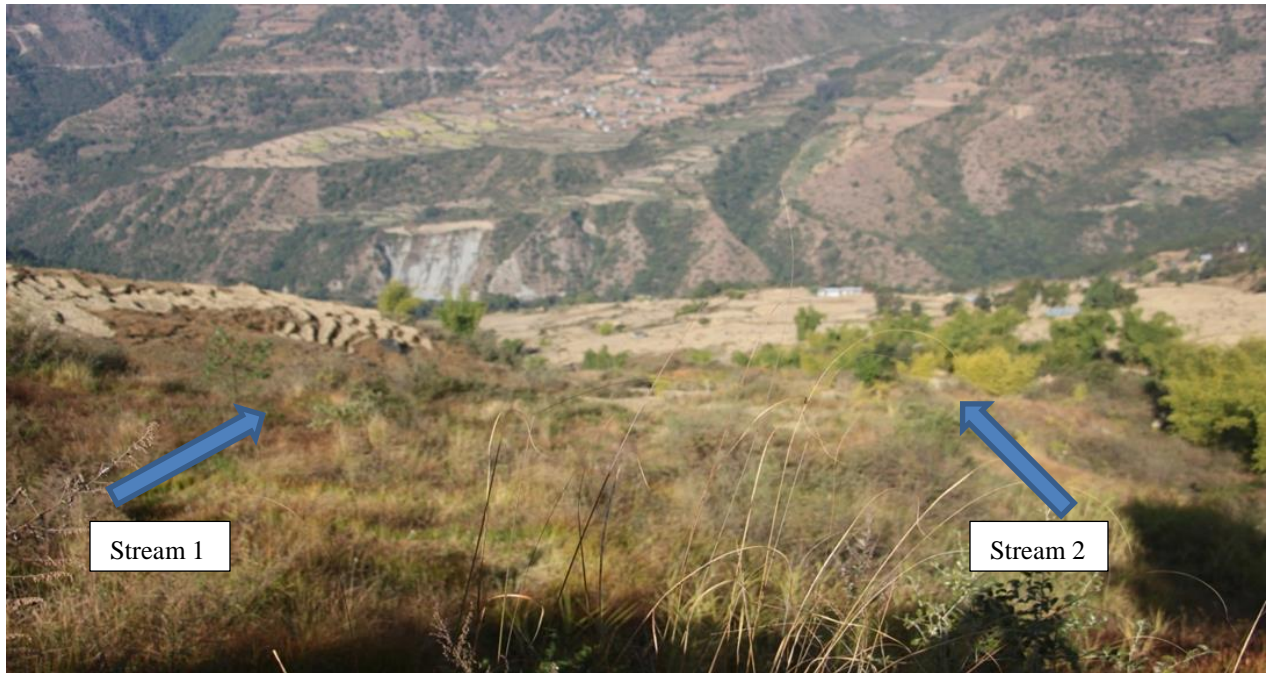
Figure 18: Location of two streams in Samtenrong Ye.

Samtenrong Ye: In Samtenrong Ye, there are two small streams flowing through paddy field. Areas between two streams were paddy field in the past. Due to water continuously flowing through the field, soil became saturated and slowly sinking and moving down the entire area. Dzongkhag and Gewog Administration have planted about 500 bamboo trees to stabilize the soil. Every monsoon, its taking away paddy fields. This area is in middle of the village. Major damage of paddy field happened long time back and the exact year and date is not available in the Gewog.

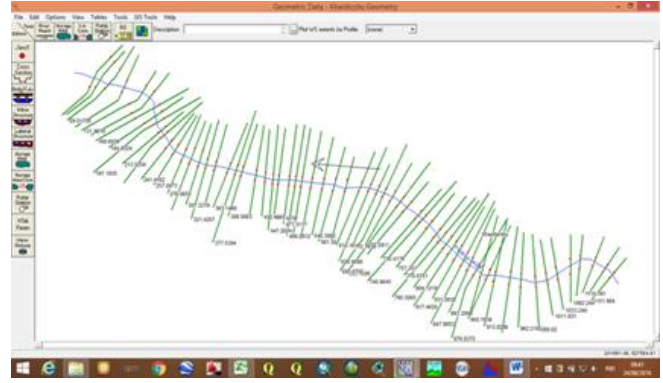
For the preparation of flood hazard map, GamriChu and Khardi Chu in Rangjung is selected since it is a big river which flows along Technical Training Institute at Rangjung and major agricultural lands. **Error! Reference source not found.** and **Error! Reference source not found.** represents the HEC-RAS schematic of Gamri Chu and Khardi Chu cross section respectively.

Figure 20: Cross section schematic of Gamri Chu

Figure 21: Cross section schematic of Khardi Chu

The schematic of geometry in HEC-RAS for Gamri Chu and Khardi Chu are shown in **Error! Reference source not found.** and **Error! Reference source not found.** respectively. The cross-section consists of three parts: main channel, left bank and right bank.

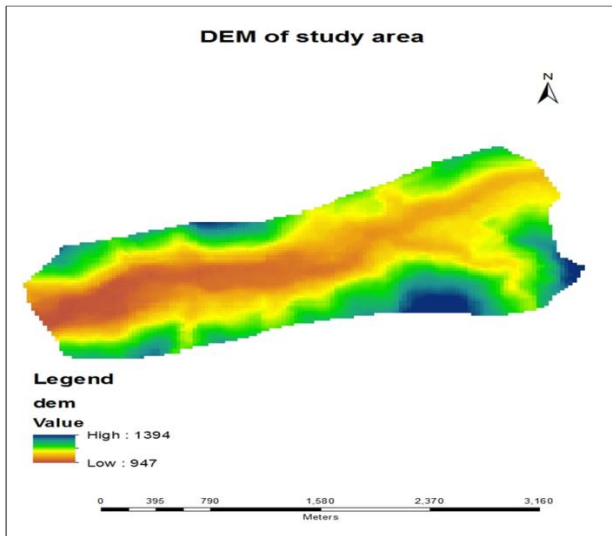
Freely available ASTER DEM (30m resolution) covered study area is downloaded. The downloaded DEM is clipped for the study area. The Geographic projection is transformed into UTM. The final DEM is shown in Figure 22 for Gamri Chu basin. The DEM in TIN format is required for HEC-RAS model.

Figure 22: DEM of study area

Figure 23: TIN of study area

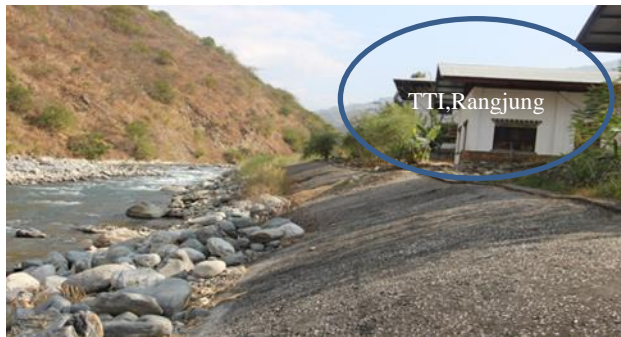
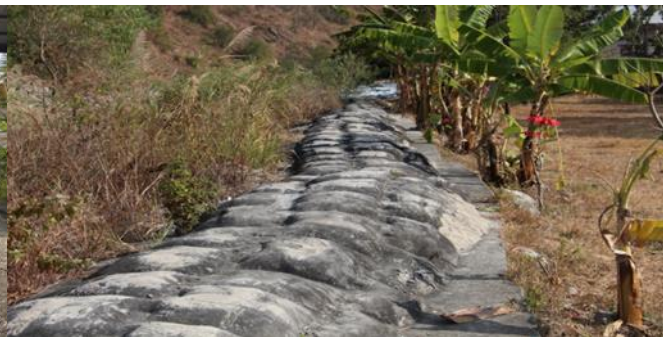
Figure 31: Embankment with PCC revetment along Gamri Chu in Rangjung.

Figure 32: AB mattress along Gamri Chu.

Plain Cement Concrete (PCC) revetment: The plain cement concrete revetments are used as flood protection structure at a location where strength and durability are important factors. The PCC revetments as presented in Figure 31 are used along the left bank of Gamri Chu in Rangjung, Trashigang to reduce the vulnerability of the community to flooding.
