# FLOOD HAZARD ASSESSMENT FOR WANGDUE PHODRANG DZONGKHAG

FLOOD ENGINEERING AND MANAGEMENT DIVISION,  
DEPARTMENT OF ENGINEERING SERVICES  
MINISTRY OF WORKS AND HUMAN SETTLEMENT

YEAR 2019

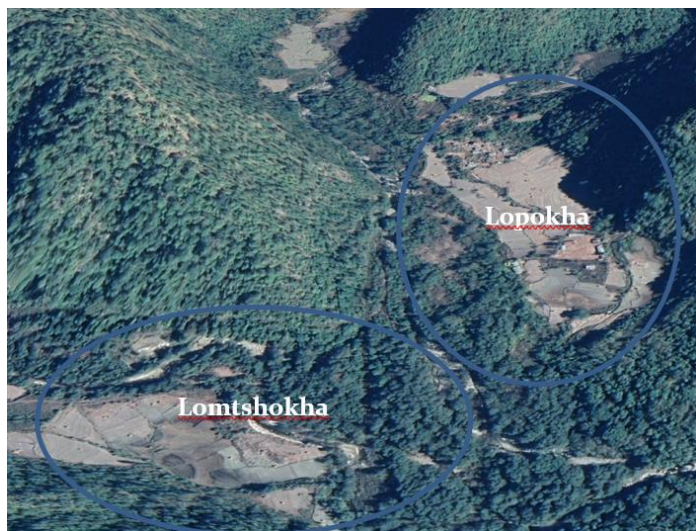
There are only two major rivers in Athang Gewogs. **Nyebachu** caused flooding in 1968 and 2017. But there is no much effect on settlement and Agricultural land. **Marachu** also caused flooding 1968 and 2017 in whole village was washed away and 3 acres of wet land effected respectively.

Figure 3: Flooding threat to Lopokha and Lomtshokha by Nybechu and Mara chu respectively.

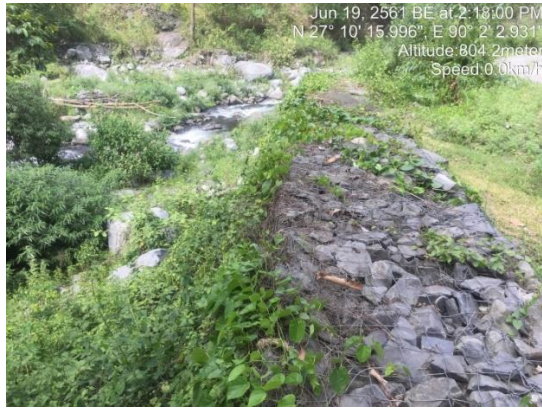
**Kamichu** and **Phunatsangchu** has no affects to Agricultural land and settlement. **Taksha chu** caused two floods in 1990 and 2017 washing away Bridge in Tsirang -Wangdue Highway and two temporary sheds of LNT labourers respectively. Gabion wall constructed by project was also destroyed in 2017 flooding. The failure of wall is mainly due to poor design of wall. There are no diaphragms and mesh used is hand woven.

Figure 4: Gabion wall constructed by PHPA II along Kamichu

Restoration of wall maybe carried out using proper design. To do this, Gewog Administration is advised to seek design from Dzongkhag or FEMD in future.

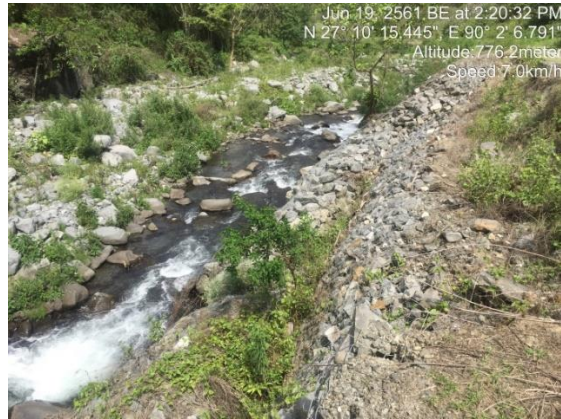
Figure 5: Failure of Gabion wall constructed by PHPA II along Kamichu

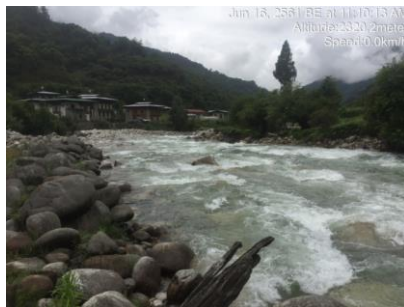
Flood by **Dangchu** in 2015 washed away RRM wall which was constructed to protect Gewog Office and Dangchu village from flooding. The wall is yet to restore. Source of Dangchu river is mainly the lakes on upstream and summer rainfall. The river bed level and ground level are minimal in most of the areas. School, Gewog Center, Dangchu Village, Tekikha Village, Kichu Resort, Forestry Office and Colony, Prison and temporary sheds for Wangdue phodrang dzong construction project, falls under risk Zone of Dangchu River.

Figure 6: Dangchu village and Gewog centre under threat.

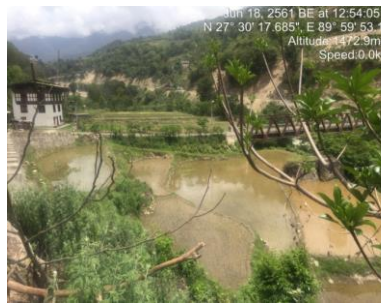
Figure 7: Tekikha village and Agricultural field under threat.

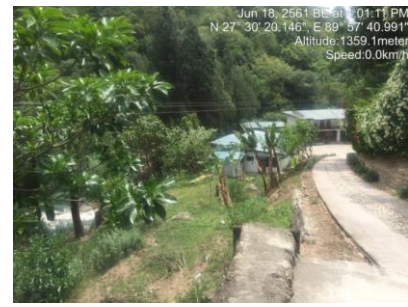
Figure 8: Kichu Resort under threat.

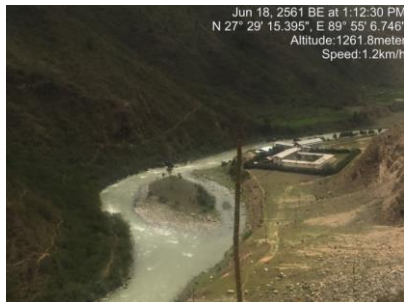
Figure 9: Prison under threat.

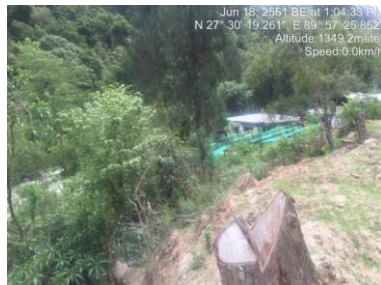
Figure 10: Forestry Office and Colony under threat.

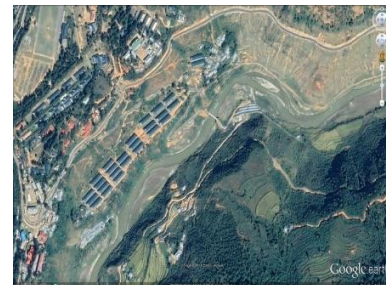
Figure 11: Temporary sheds of Labours in Wangdue Dzong reconstruction project under threat.

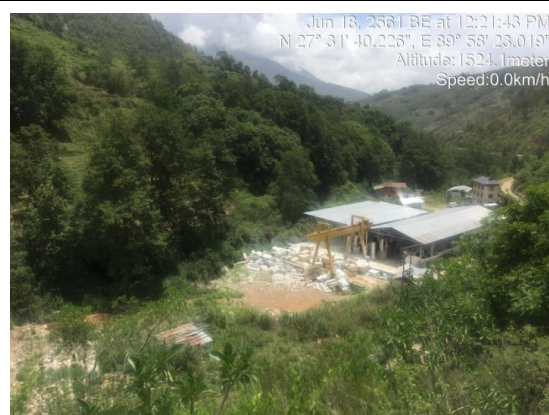
Figure 13: Marble and Incent sticks factory under threat.

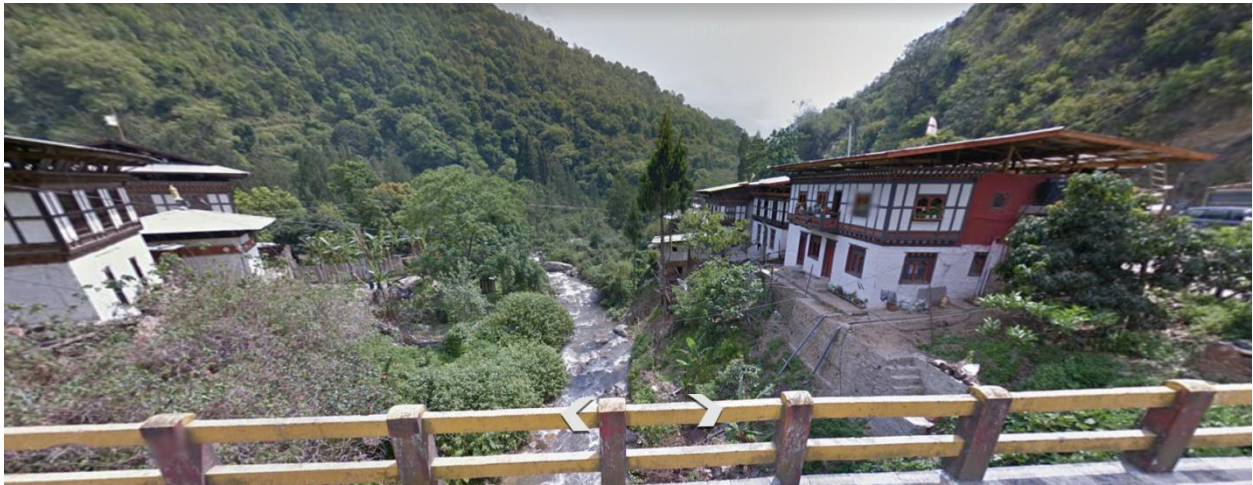
Figure 14: Chuzom under threat by Baychu

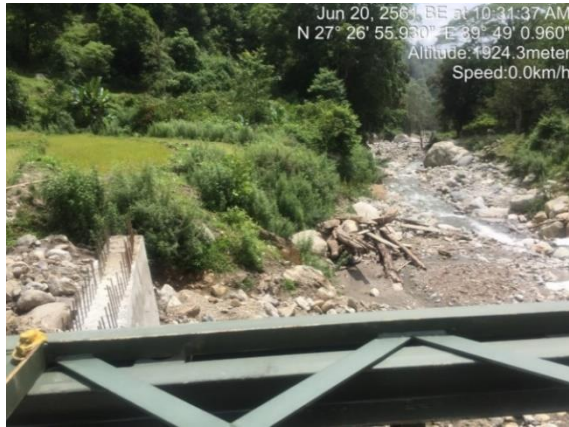
During 2014 flooding, Nebesa Chiwog bridge was washed away and restored in 2015. Bridge constructed by JICA in 2012 just above the Nahi primary school was also affected.

Figure 15: Agricultural land in downstream of bridge connection Nebesa Chiwog on left Bank.

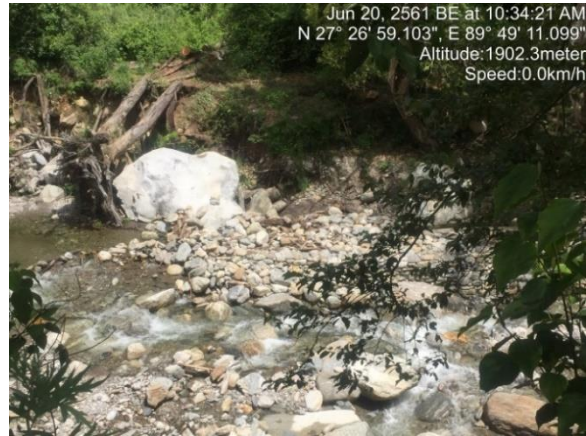
2017 flood is the second largest flooding event recorded in Hinley Rongchu River. Irrigation channel source for Yusawom Chiwog restored in beginning of 2017 was washed away.

Figure 16: Irrigation Channel source of Yusawom and Hebasa Chiwog on left Bank

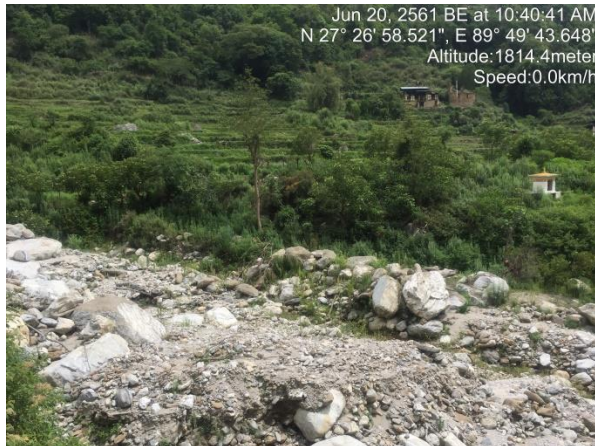
Figure 17: Paddy field and chorten in Yusawom Chiwog under threat in left Bank

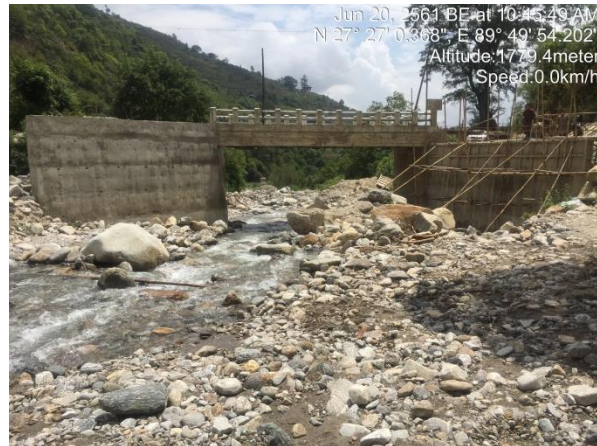
Figure 18: Bridge connecting Yusawom and Yusagom Chiwang is under reconstruction after it was washed away in 2016

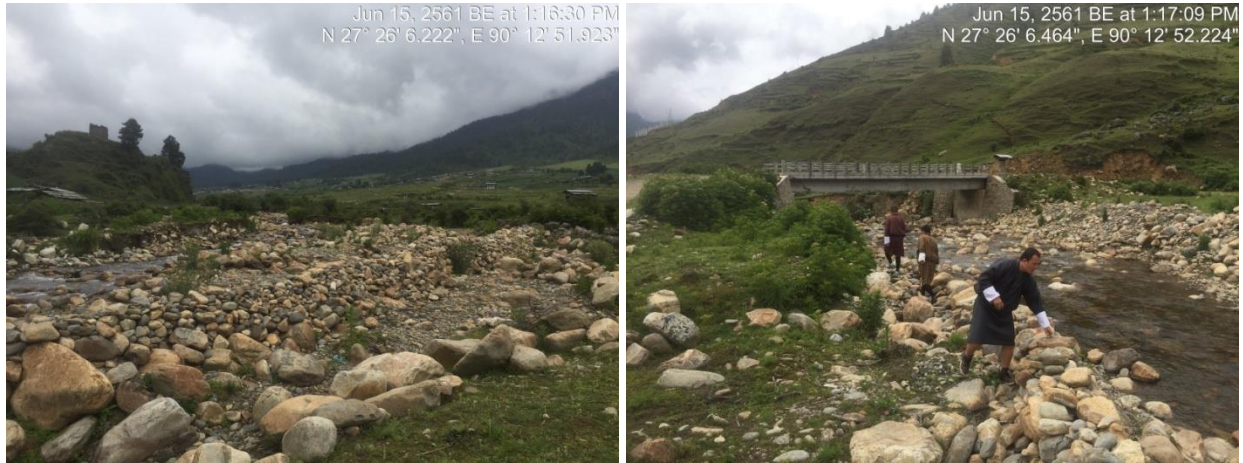
Phobji Gewog has two rivers affecting settlement and Agricultural land. **Pakshingzangpa** chu affects one motorable bridge and approximately 17 acres of dry land.

Figure 19: Upstream of PakshingZangpa bridge.

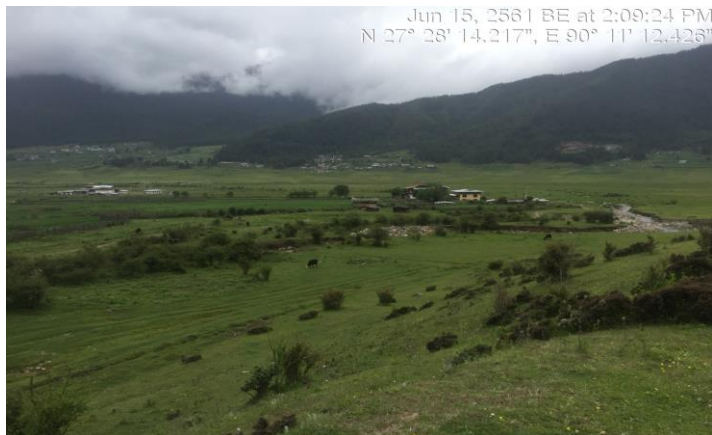
**Khem chu** affects 4 houses, 30 people, 150 cattle and about 6 vehicles in khewa village. Recent flood in 2016 destroyed about 1 acre and 3 acres of potatoes in Pakshingzangpa and Khewa village respectively. Moreover, Khewa village was evacuated during 2016 flooding.

Figure 20: Khem chu in Khewa Village.

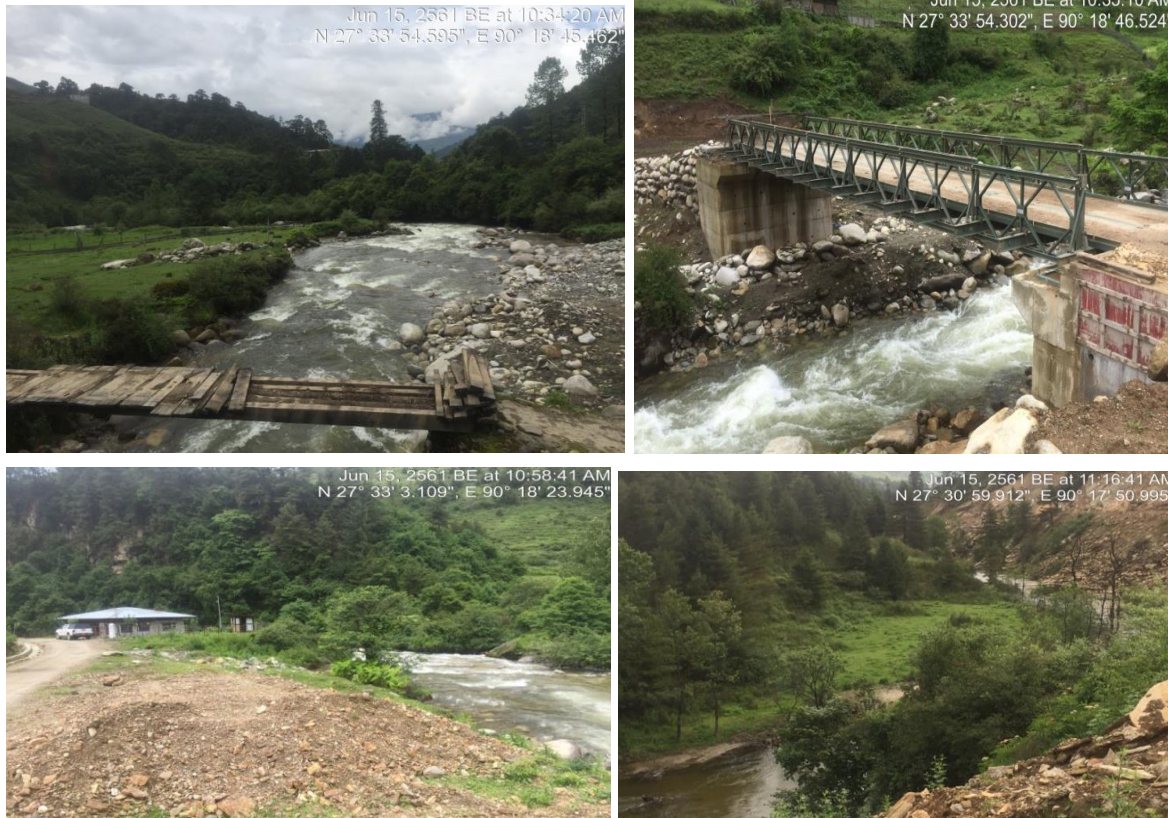
**Nikachhu** is only river that causes flooding to settlement and Agricultural land in Sephu Gewog. This river flows from highland of Sephu Gewog and finally joins mangde chu in Trongsa. Nikachhu washed away Bazam Bridge in August 2008 and was restored in December 2008. It was once again washed away in August 2013 and restored in December of same year. Gewog also has other rivers like Chusayang chu, Sarchona chu & Tsa chu, but there is no effect of these rivers to settlement and Agricultural land.

Figure 21: Threats caused by Nikachu

- **Downstream of motorable bridge connecting Lubzor and Lubzor Phakha**  
There is a dry land of about 1 acres on the downstream of motorable bridge connecting Lubzor and Lubzor Phakha on the left bank of Nikachhu. Since there minimal elevation difference between river bed and dry land, this area is prone to flooding.

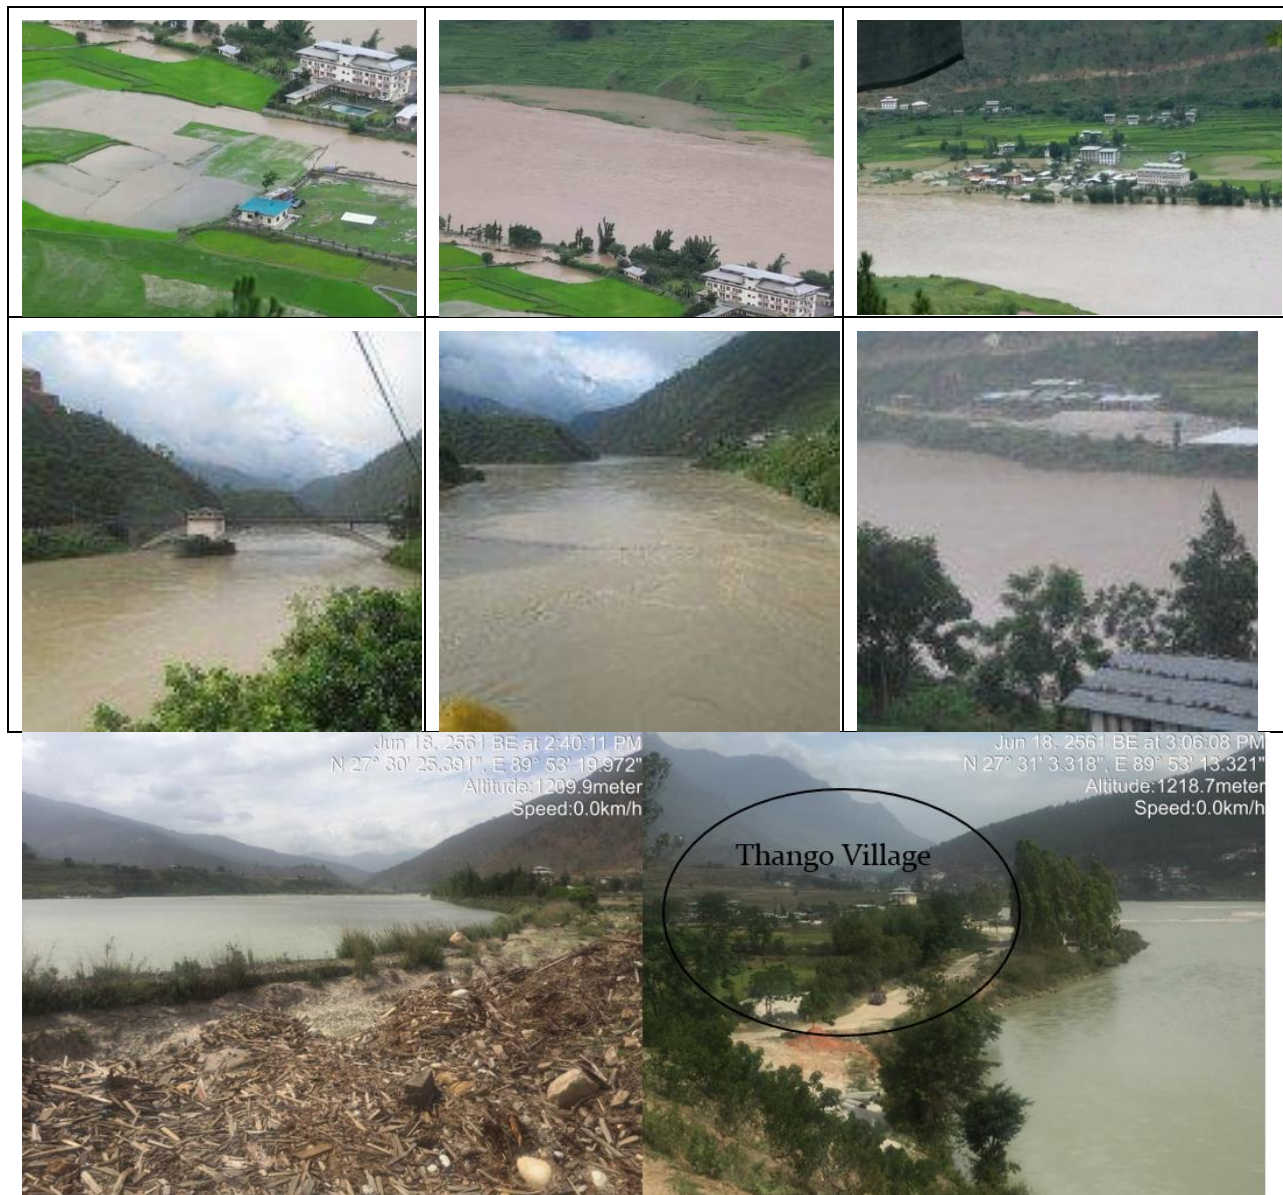
**Punatsangchu** has long history of flooding. In 2009, two houses in Thango village were completely washed away. Again in 20016, Thango village was inundated and artificial pond was created behind Hotel Pema Karpo. Two excavators were used to draw water out of this pond.

It was seen that, the elevation difference between river bed level and ground level is minimal as compared to the discharge of river. Hence, during flooding water flows over existing gabion walls and settlements get inundated.

Figure 22: Thango village under threat by Punatsangchu.
