**GEOTECHNICAL STUDY FOR ZHEMGANG
EXISTING TOWN AND TINGTIBI**

FINAL REPORT

**PROJECT CLIENT: DEPARTMENT OF HUMAN SETTLEMENT
(DHS), MINISTRY OF WORKS AND HUMAN SETTLEMENT
(MOWHS)**

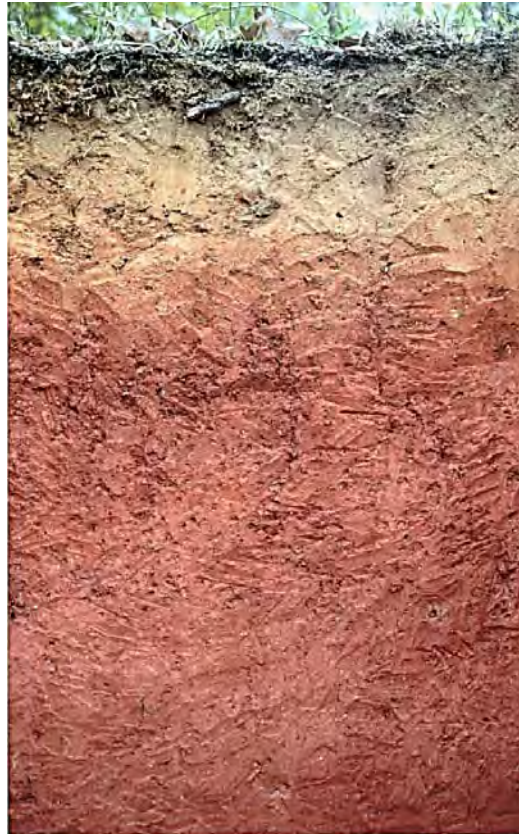
Figure 6: Residual Soil found at Study Area (Zhemgang Town and Tingtibi)

At both Zhemgang Town and Tingtibi, the soil was predominately residual soil. At Zhemgang, the residual soil was formed from weathering of phyllites while at Tingtibi the residual soil was a product of weathered quartzites. Usually, three layers of subsurface soil were observed. The top surface layer was dark brown or dark fine grained organic soil comprising of roots and grass. Below this, the soil layer was pale brown fine sandy loam. The bottom subsoil was red clay loam and sandy clay loam. The generalized residual soil type at Zhemgang and Tingtibi is shown in **Figure 6**. This soil may be referred to as a loam soil. Loam is soil composed mostly of sand, silt and a

smaller amount of clay. Sandy loam soils are dominated by sand particles, but contain enough clay and sediment to provide some structure and fertility. Sandy loam soils have visible particles of sand mixed into the soil. Sandy loam soils have a high concentration of sand that gives them a gritty feel. In gardens and lawns, sandy loam soils are capable of quickly draining excess water but cannot hold significant amounts of water or nutrients for your plants.

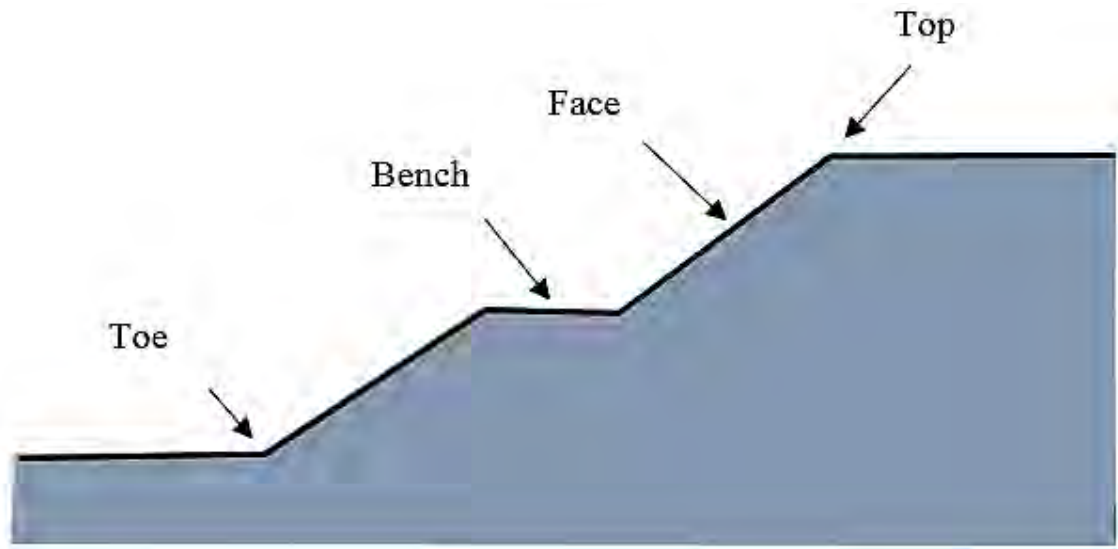
Figure 16: Benching/terracing on slope

This is the most common method that has been used in residential areas. This method is usually simple and less costly. The changing of the slope angle from steep slope to a gentler slope increases the stabilization of slope (**Figure 16**). This method has been used in all the mining projects in Bhutan. Terracing is the technique of converting a slope into a series of horizontal step-like structures with the aim of controlling the flow of surface runoff (by guiding the runoff across the slope and conveying it to a suitable outlet at a non-erosive velocity); reducing soil erosion by trapping the soil on the terrace; and creating flat land suitable for development. Terraces can be made in a variety of ways. The best approach depends on many factors including the steepness of the slope, the intended use, and the soil. The terraces are easily constructed. The

spacing between the terraces depends on the slope of land; the distance between terraces goes down as the slope increases. Benching, also called terracing, allows the use of sections steeper than the overall slope.
