FIELD EXPLORATION

GEOTECHNICAL REPORT FOR TINGTIBI

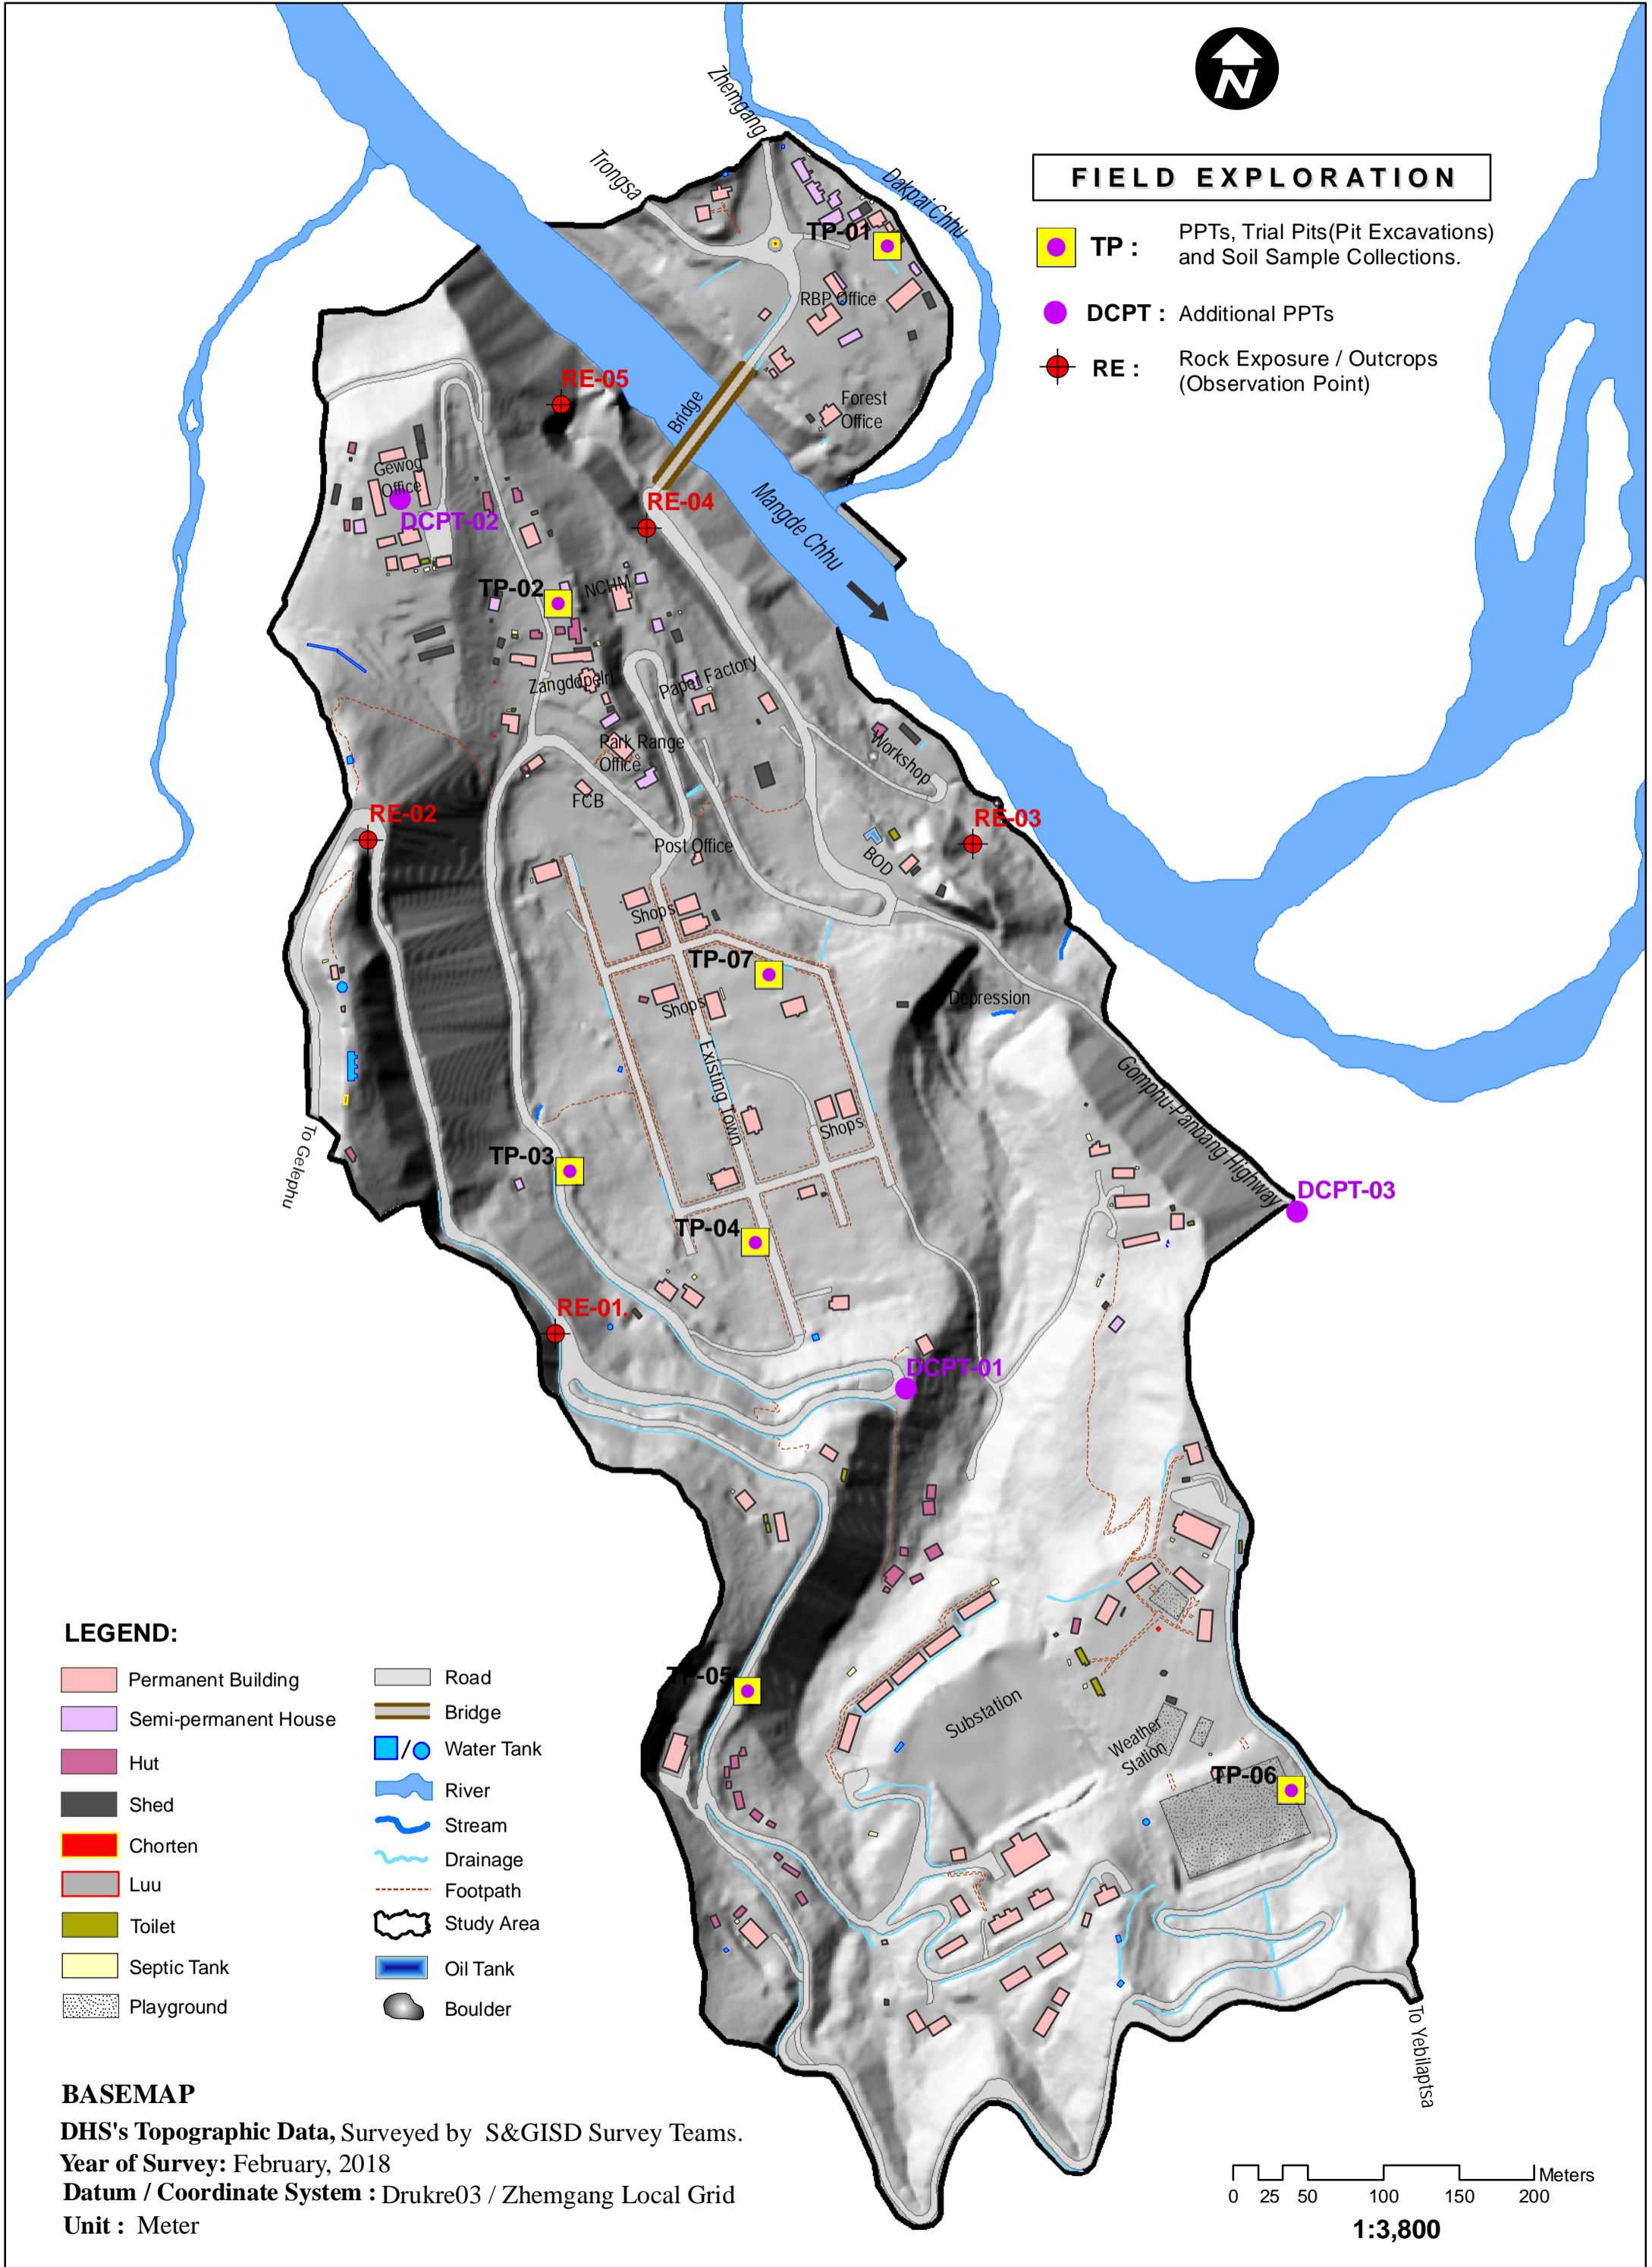
- TP : PPTs, Trial Pits(Pit Excavations) and Soil Sample Collections.
- DCPT : Additional PPTs
- RE : Rock Exposure / Outcrops (Observation Point)

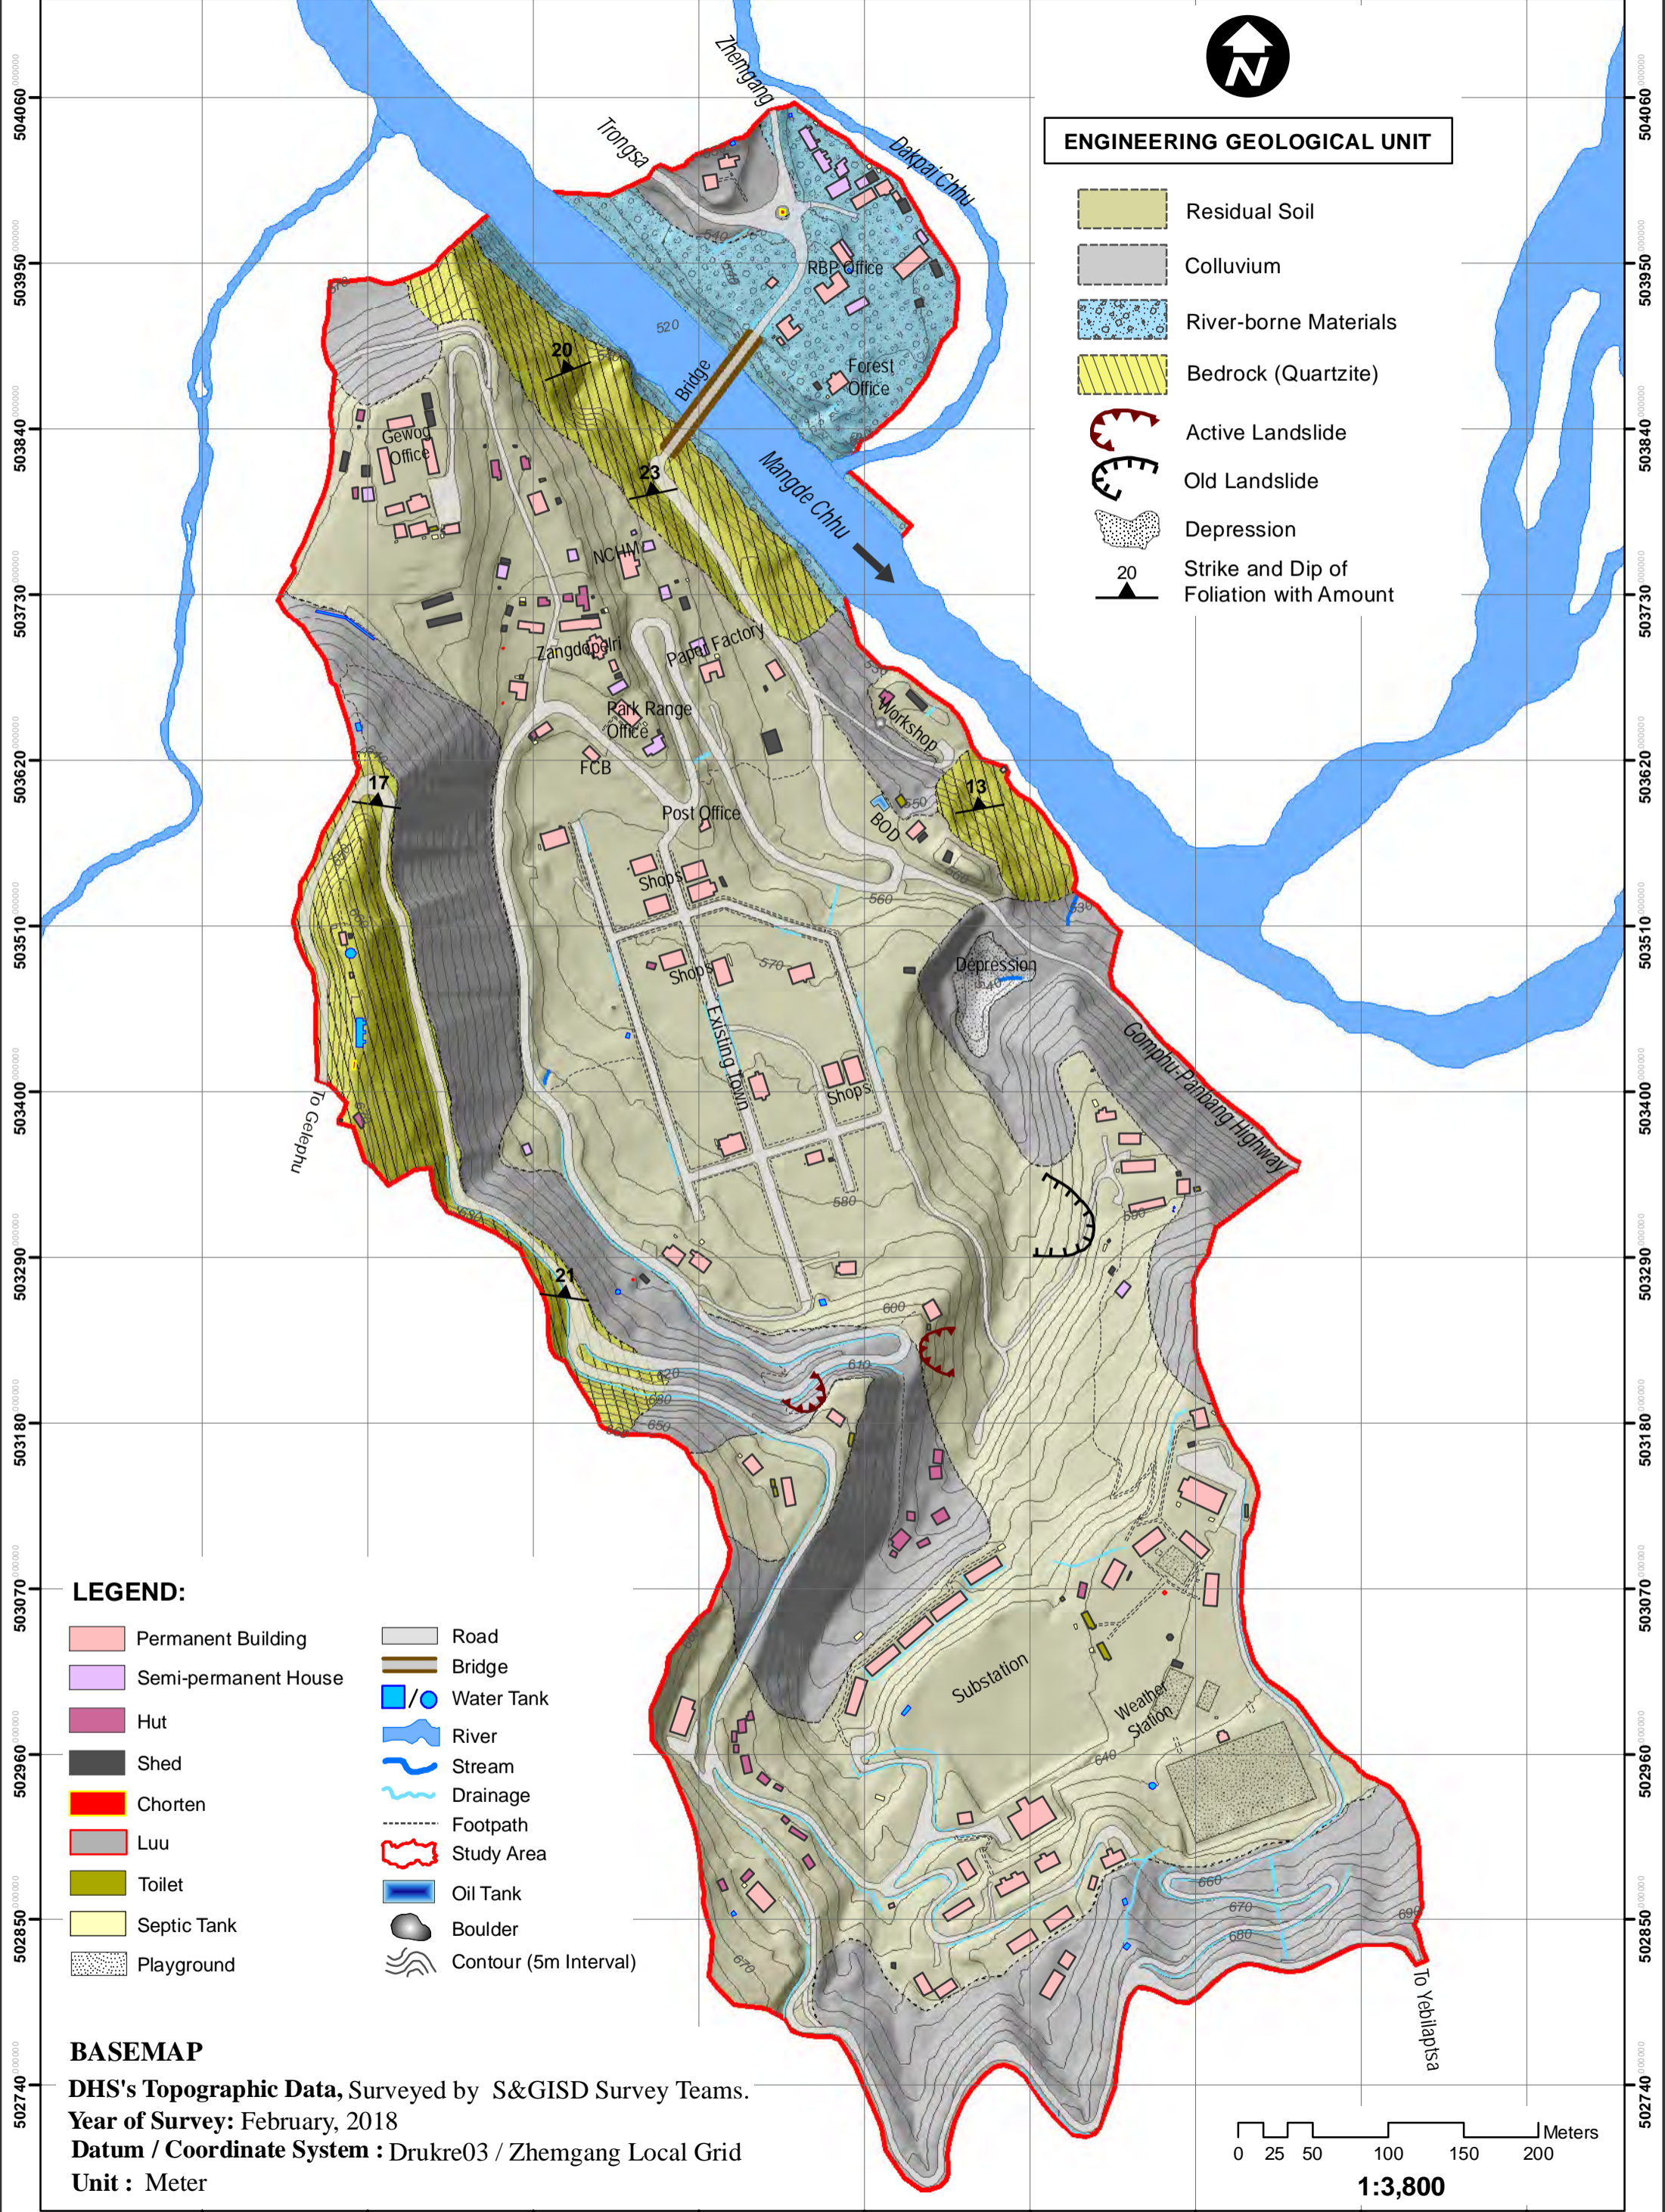
ENGINEERING GEOLOGICAL MAP:

ENGINEERING GEOLOGICAL UNIT

- Residual Soil
- Colluvium
- River-borne Materials
- Bedrock (Quartzite)
- Active Landslide
- Old Landslide
- Depression
- Strike and Dip of Foliation with Amount
