**DEPARTMENT OF ENGINEERING SERVICES,  
MINISTRY OF WORKS AND HUMAN SETTLEMENT  
ROYAL GOVERNMENT OF BHUTAN**

# **Flood Management Plan for Kerongchu, Nganglam, Pema Gatshel Dzongkhag.**

**PREPARED BY FEMD, DES, MOWHS**

**OCTOBER, 2020**

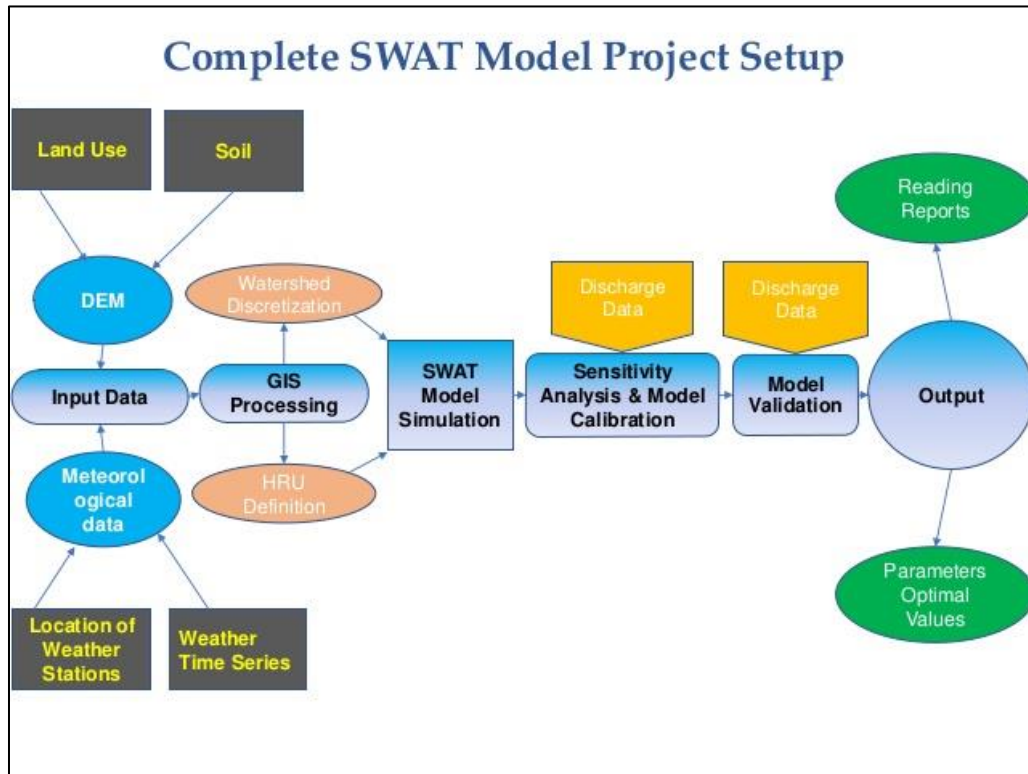
**Figure 3 Model set up flow chart**

The model set up as shown in Figure 3 will be explained subsequently in relation to the specific project area.

The SRTM DEM of resolution 90x90 projected to WGS 1984 UTM zone 46N and clipped in ArcGIS environment which was then loaded to DEM raster in ArcSWAT. An outlet of the basin was selected which resulted in delineation of Nganglam catchment with an area of 498 square km consisting of 132 sub basins. Further the catchment of Kerongchu with an area of 88 square km was delineated by selecting an outlet near the confluence of Drangme chu. The sub-basins were further divided into multiple Hydrologic Response Unit (HRU). The projected land use map and soil map were overlaid in the watershed to process the HRU definitions. The land use classes of the Land use Bhutan had to be reclassified to the nearest matching land use category of the SWAT database. This was carried out by making a simple land use look-up table. The soil types and its

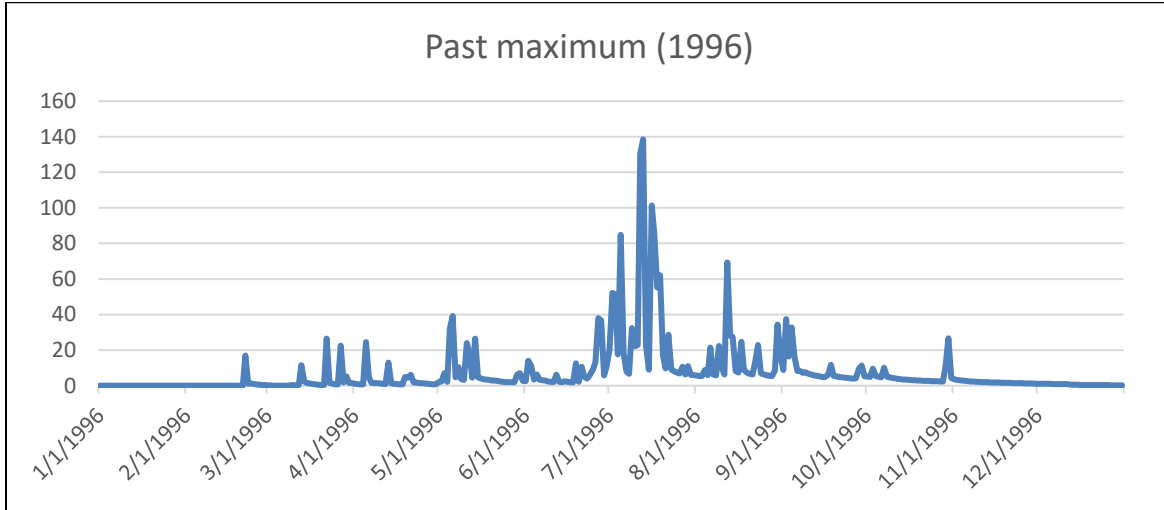
**Figure 5 Hydrograph showing past maximum daily discharge in 1996.**

The simulated discharge was validated against the measured discharge from Floating method carried out during the site visit in October 2018 at the Bridge point where the peak discharge was determined as 114 Cumeecs (this discharge should be higher since the river velocity during the monsoon season is greater than the assumed one in lean season). After comparing the measured discharge with the simulated discharges of past years (1988 to 2017), the simulated discharge in the year 2012 with 120.5 Cumeecs has been seemed as corresponding to the floating method discharge, as from the historical google satellite image it can be seen that the bridge with the flood mark was completed at least after in 2010 (Figure 5).

\*The peak daily discharge of the past maximum was simulated as 138.5 Cumecs in 1996.

Hence, this simulated discharge can be found to be more or less reliable and thus the past maximum discharge (viz. 1996) was considered to produce hydrograph for return year period as input data for hydrodynamic model.

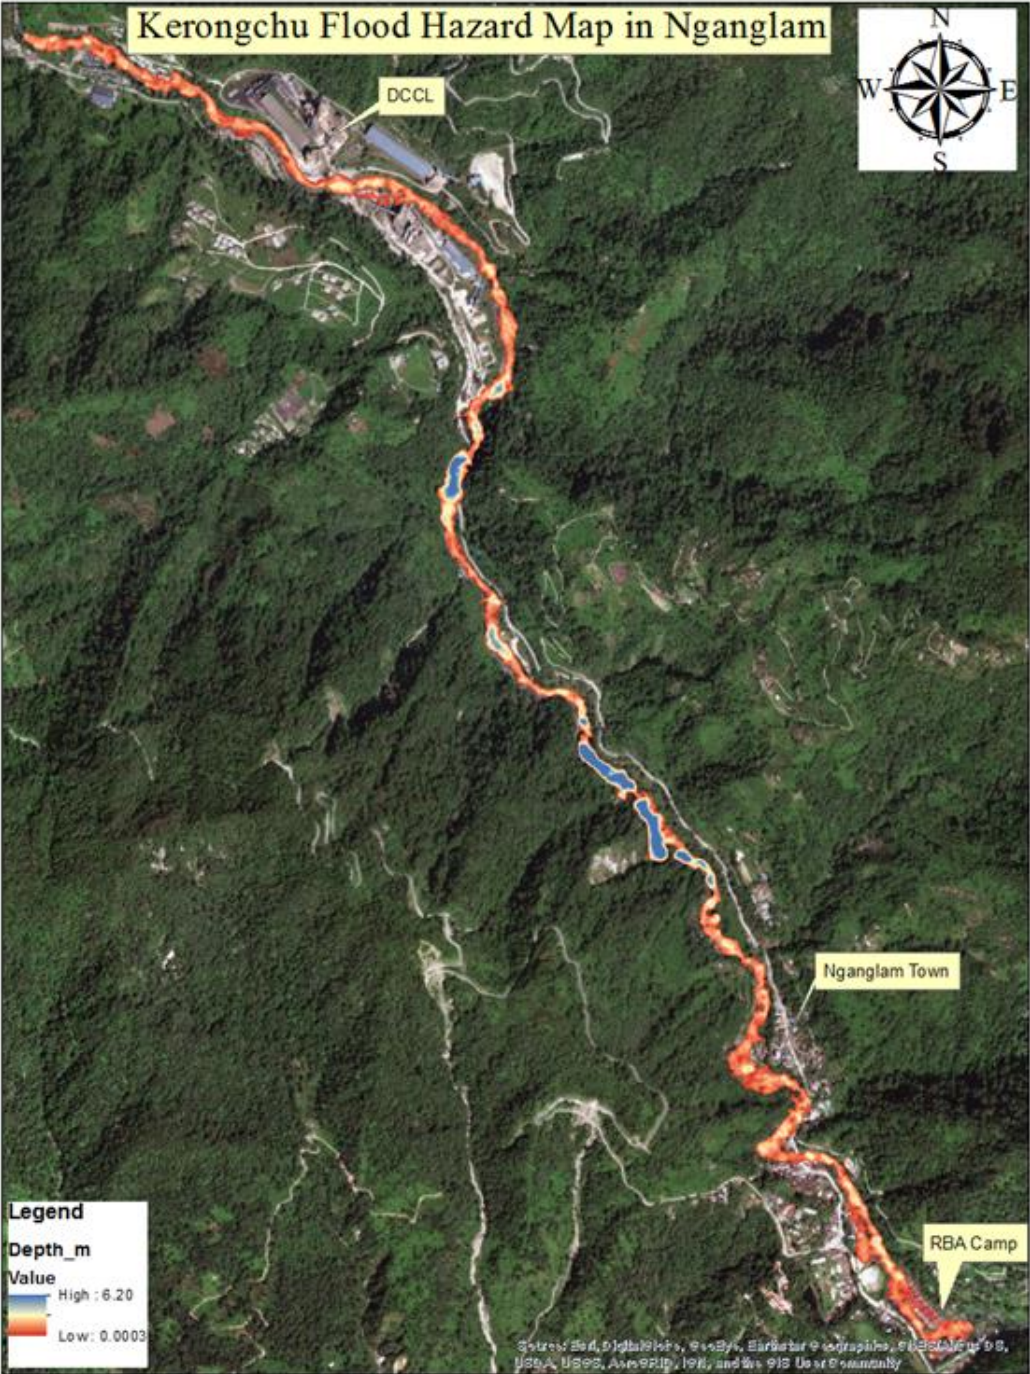
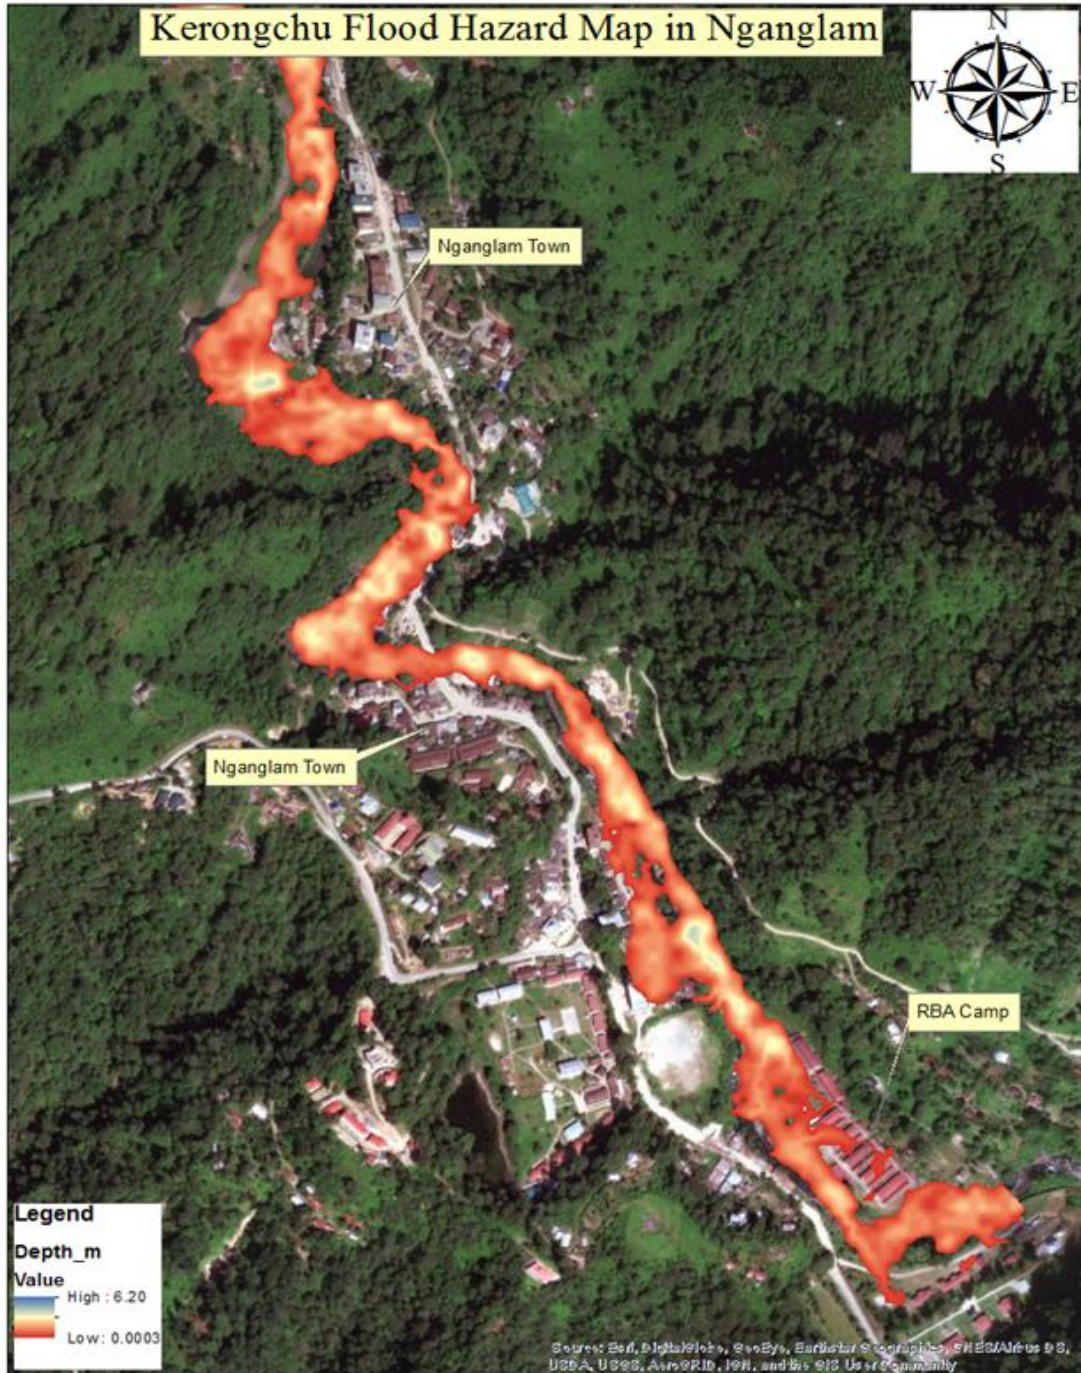
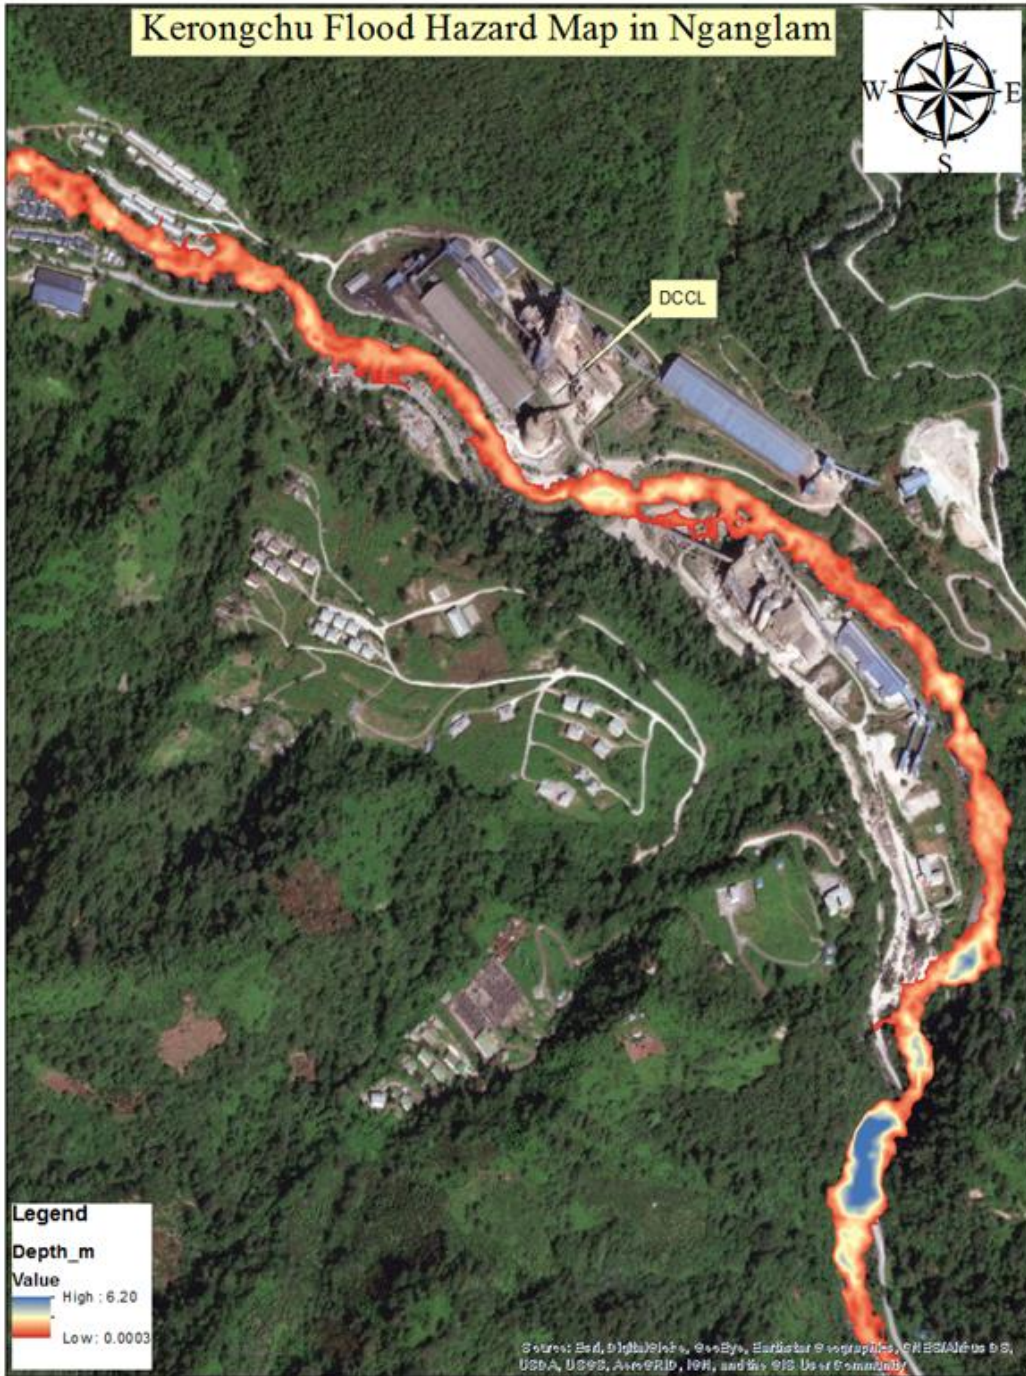
The following Figure 12, Figure 13, Figure 14 shows the flood hazard maps of Kerongchu under Nganglam from the HEC-RAS modelling:

**Figure 12 Overall Flood Hazard map of the study area**

**Figure 13 Flood Hazard Map for Nangalam Town area and RBA Colony**

**Figure 14 Flood Hazard Map at Dungsam Cement Corporation Limited Area**

The Flood hazard map for 100-year return period has been prepared which indicates the details on inundation area and depth at each point. The flood hazard zone developed from the HEC-RAS flood modeling was tested for validation with the satellite-based historical inundation maps.

All the inundation areas shown in the model were mapped and identified specific location in the hazard map for validation purposes. While analyzing in the map it shows that about 9 areas of total inundation lie in high hazard and very high hazard zones, respectively; while, about 5 areas of inundation comes under low and moderate hazard zones, respectively.

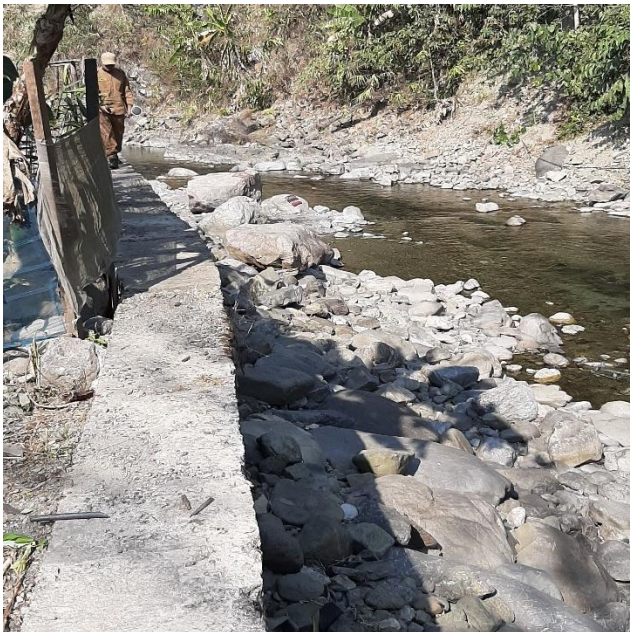
**Figure 21 RCC wall near the automobile workshop**

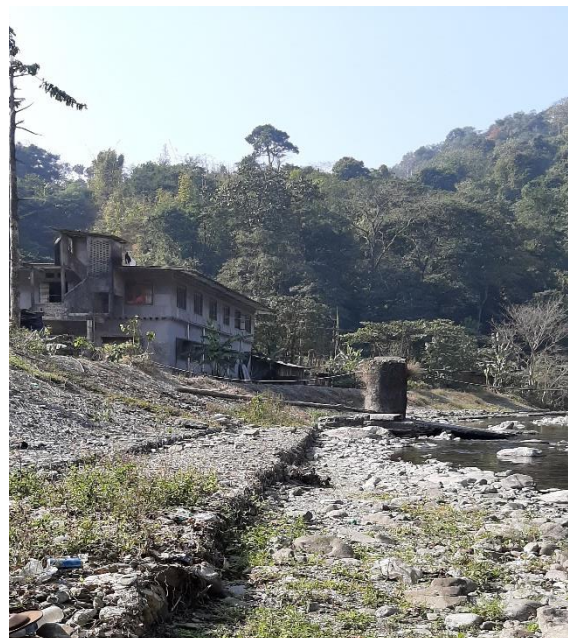
**Figure 22 Gabion revetment below the motorable bridge**

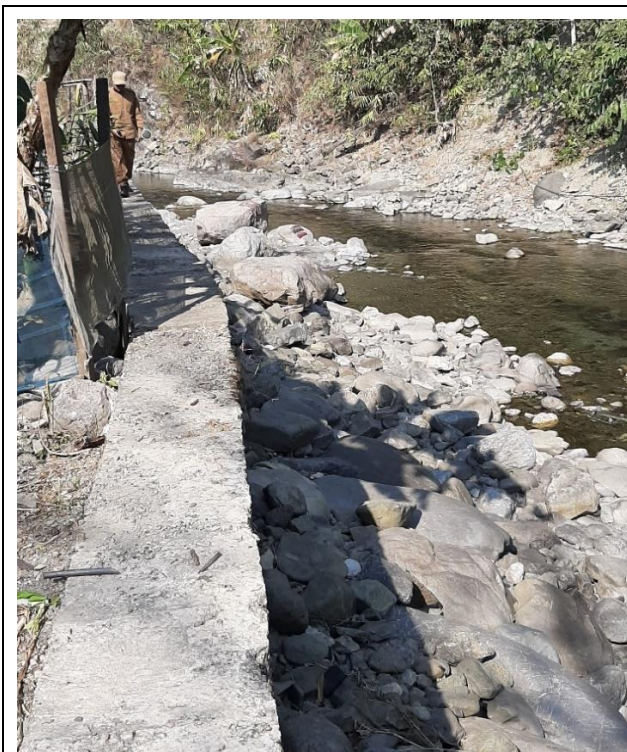
The Dungkhag Administration with the technical and financial support from the FEMD, DES has constructed the flood protection works along the banks of Kerongchu during the financial year 2017-2018 which has immensely helped in protection of Nganglam Town from flash flood in the later year. Those structures consist mainly of RCC wall, gabion wall and gabion revetments constructed near the automobile workshop and downstream of the bridge (Refer Figure 26).

**Figure 26 Existing RCC structures**

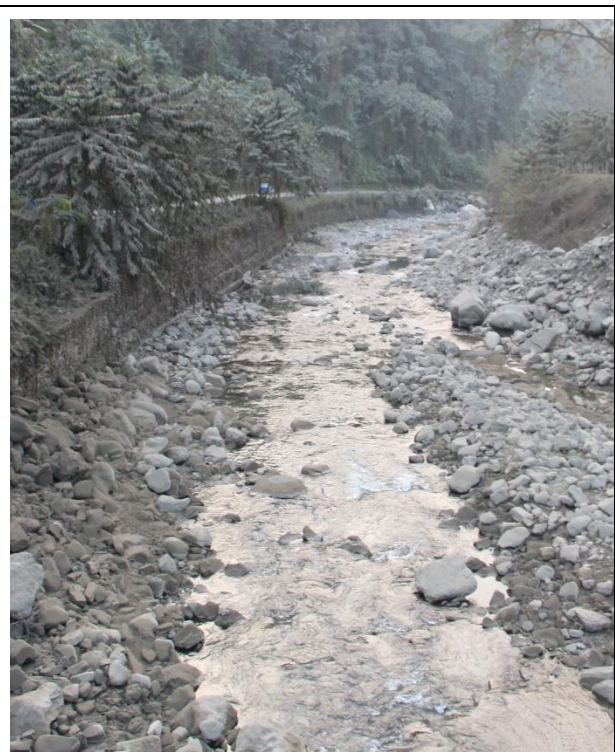
Never the less, it has also been observed that the gabion walls have been constructed adjacent to RBA camp and near DCCL colony to protect the respected areas from the river flood (Refer Figure 28 and Figure 29). In some places, due to scouring of the bank, some gabion walls were at the verge of failure and needs immediate replacement or maintenances. List of existing flood protection structure are given in Table 4 with its coordinate for kind references.

**Figure 27 Existing gabion wall**

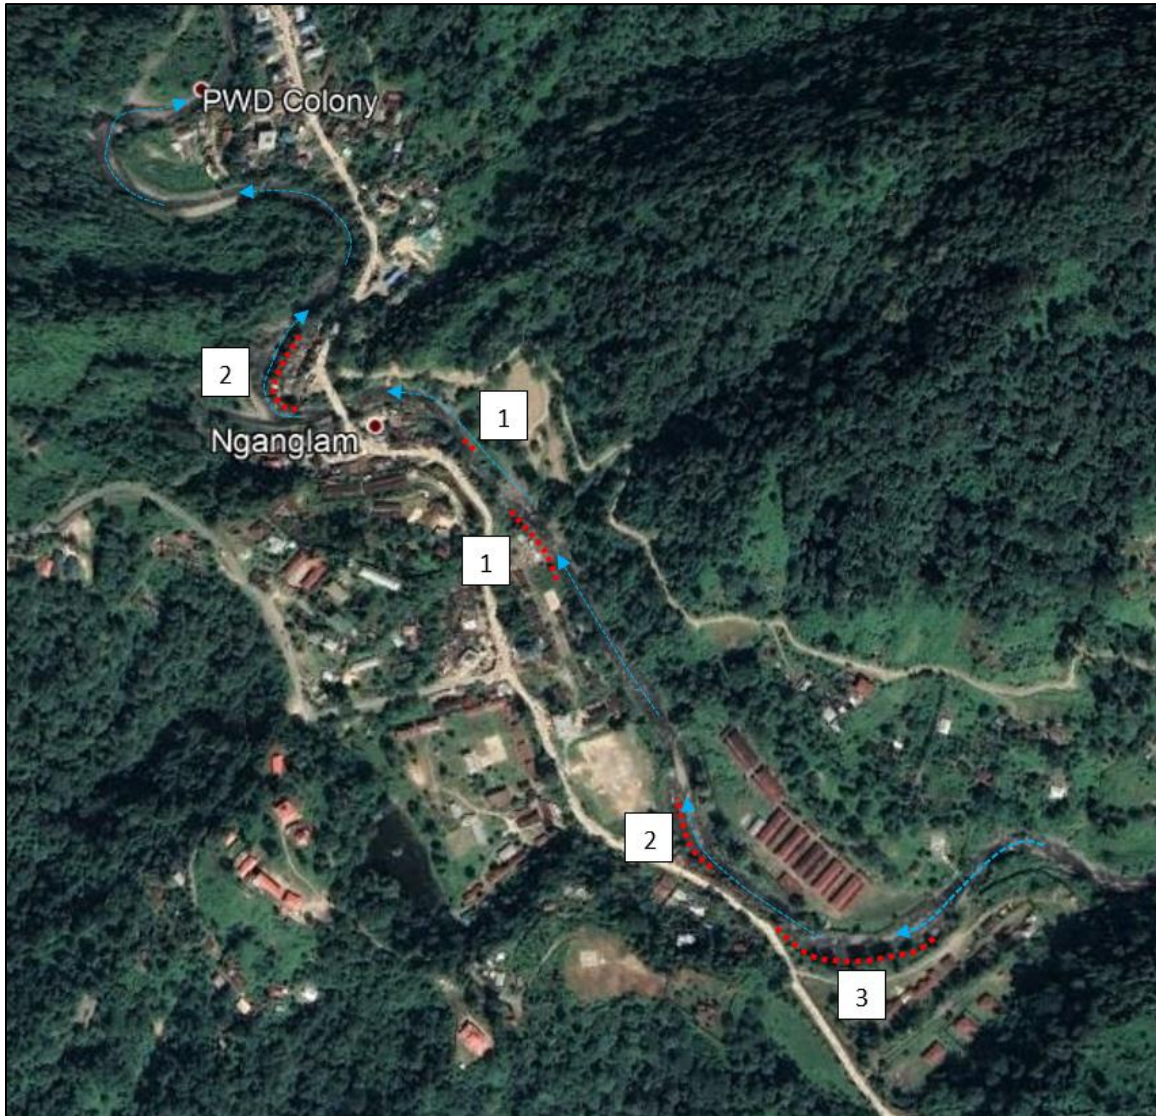
**Figure 33 Priority map for upstream of Nganglam town**

- Below the football ground, left bank: The left bank area has been found critical and needs to be protected with gabion walls with an apron (50m).
- Near the automobile workshop: The left bank, RCC walls needs to be extended (15m).
- Above the DPCL colony: The left bank needs to be protected by providing Gabion Revetment (310m).
