FLOOD HAZARD ASSESSMENT FOR SARPANG DZONGKHAG

**FLOOD ENGINEERING AND MANAGEMENT DIVISION,
DEPARTMENT OF ENGINEERING SERVICES
MINISTRY OF WORKS AND HUMAN SETTLEMENT**

YEAR 2019

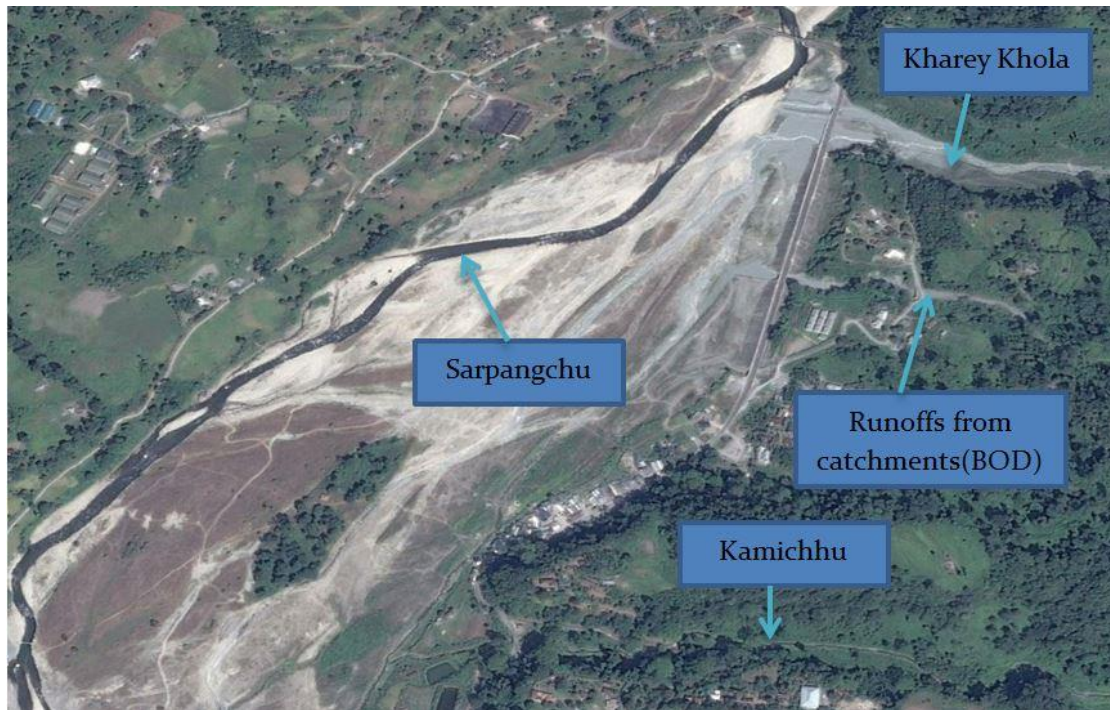
Figure 6: Sarpang Chhu with its tributaries.

There are about three tributaries of Sarpang Chhu discharging into the main river below the downstream of the Hilley Bridge as seen from *Figure 6*. As per the local residents, Kamichhu is perennial while Kharey Khola⁴ and the third stream are seasonal. The third stream is the

discharge from the catchment around BOD in Sarpang Bazaar during rainy seasons. The existence of the two seasonal streams can be confirmed from the presence of stream flow path filled with debris of various sizes.

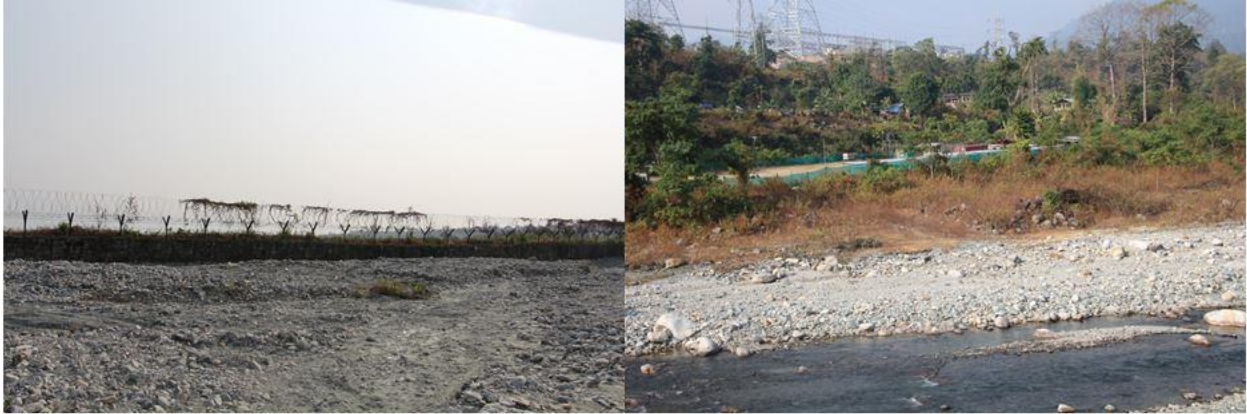
Presently, as per the visual inspection and hearsay during the site investigations, there seems to be no threat from the Big Aipoly to the settlements and agricultural fields. However, if it changes its course, the Gelephu Domestic Airport will be under threat from flooding since it flows right above the airport as shown in *Figure 10(a)*. Likewise, the Bhur Khola also does not pose much flooding hazard to the settlements and the agricultural fields since it is located far away from the community. On the contrary, Small Aipoly and Paithrai Khola are the rivers which are prone to flooding in the Gewog.

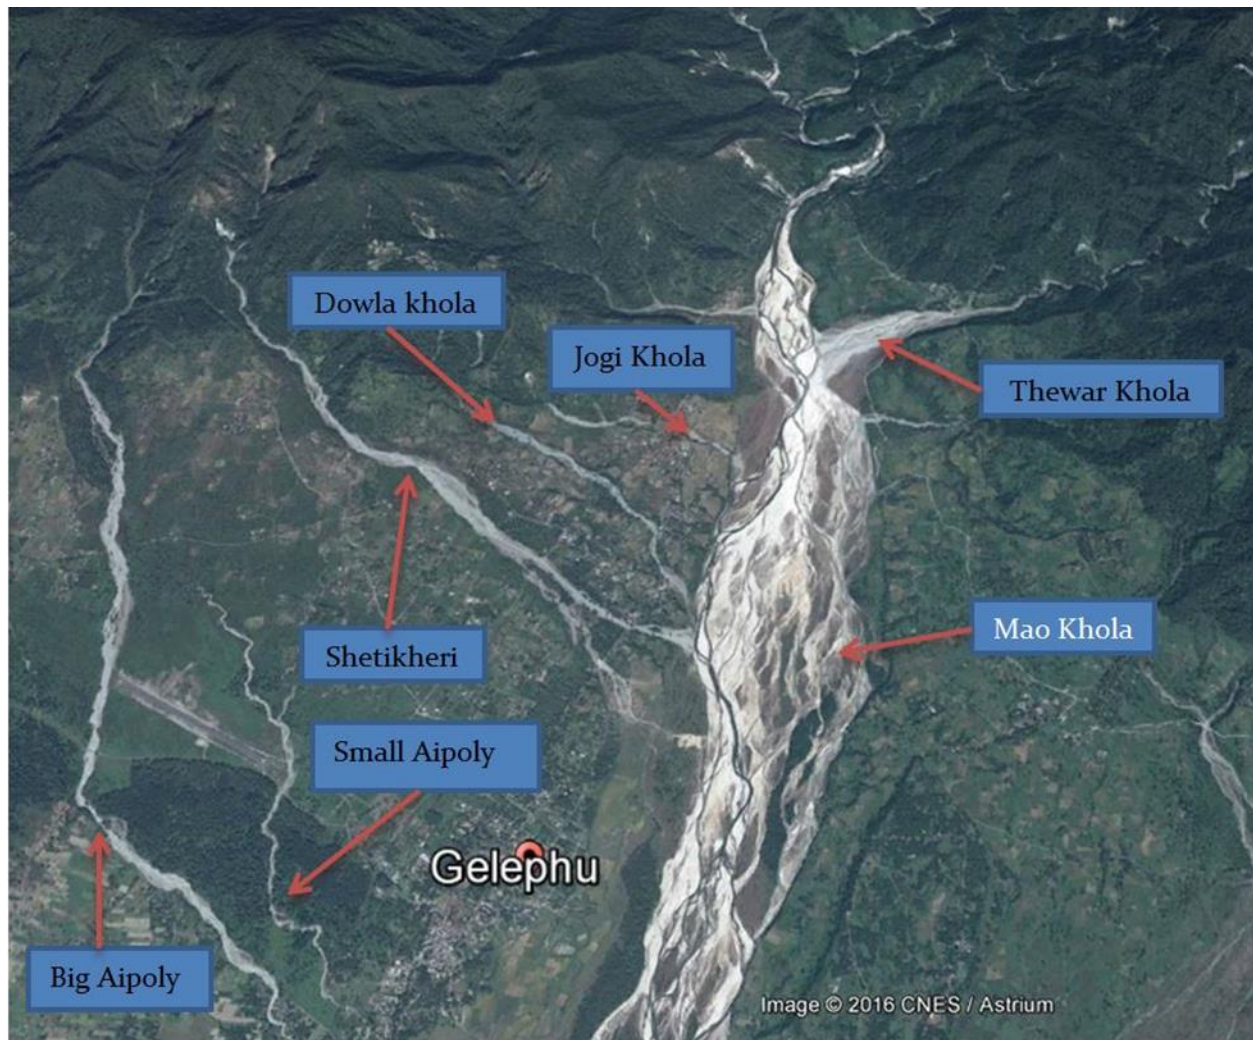
Figure 13 : Mao River in Gelephu with its tributaries.

Mao River, over the past many decades, has been eroding both the banks. The Mao River, with an average flow of just 40 cubic meters per seconds, has developed a very wide channel as seen from *Figure 13*. At certain sections, the width of the river channel is as wide as 1,500 meters. Without immediate attention, these plains are under high risk from the threat of degradation. During the monsoon period from June till September four gewogs of Sarpang Dzongkhag are inaccessible due to the Mao River. During the monsoon period the river gets swollen and the whole area on the left bank is completely cut off, leading to great inconvenience to the entire population of the four gewogs.

Built with a huge cost is the water treatment plant of Gelephu Town, which is located on the right bank of Mao River. The Mao River Infiltration Gallery which produces 4MLD was constructed under Danida funding in 2010. There are also other infrastructures like private houses, private fisheries, Bhutan Olympic committee (BOC) located very close to the right bank. These infrastructures are in grave risk of being flooded and washed away. Moreover, the left bank also has been experiencing constant erosion. A few meter width of land is being eroded every monsoon.

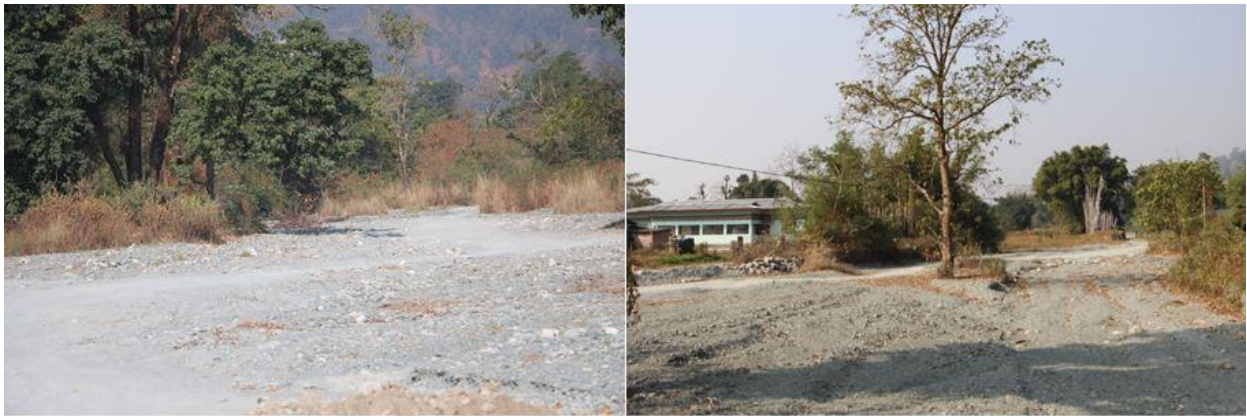
Both Dowla Khola and Jogi Khola are seasonal and doesn't pose much danger to Gelephu town. However, Dowla Khola during rainy season damages the Gelephu- Zhemgang Highway making it inaccessible to the public. It doesn't affect the agricultural fields and the settlements. On the other hand, Jogi Khola affects the settlement and the agricultural fields in and around Gelephu Gewog since it flows through the settlements as given in *Figure 17*. If left without any

interventions, there is high chance of it changing its course and affecting the settlements in the Gelephu Thromde.

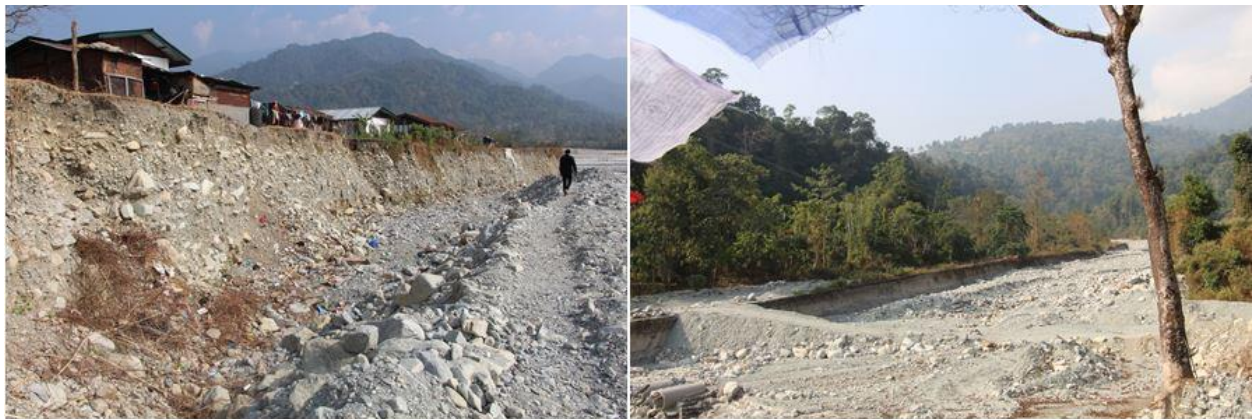
As per the assessment, the Lodrai Khola does not impact the agricultural fields and settlements in the Gewog since the Dzongkhag has provided RCC(Reinforced Cement Concrete) flood protection walls along the right bank of Lodrai. However, the river has eroded the left bank of Lodrai Khola near the RBA (Royal Bhutan Army) colony at the confluence of Mao River. There is an urgent requirement of flood protection structures near the colony as seen from *Figure 18*. Nevertheless, foundation work for the flood protection works are going on as per our observations.

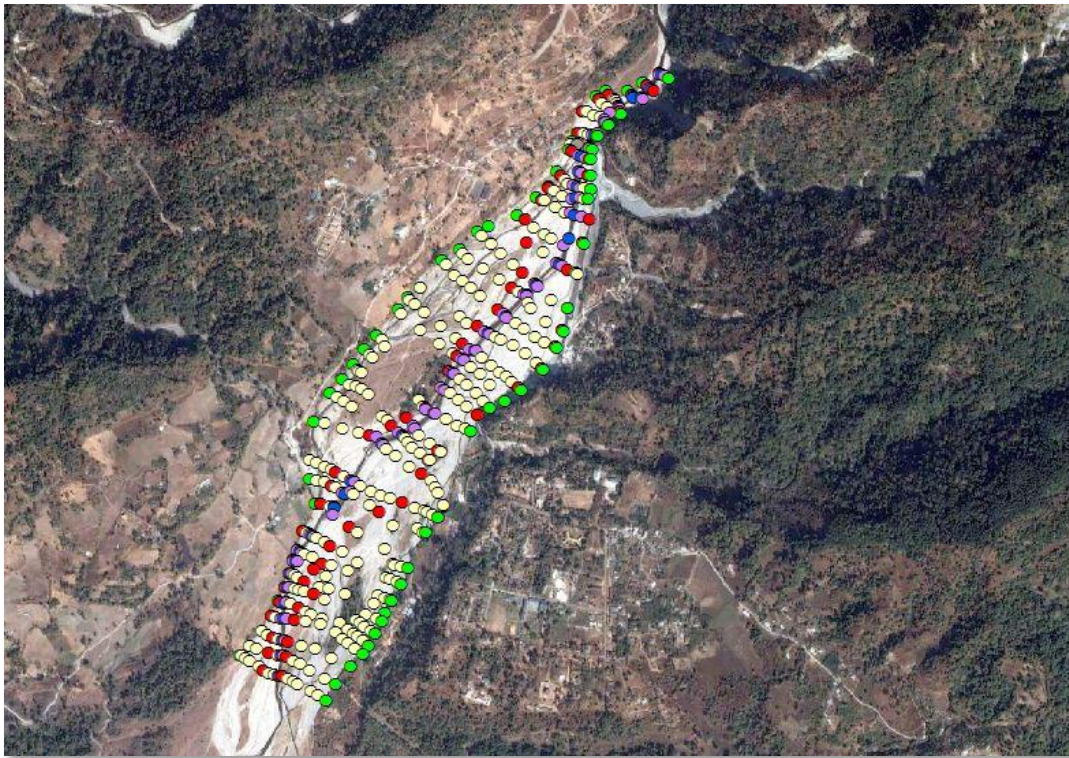
Figure 36: Sarpang Chhu cross-section survey

Taking cross-section survey of a river channel is important while conducting river analysis to find the river discharge, velocity, river profile etc. Cross-sections are required to represent channel geometry in a river hydraulic model. The accuracy of the simulated water levels and the floodplain delineation largely depends on the shape as well as extent of these cross-sections. For the assessment, the cross-section data was derived from DEM and also surveying using total station. The cross-section survey of Sarpang Chhu was carried out by FEMD, DES, MoWHS in December, 2016 as shown in *Figure 36*. About 42 numbers of cross-section data were collected along Sarpang Chhu.

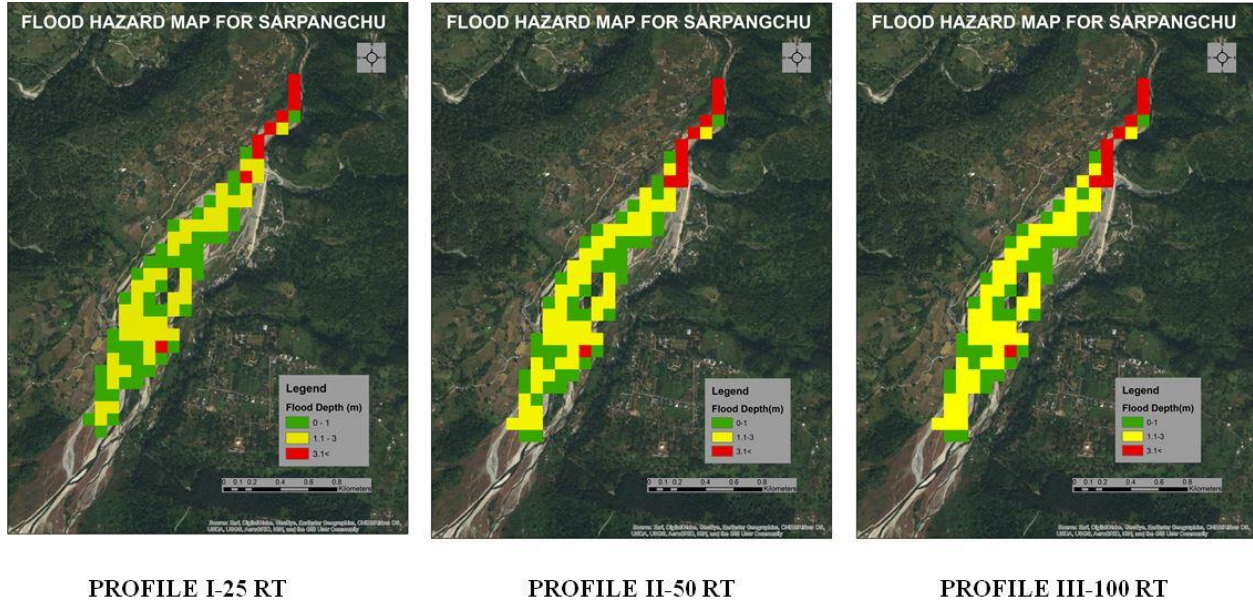
Figure 39: Preliminary flood hazard mapping for different discharges.

The flood maps in *Figure 39* show a clear snap shot of the flooding visualization along the river with elevation levels and areas susceptible to flooding for different scenarios. Generally, high water depth occur along the main channel and spreads gradually to the flood plains. The preliminary flood hazard map only identifies the likely areas to be flooded due to extreme rainfall events and give a mean depth of floodwaters within each region. The maps are based on the general land characteristics and rainfall pattern over the Sarpang Chhu catchment.
